國立臺灣大學工學院土木工程研究所

碩士論文

加勁擋土牆以含細粒料之回填土在降雨作用下之行為及改善方法評估

Evaluation of Improved Methods for Geosynthetic-Reinforced Soil Walls  
with Marginal Backfills subjected to Rainfall

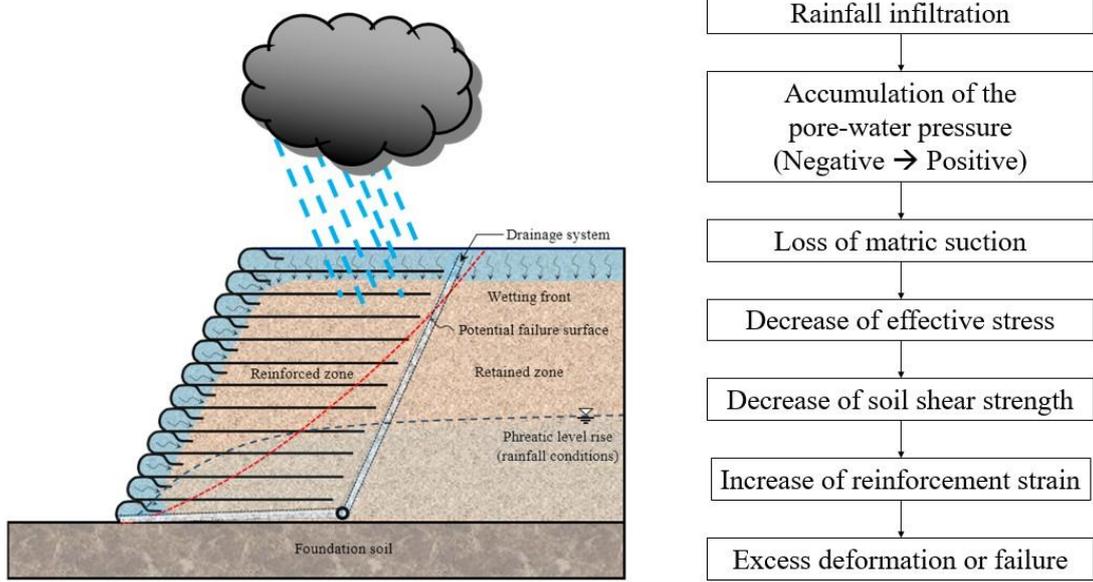
Figure 1.2 Mechanism of rainfall induced GRS structure failure

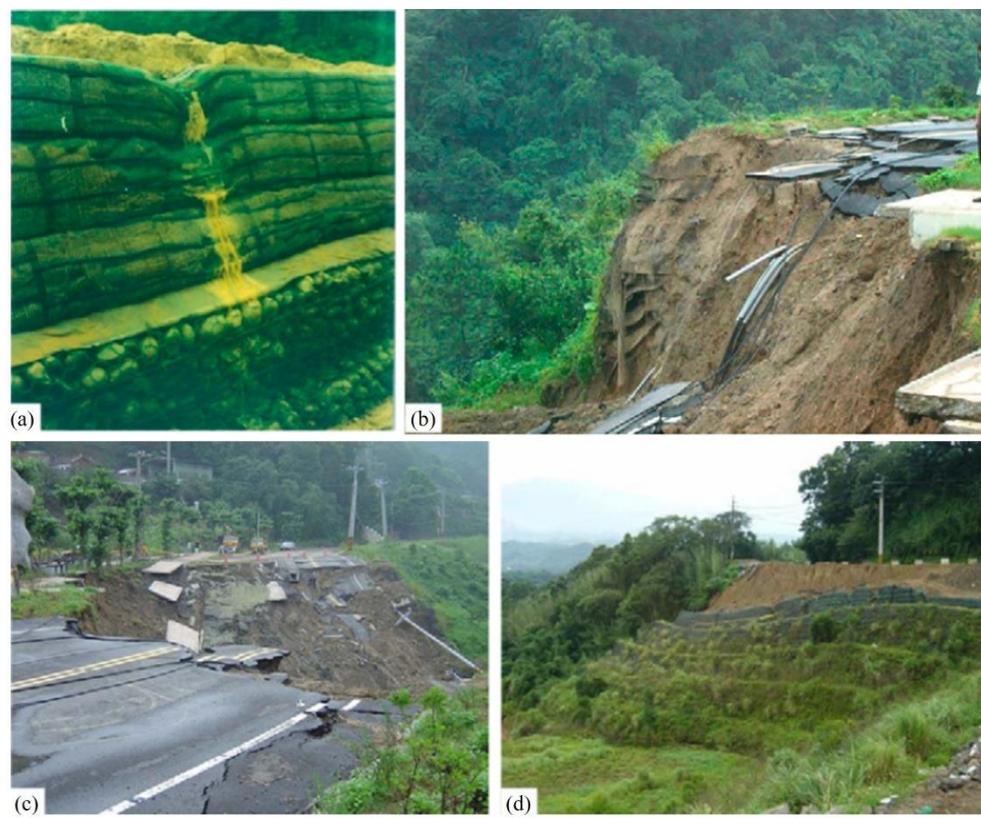
Figure 1.3 GRS wall failure caused by rainfall (Wu and Chou, 2013)

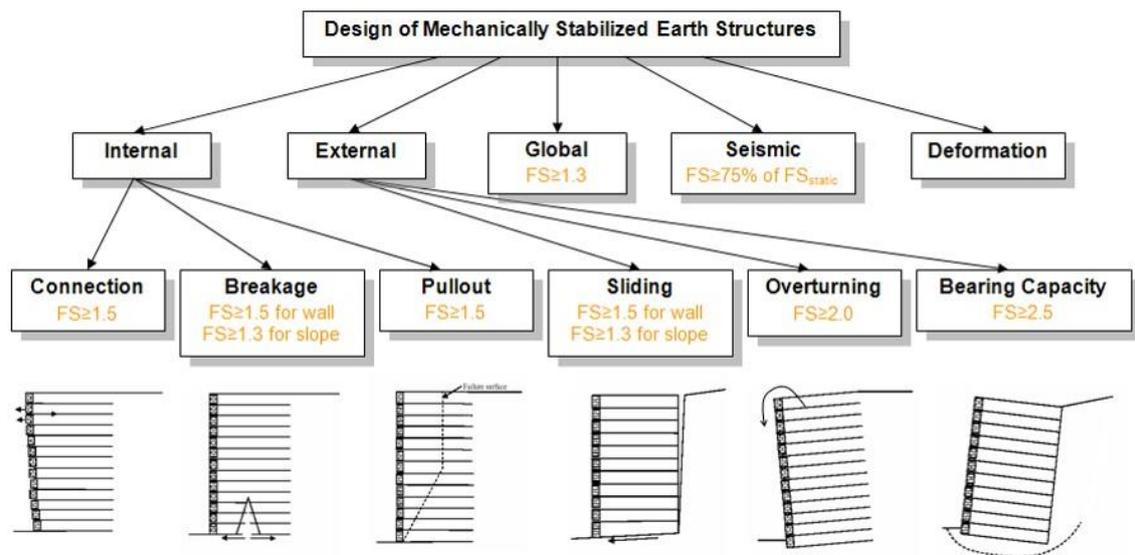
The failure mechanisms of the GRS structures, as shown in Figure 2.1, can be classified into two categories, namely, internal and external failure. Internal failure includes breakage, pullout, and connection of the reinforcement while external failure involves failure of sliding, bearing capacity, and overturning. The designing regulations for GRS structures, for example, FHWA, ASSHTO, and NCMA take the failure mechanisms into consideration. Breakage and pullout failure of the reinforcement are enunciated in the following sections. The failure mechanisms of external failure will not be elaborated since they are similar to that of the general retaining walls.

Figure 2.1 Failure mechanisms of GRS structures

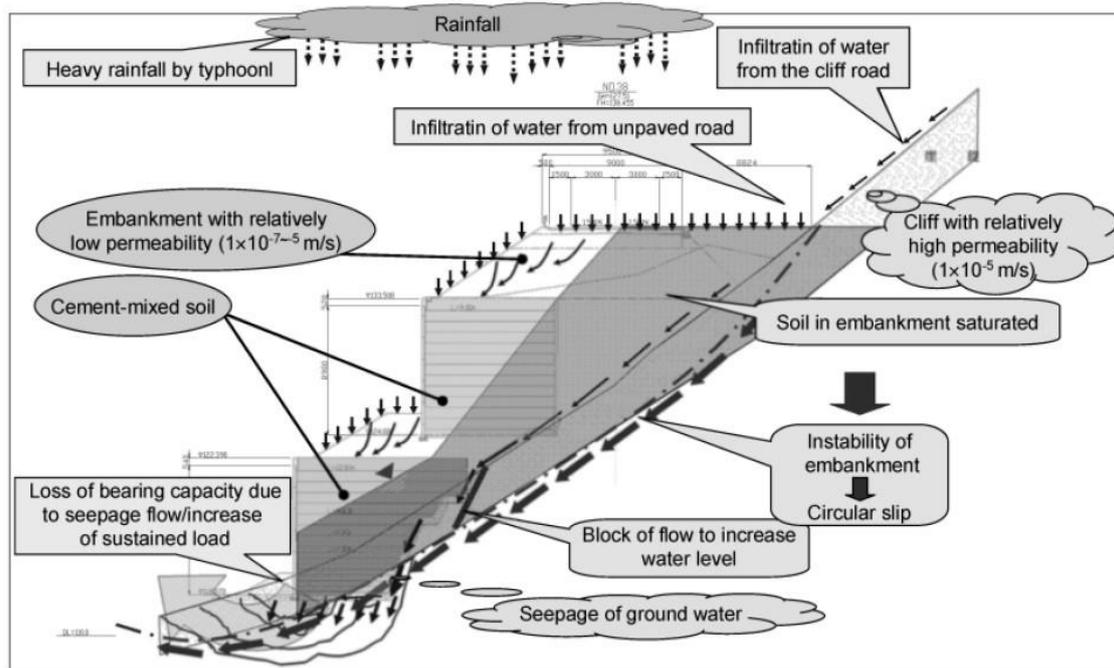
The western part of Japan was struck by Typhoon No. 23 in October 2004. Infrastructures over a wide area in Kansai were damaged severely. The accumulated rainfall was 226 mm while the maximum intensity was 10 mm/hr. Shibuya et al. (2007) investigated a failure of a large reinforced earth wall with a maximum height of about 23 meters that took place in a mountainous area. Figure 2.6 enunciates the scenario of the wall failure. The backfill material has a fines content larger than 25%. The wall failure may be attributed to simultaneous occurrence of several causes, including the concentration of in-soil seepage and surface water that flows into the failure zone, the relatively low permeability of the embankment, the poor drainage behind the wall, and the softening characteristic of the foundation soil as sheared undrained. It was concluded that drainage system should take care not only the wall but also the embankment behind and the wall should be placed on a foundation with larger bearing capacity (i.e., rock with SPT N-value larger than 50). Additionally, the short-term stability analysis of the wall should be employed considering the undrained condition upon designing.

Figure 2.6 Scenario of the wall failure (Shibuya et al., 2007)

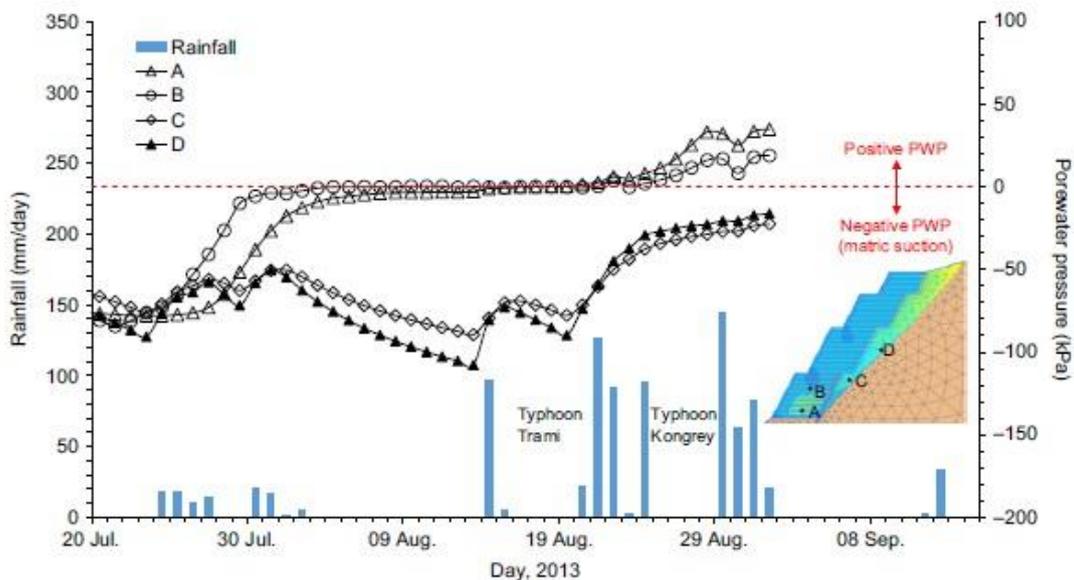
Yang et al. (2019) presented a comprehensive failure investigation of a GRS slope subjected to rainfall. The slope was 26-m high with four layers of geogrid reinforcement. The backfill soil contains more than 60% of fines and is considered as silty clay. Excessive deformation induced by heavy rainfall after typhoons were observed. The slope was pushed by the deformed weathered sandstone at the back and eventually collapsed in 2013 due to the accumulation of the rainfall (600mm). Figure 2.8 presents the development of the PWP along with the rainfall patterns. It was concluded that PWP was able to accumulate in the slope owing to the low draining capacity of the marginal backfill. Moreover, drainage system with flexible joints should be adopted in marginal backfilled GRS walls since excessive slope could occur upon the infiltration of rainfall.

Figure 2.8 Development of the pore water pressure (Yang et al., 2019)

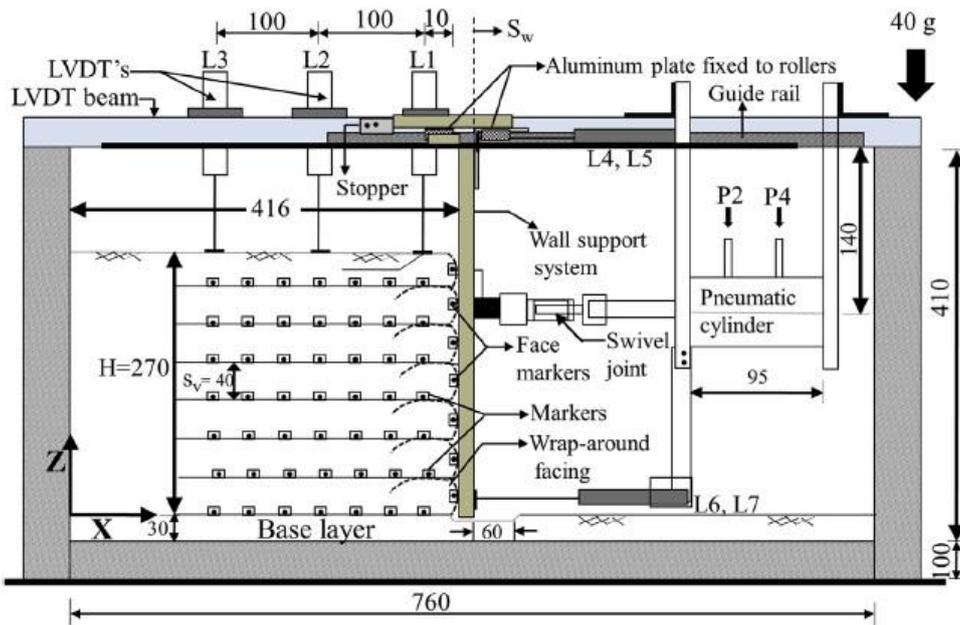
Figure 2.11 Cross-section view of the centrifuge model test instrumentation

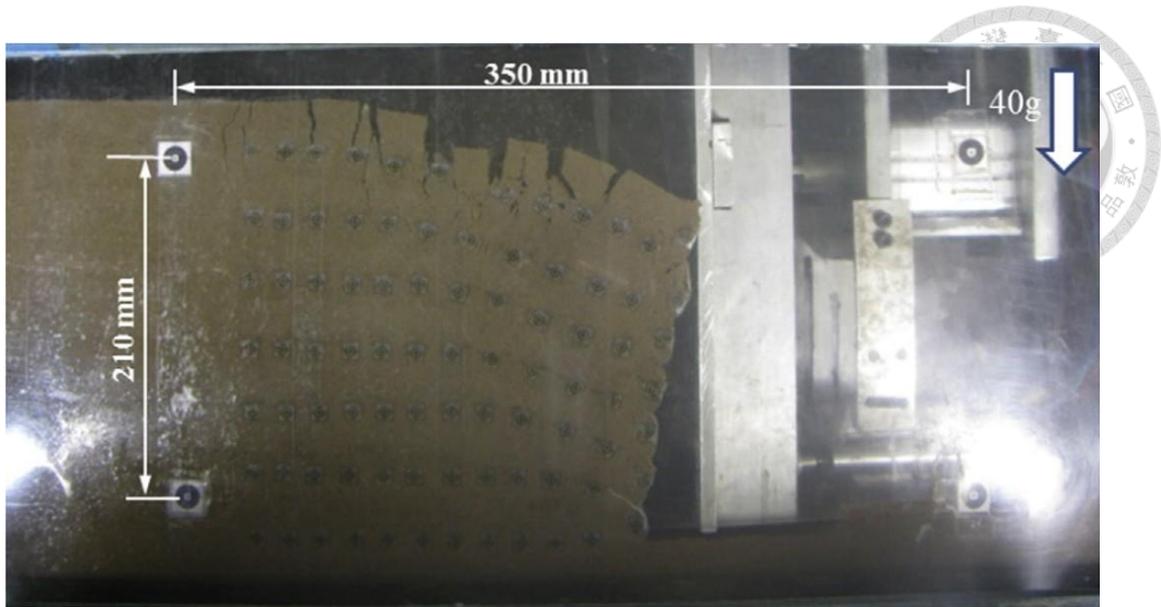
Centrifuge model tests were further conducted to convince the statement that the loss of interfacial shear resistance due to wetting of backfill is one of the possible reasons responsible for GRS wall failures (Balakrishnan and Viswanadham, 2016). A marginal soil with 21% fines was chosen as the backfill in the study. The testing soil had a maximum dry unit weight of  $17.3 \text{ kN/m}^3$  and a friction angle of  $34^\circ$ . Geogrid was used as the reinforcement; notably, a thin non-woven geotextile was stuck to geogrid in the facing portion to prevent soil particles coming out of geogrid openings. Figure 2.11 shows the instrumentation of the model tests. Excessive wall displacements were found and tension cracks were observed to take place right behind the reinforced zone if the reinforcement strength was not enough, as shown in Figure 2.12.

Figure 2.12 Tension cracks inspected during the tests (Balakrishnan and Viswanadham, 2016)

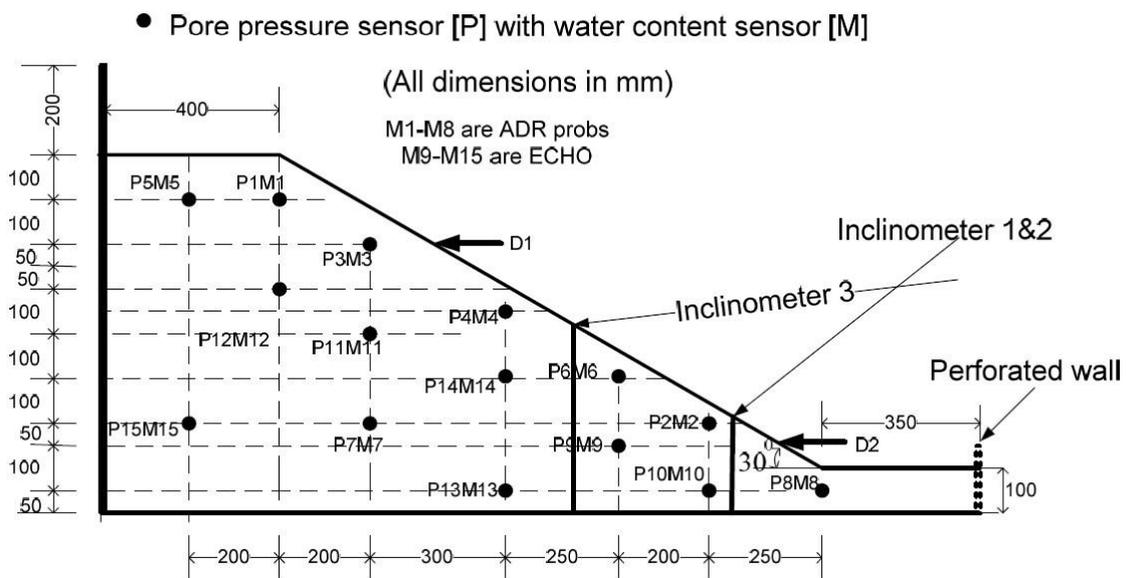
Gallage et al. (2012) conducted model tests of GRS slopes with different slope angles subjected to rainfall. The backfilled silty sand which contains 17% fines content had a maximum dry density and a specific gravity of  $1.725 \text{ g/cm}^3$  and 2.75, respectively. The slopes were subjected to rainfall with an approximate intensity of 40 mm/hr. Figure 2.13 presents the location of the sensors and Figure 2.14 shows the change of the pore water pressure and the volumetric water content throughout the test. The results indicated that the slopes with the inclination larger than the friction angle of the backfill can be stable until the suction was decreased by the infiltration of the rainwater into the slope; failures in slopes with gentler inclination were initiated by the development of the positive pore water pressure near the toe and is rather slow and progressive. Both results led to the conclusion that rainfall infiltration is a critical factor to the wall stability.

Figure 2.13 Sensor locations in the model tests (Gallage et al., 2012)

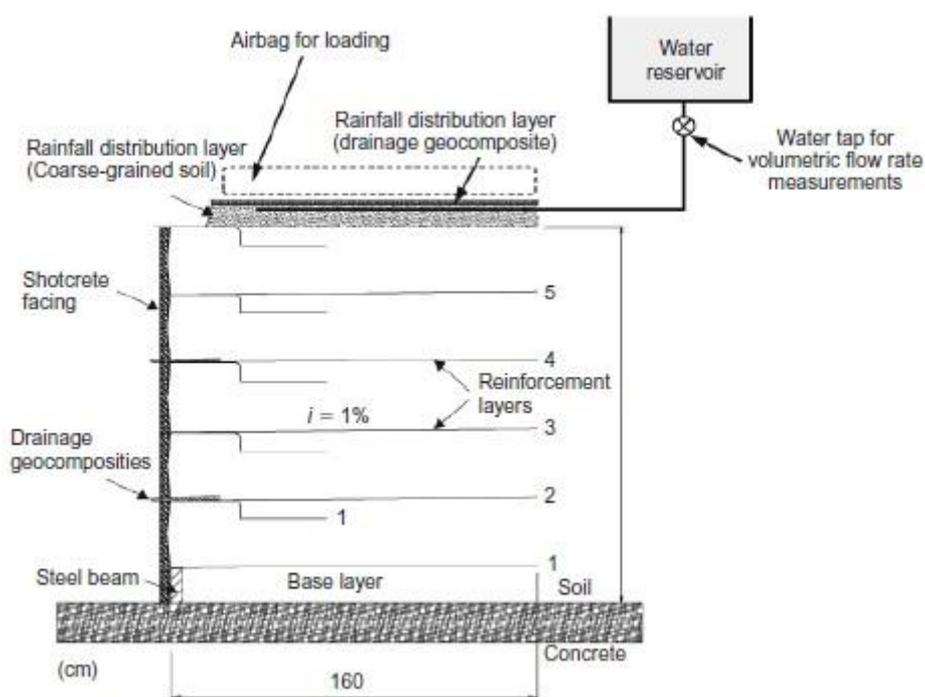
Full-scale laboratory model tests concerning the effect of rainfall infiltration were also carried out by Portelinha et al. (2013) and Portelinha and Zornberg (2017). Figure 2.17 presents the schematic view of the model wall and Figure 2.18 shows a full scale GRS wall test, done to monitor the hydraulic and mechanical responses. The model wall was 1.8 m and 1.55 m in height and width respectively. The backfill material includes 44% fines and has a saturated hydraulic conductivity of  $4.9 \times 10^{-7}$  m/s. A polyester needle-punched nonwoven geotextile was used as reinforcement to provide tensile strength and drainage. Vertical spacing of 30 cm was adopted in the study. The results illustrated that nonwoven geotextiles did provide internal drainage, which diverted approximately 25% of the water volume. Additionally, the infiltration of the rainfall led to a significant increase in reinforcement strains and wall displacement. In particular, the increase was caused by pore water accumulation, which resulted in an increase in the unit weight of the backfilled soil.

Figure 2.17 Schematic view of the full-scale model (Portelinha et al., 2013)

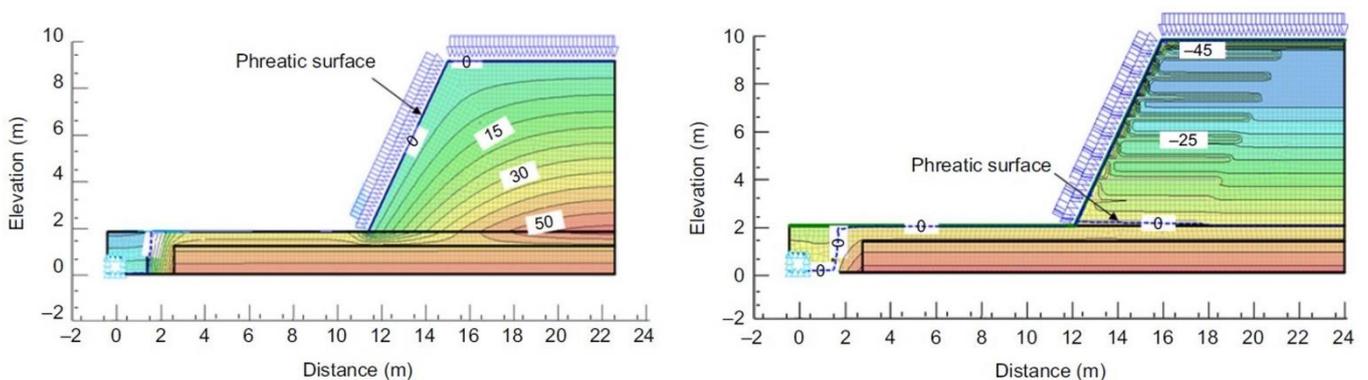
Bhattacharjee and Viswanadham (2015) discussed the effect of geosynthetic reinforcement to slopes under rainfall conditions. Numerical simulation was performed with the rainfall duration of 24 hours and the intensity of 2-80 mm/hr. Figure 2.19 presents the distribution of the PWP after rainfall in unreinforced and reinforced slope. The study concluded that reinforcement can provide drainage, restrain wall displacement, and enhance the wall stability.

Figure 2.19 Distribution of PWP after rainfall (Bhattacharjee and Viswanadham, 2015)

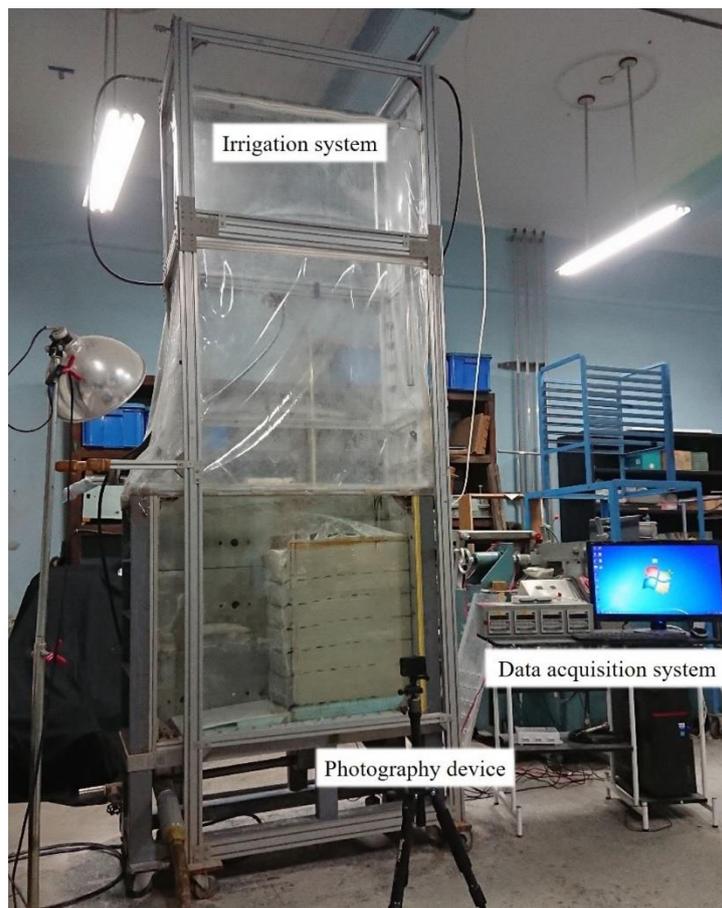
The sandbox used in this research has the dimensions of 100 cm, 30 cm, and 90 cm in length, width, and height, respectively. A Plexiglas window is mounted in the front of the sandbox for visual observation during the tests. Four wheels on the steel frame allows the sandbox be moved to or fixed at the designated location. The backside of the sandbox consists of three steel plates. The top one can be removed for the construction of the wall models. Various holes were chiseled on the steel plates for the installation of the measuring devices: two pore water pressure transducers and three volumetric water content gauges were installed to monitor the hydraulic performance during the tests. The details of the measuring apparatus are discussed later in Section 4.2. Figure 4.1 illustrates the schematic view of the sand box and the locations of the sensors, and Figure 4.2 shows a panorama of the experiment.

Figure 4.2 Panorama of the experiment

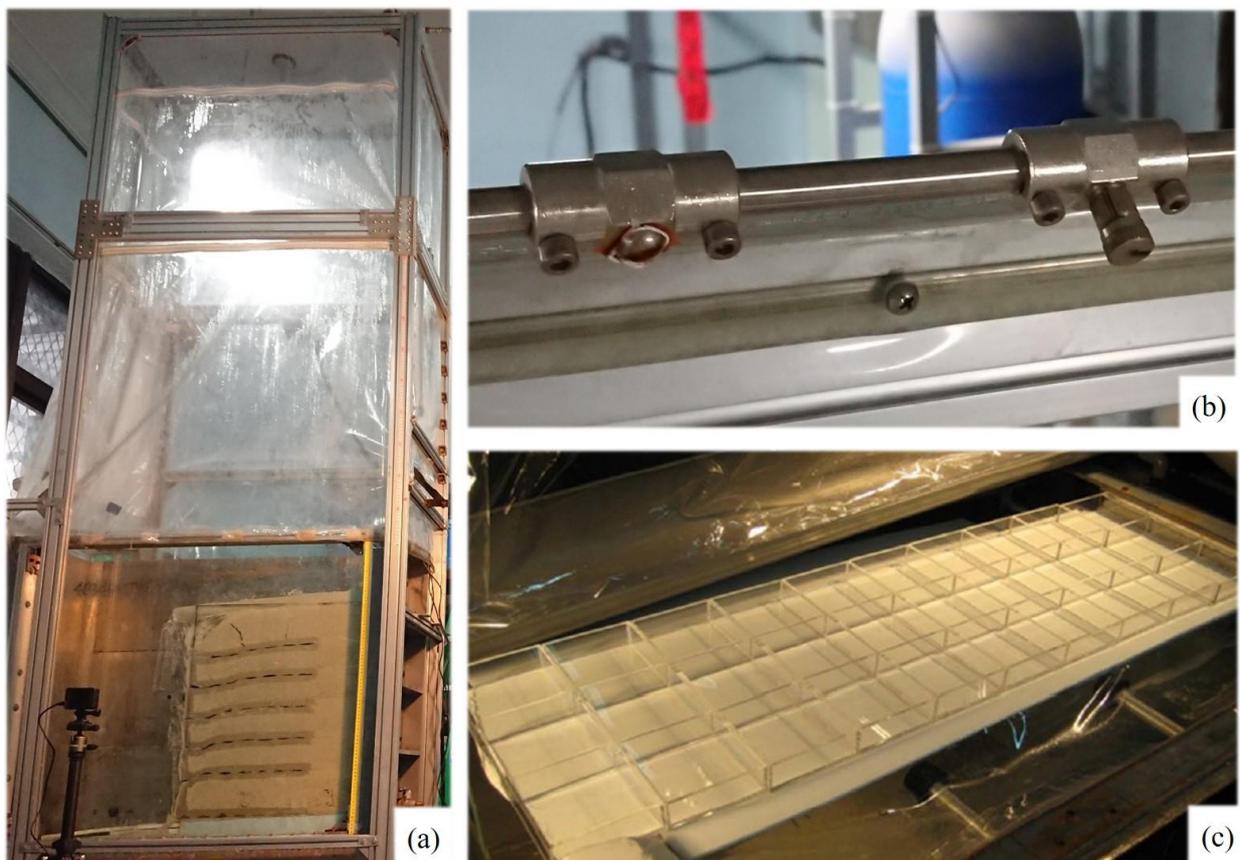
An irrigation system hanging over the sandbox was used to simulate rainfall. The tube at the left side of the sandbox served as the outlet of the rainfall and surface runoff. The irrigation system consists of two series of nozzles, 8 nozzles on each series was hung 160 cm above the sandbox to simulate rainfall conditions. The picture of the irrigation system is presented in Figure 4.3 (a). A pressurized motor connected to a faucet was used to pump the water up to the nozzles (Figure 4.3 (b)). The rainfall sprayed out from the nozzles was smaller than 0.1 mm. The fine sprays were ensured to achieve the terminal velocity upon falling on the GRS wall and do not erode the crest.

Figure 4.3 (a) Irrigation system; (b) Nozzles; (c) Transparent boxes

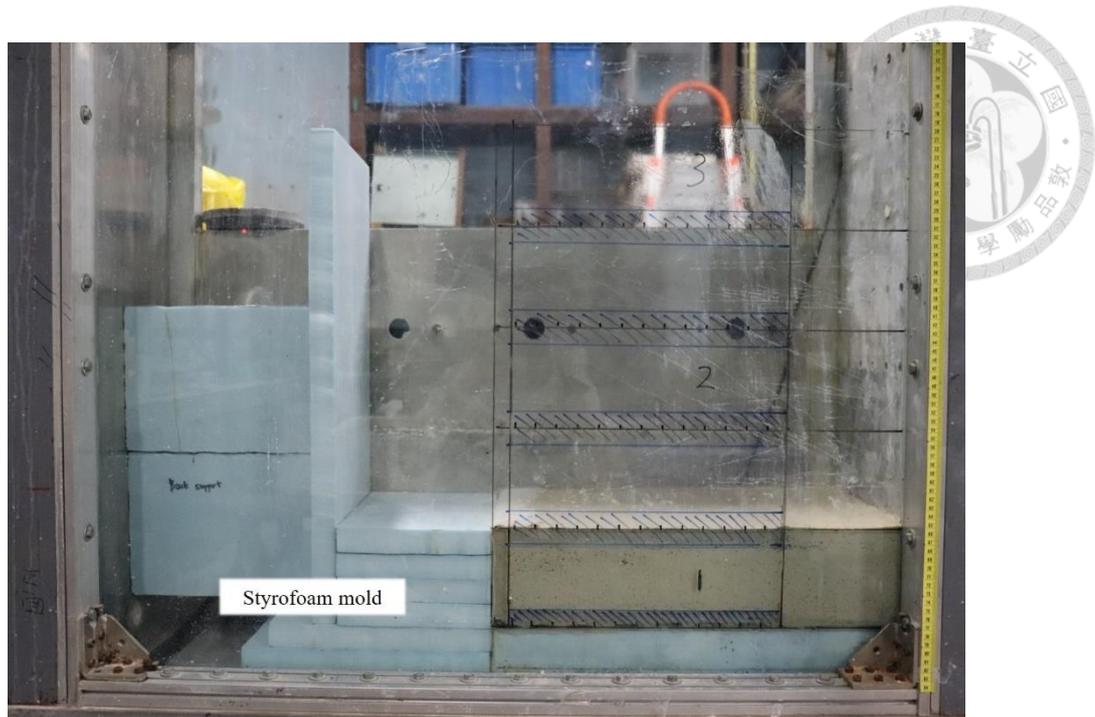
Blue Styrofoam boards were used as the formwork during the construction of the specimen, as shown in Figure 4.6. The Styrofoam boards were cut according to the designated length, width, and height and were piled up along with the construction of the specimen layer by layer. Moreover, interface treatment to reduce the effect of boundary friction is adopted according Liu et al., (2014), in which they suggested that lubricant sandwiched between PE sheets can reduce up to 67% of the boundary friction. Thus, water-based lubricant sandwiched between two PE sheets were applied to both side of the sand box to reduce the effect of boundary friction in this research. Thorough description of the procedure is enunciated subsequently.

Figure 4.6 Blue Styrofoam mold used for construction

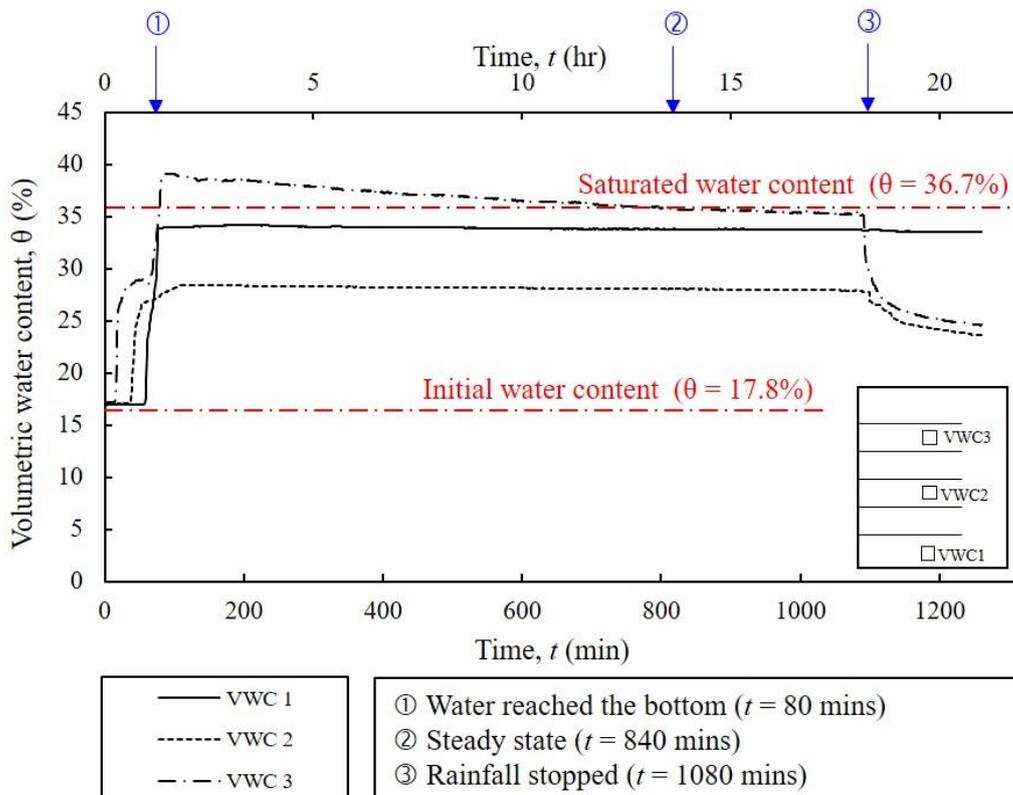
Figure 5.2 indicates the variation of the volumetric water content throughout the test. The important events were marked on the figure. It was suggested that VWC3 first sensed the flow of the water, followed by VWC2 and VWC1, conforming with the direction of water infiltration. Measured value is the same as the initial water content for soil preparation ( $\theta = 17.8\%$ ). VWC3 showing a value exceeding saturation resulted from the displacement-induced crack inside the model wall. The cracks (Figure 5.3) led to the phenomenon that the volume of the water is larger than the volume of the soil particles, making the original calibration curve no longer applicable. VWC1 and VWC2 were not able to reach saturation because the permeability of the backfill soil was extremely small compared to the rainfall intensity ( $i/k = 5.4$ ). VWC1 has larger value than VWC2 because of gravity; the water tended to flow down while some was still trapped in the top layers.

Figure 5.2 VWC with time elapse

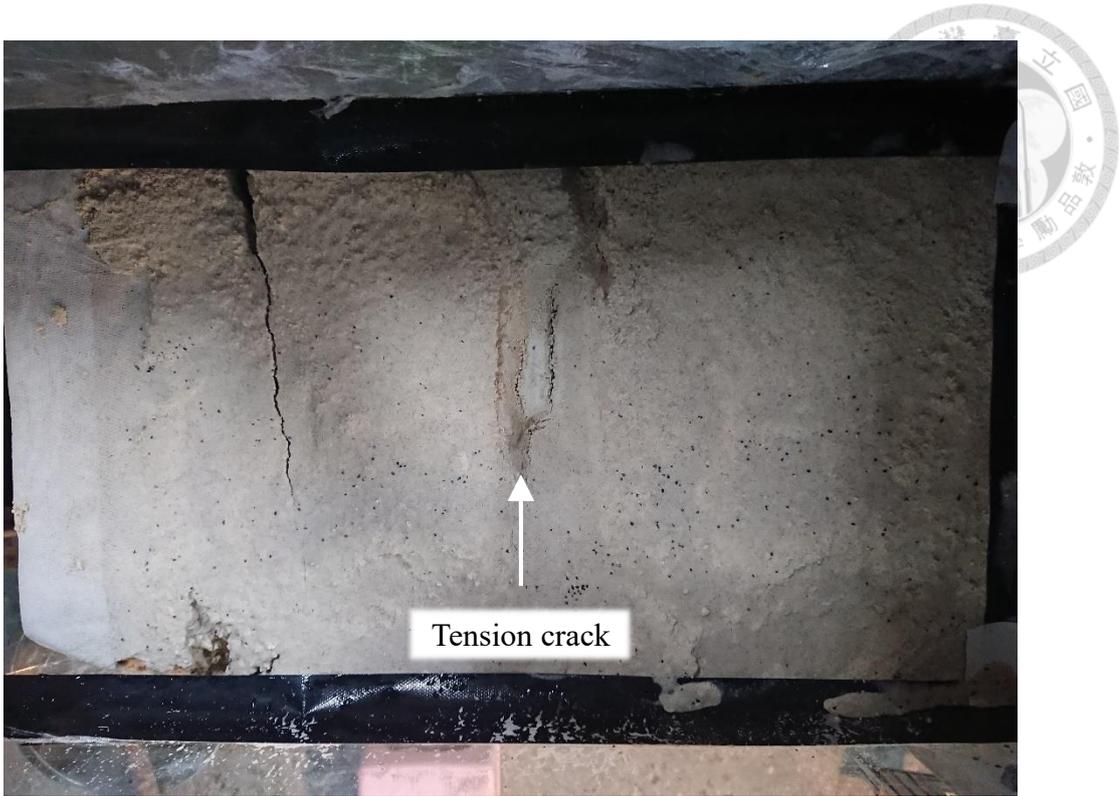
Figure 5.3 Picture of the cracks

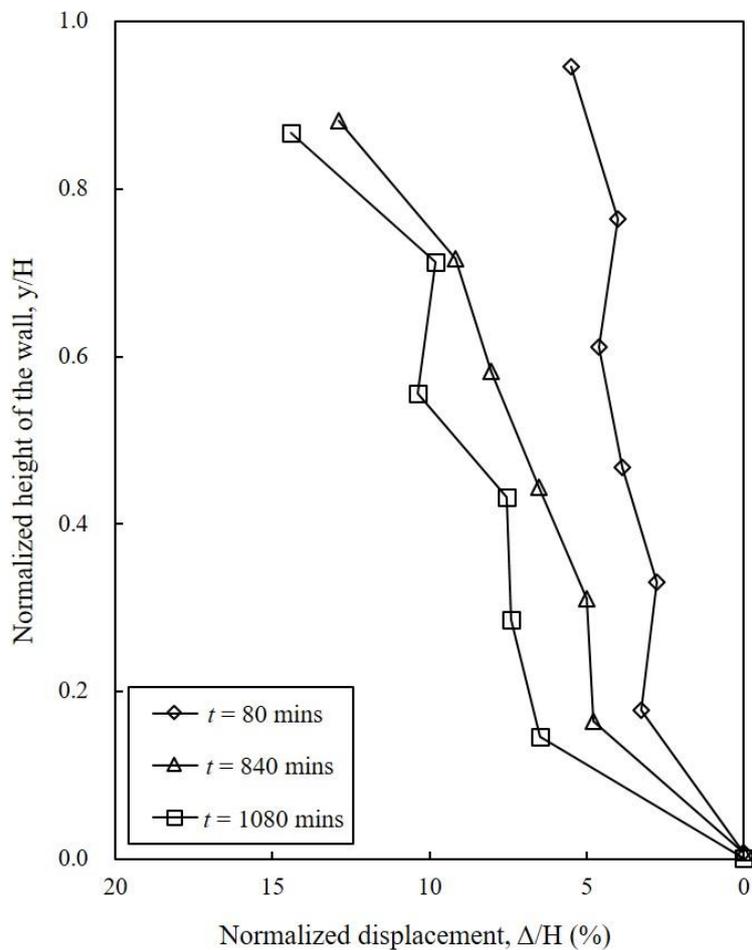
Figure 5.4 indicates the wall facing displacement profile at different time of the test. The figure suggested that the wall had moved when the water reached the bottom ( $t = 80$  mins). Since the permeability of the backfill is relatively low, the infiltrated rainfall concentrated at the top. Therefore, the maximum displacement was found at the topmost layer, around 15% of the wall height, forming a cantilever type of deformation. The bottom of the wall hardly moved because the friction between the model wall and the foundation was large enough to prevent sliding.

Figure 5.4 Wall displacement profile

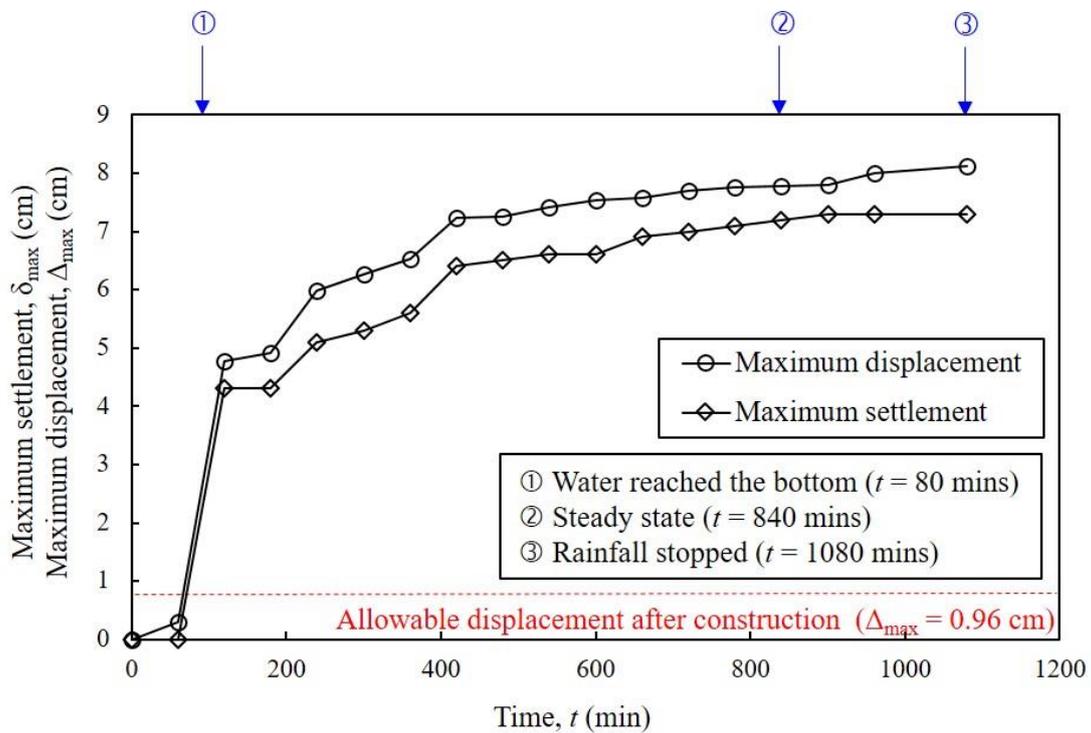
Figure 5.5 presents the maximum wall displacement and settlement versus time. The major displacement of 5 cm happened 1 hour after the rainfall started because of the influence of water infiltrated into the specimen, which caused the loss of matric suction in the backfill. Afterward, the wall displacement was progressively developed. A relatively small successive movement (3 cm) as rainfall proceeded and the wall eventually reached steady state. The geogrid reinforcement was able to minimize excessive wall displacement. The allowable displacement after construction indicated in the figure was based on the regulations of FHWA and AASHTO. In this study, a model GRS wall with 60 cm high and extensible geogrid as the reinforcement, the allowable displacement upon construction is 0.96 cm.

Figure 5.5 Maximum wall displacement and settlement versus time

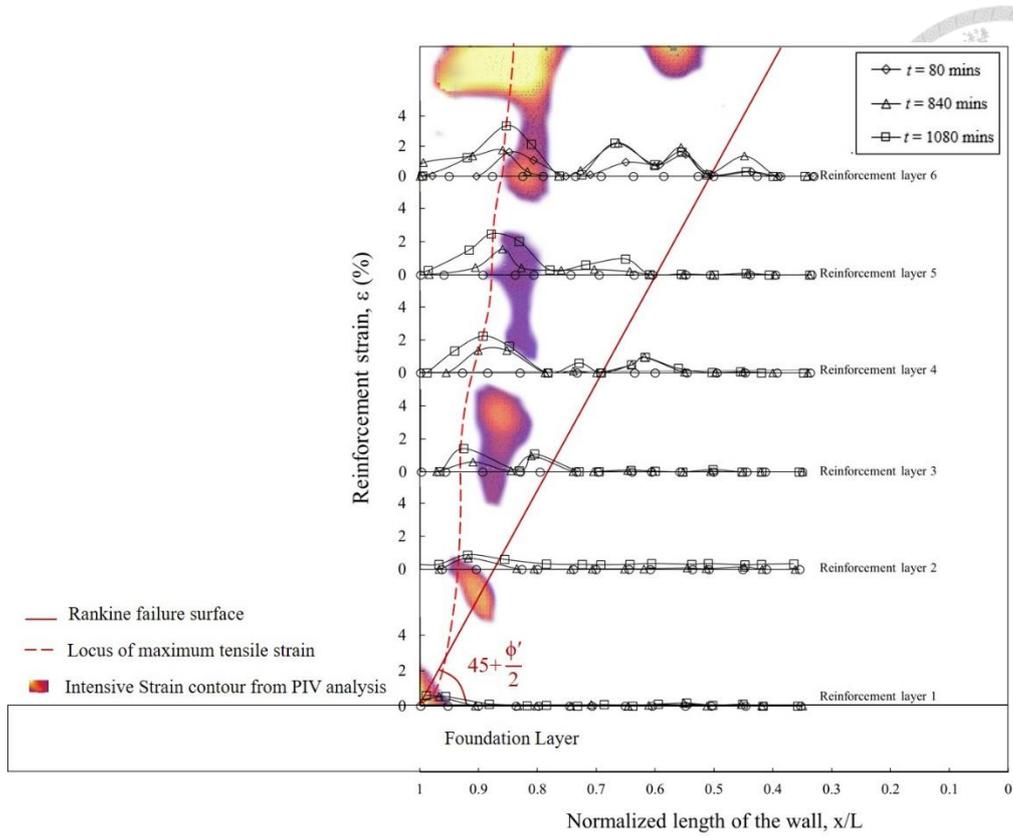
Figure 5.6 Reinforcement tensile strain and comparison of potential sliding surface

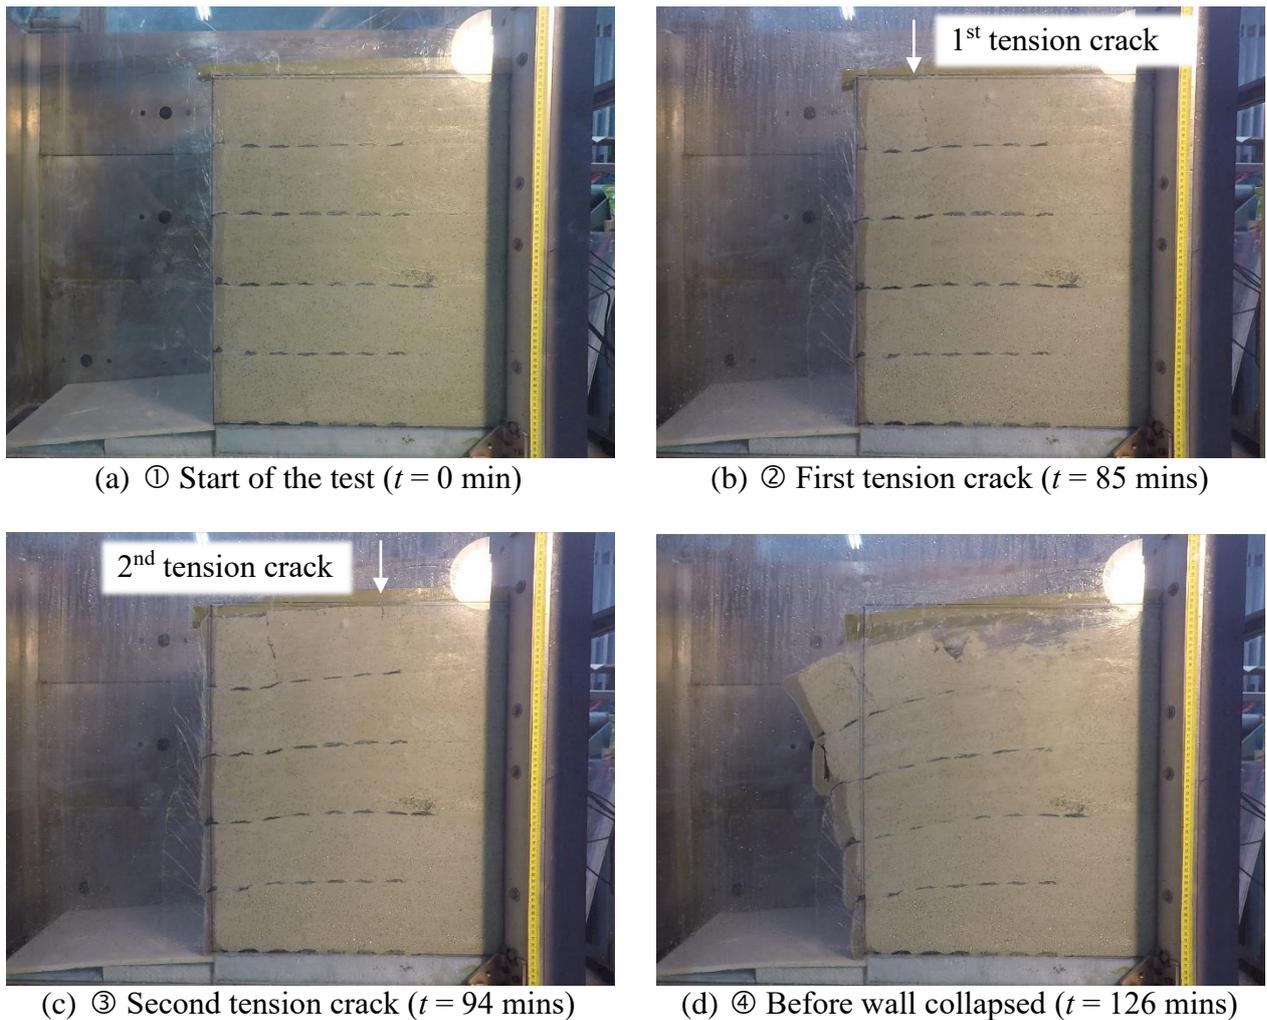
Figure 5.8 presents the photos of the test SM-S<sub>v</sub>12. The reinforced wall in this test failed in interlayer sliding mode. The wall displacement was too large for the PIV software to estimate the soil shear strain, so only the pictures during the test were presented. At  $t = 85$  mins, the development of the first tension crack was observed at the top of the wall. At  $t = 94$  mins, the second tension crack developed. Figure 5.9 shows a picture of the wall after collapse. Excessive wall displacement had ensued as rainfall proceeded, consequently causing the flip over of the wrap-around part of the top two layers.

Figure 5.8 Pictures of the model test SM-S<sub>v</sub>12

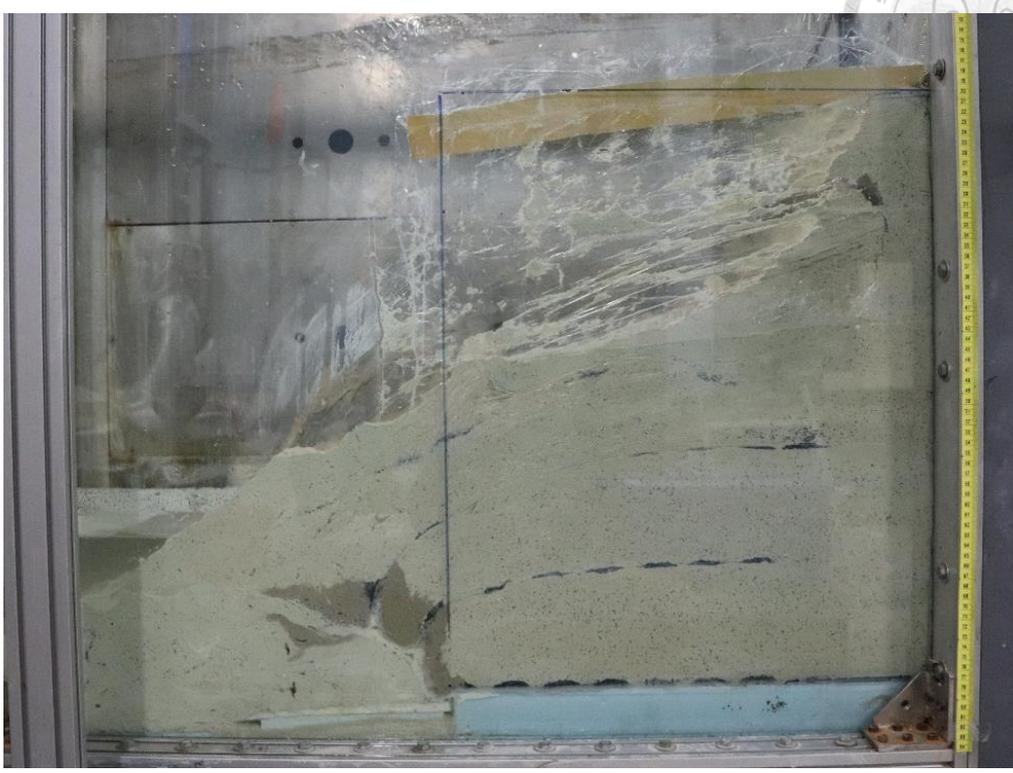
Figure 5.9 Collapse of the wall

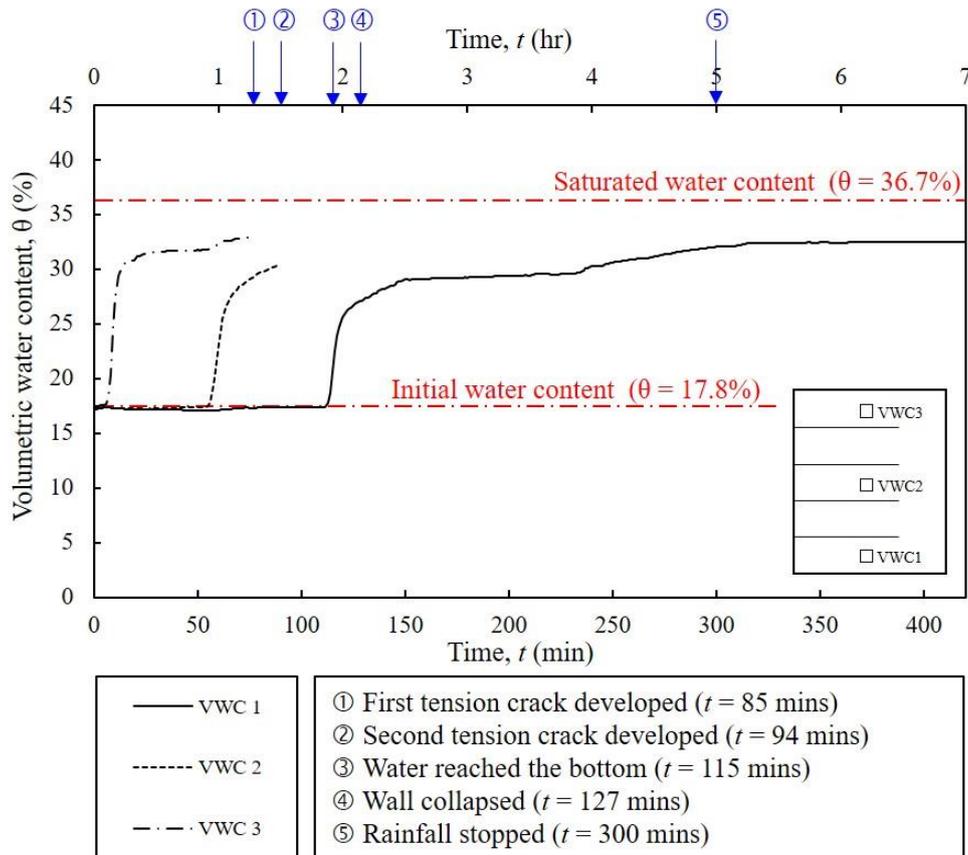
Figure 5.10 shows the change of the VWC with time elapse. The increase of  $\theta$  commenced in the order of VWC3, VWC2, and VWC1 as the water flowed from the top to the bottom. Notably, the water filled in the cracks, causing the measured VWC value exceeded saturation. The values for VWC3 and VWC2 were therefore cut off in succession upon the development of the tension cracks at 85 mins and 94 mins, respectively. The development of the cracks might issue in the longer time for water to reach the bottom of the wall ( $t = 115$  mins) compared to the test SM-S<sub>v</sub>9 ( $t = 80$  mins). VWC3 registered the highest  $\theta$  value, indicating that the water was confined in the top layers, causing the loss of matric suction. This is correlated to the observation that the deformation was the largest at the top layer where failure first commenced.

Figure 5.10 VWC with time elapse

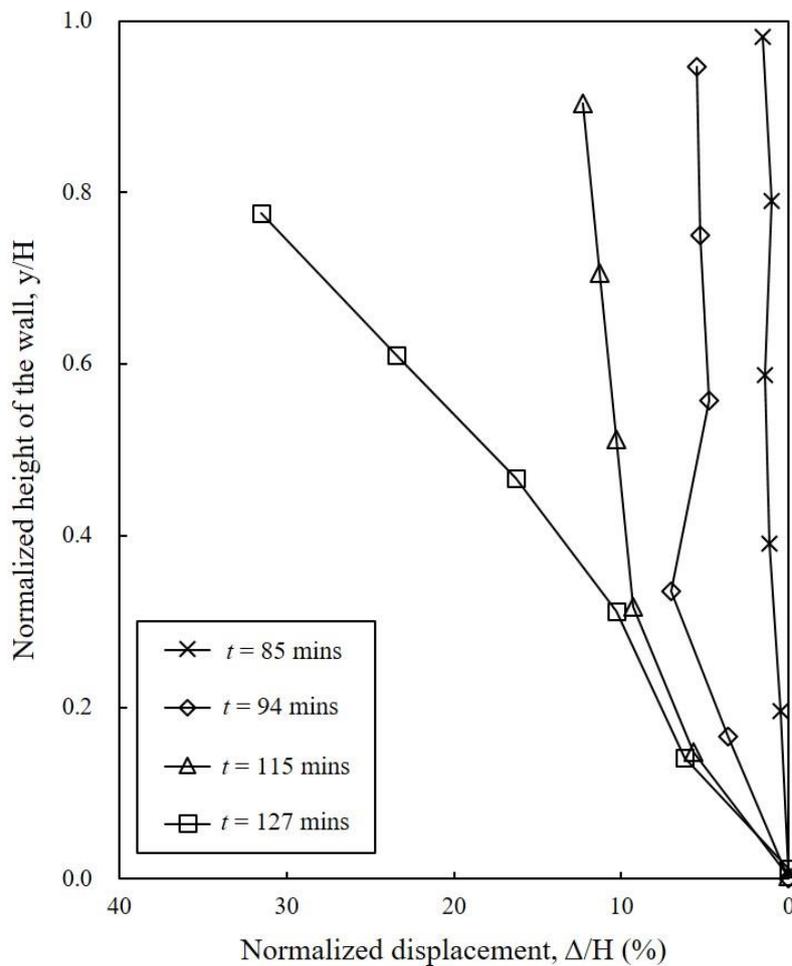
Figure 5.11 shows the development of the wall displacement profile of the reinforced wall before failure. When  $t \leq 94$  mins, before the two tension cracks were fully developed, the wall only deformed around 6% of the wall height. The wall continued to deform in the following 30 minutes and eventually collapsed. The maximum wall displacement before the wall failure was 32% of the wall height. The wall displacement increased with the increase of the elevation, displaying same deformation pattern as the test SM-S<sub>v</sub>9. The excessive deformation eventually dismissed the effect of the wrap-around although the wrap-around length for the topmost layer was extended.

Figure 5.11 Wall displacement profile

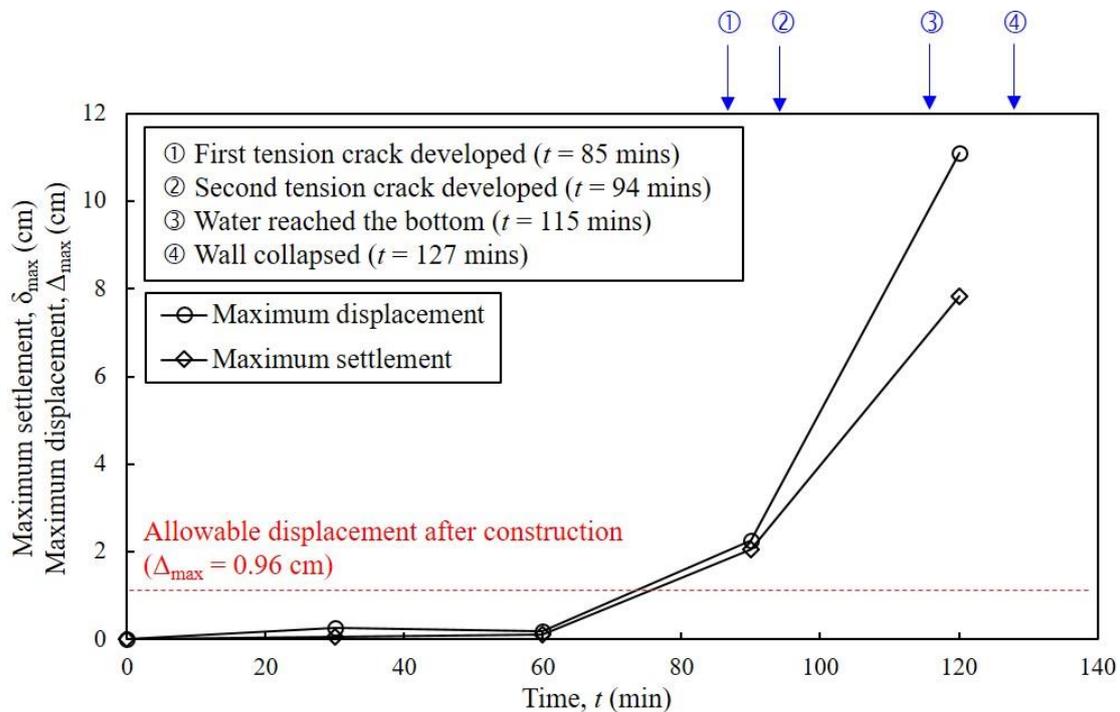
Figure 5.12 presents the maximum wall displacement with time. Displacement increased dramatically after the two tension cracks fully developed ( $t = 94$  mins) likely because the water filled into the voids, resulting in the reduction of the shear strength at the soil-geogrid interface. The wall displacement was only 2 cm at  $t \leq 94$  mins; however, the displacement continued increasing in the next 30 minutes and reached a maximum displacement of 11 cm right before the wall collapse. The soil can no longer withstand the lateral earth pressure due to the failure of the soil mass induced by the loss of matric suction and soil shear strength. The wrap-around of the topmost layer flipped over and the second layer failed in a resembling manner 90 minutes after that. The collapsed soil piled up and block the lower part of the reinforced wall. The remaining layers, layers 3, 2, and 1, would have failed in the resembling manner in succession without the limitation of the sandbox.

Figure 5.12 Maximum wall displacement and settlement versus time
