國立臺灣大學工學院土木工程研究所

碩士論文

加勁擋土牆以含細粒料之回填土在降雨作用下之行為及改善方法評估

Evaluation of Improved Methods for Geosynthetic-Reinforced Soil Walls  
with Marginal Backfills subjected to Rainfall

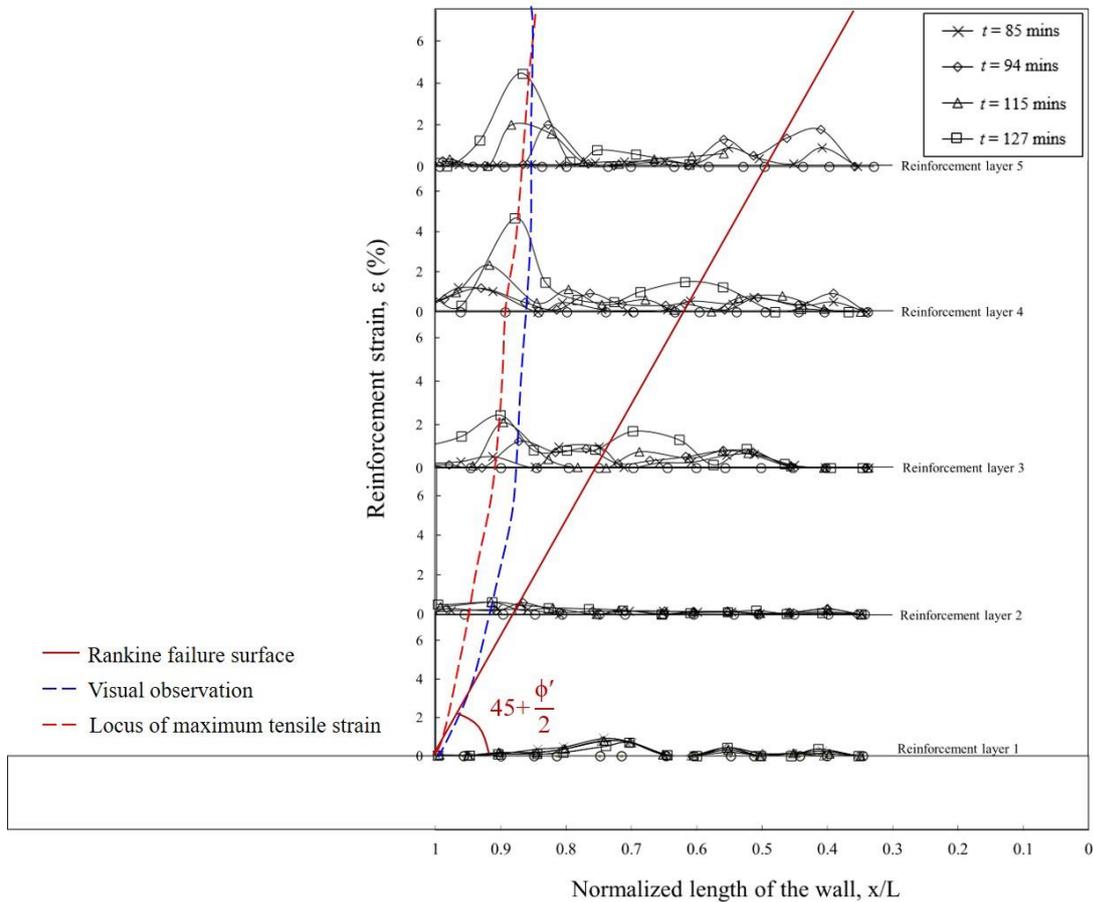
Figure 5.13 shows the mobilized reinforcement tensile strain in each layer before the wall collapsed. The largest displacement occurred in the top two layers, causing large reinforcement tensile strain be mobilized ( $\epsilon = 5\%$ ). The soil shear strain could not be estimated in the test SM-S<sub>v</sub>12 due to the limitation of the PIV software. The locus of maximum reinforcement strain in each layer was connected, indicating the critical failure surface. Notably, Rankine's failure surface corresponded to the secondary potential sliding surface indicated by the locus of larger reinforcement tensile strain.

Figure 5.13 Reinforcement tensile strain and comparison of potential sliding surface

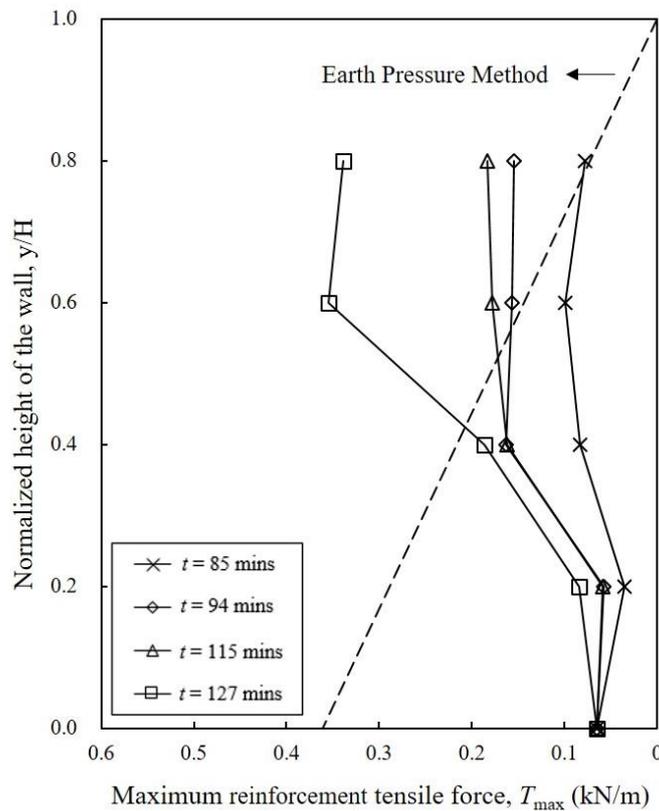
Figure 5.14 presents the maximum reinforcement tensile force profile. The mobilized reinforcement tensile strain showed similar pattern, cantilever type, as the wall displacement, which is different from the pattern suggested by the Rankine's earth pressure method. Therefore, the reinforcement at the top layers should be enhanced.

Figure 5.14 Maximum reinforcement tensile force profile

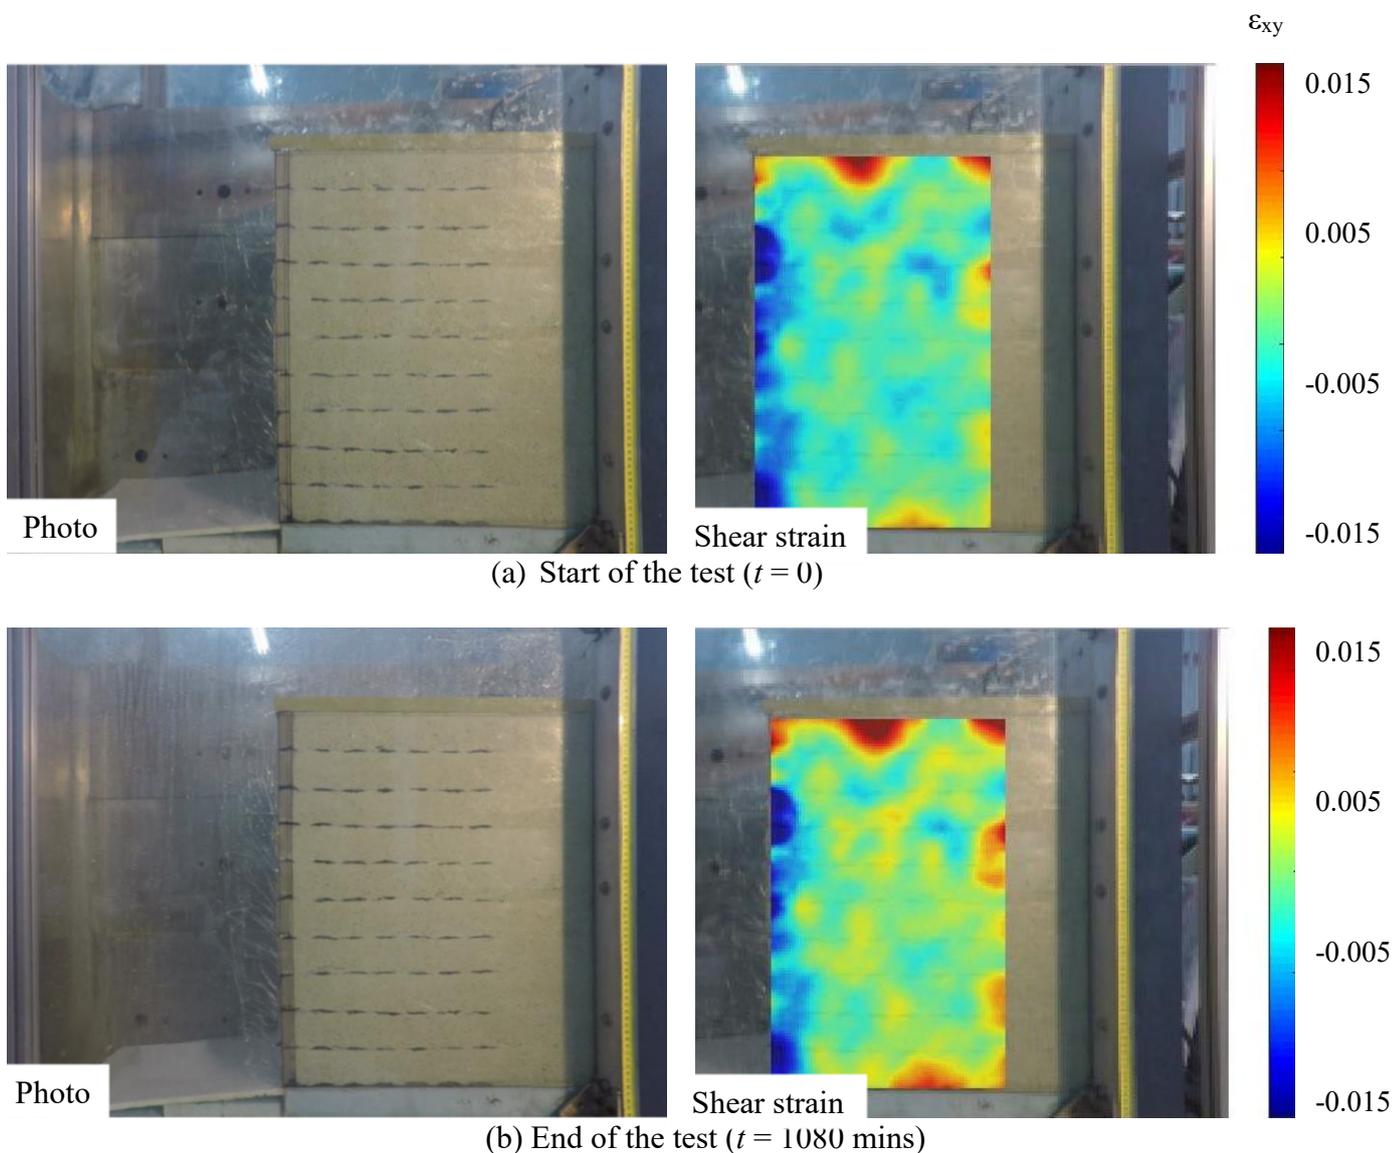
Figure 5.15 presents the photo of the model wall at the initial condition and the end. The wall remained stable and negligible displacement developed throughout the test because the spacing of the reinforcement is small enough to reinforce the marginal backfill. No failure was found as indicated by the rather high factor of safety and the observation after the test; neither was the displacement observed.

Figure 5.15 Pictures of the model test SM-S<sub>v</sub>6

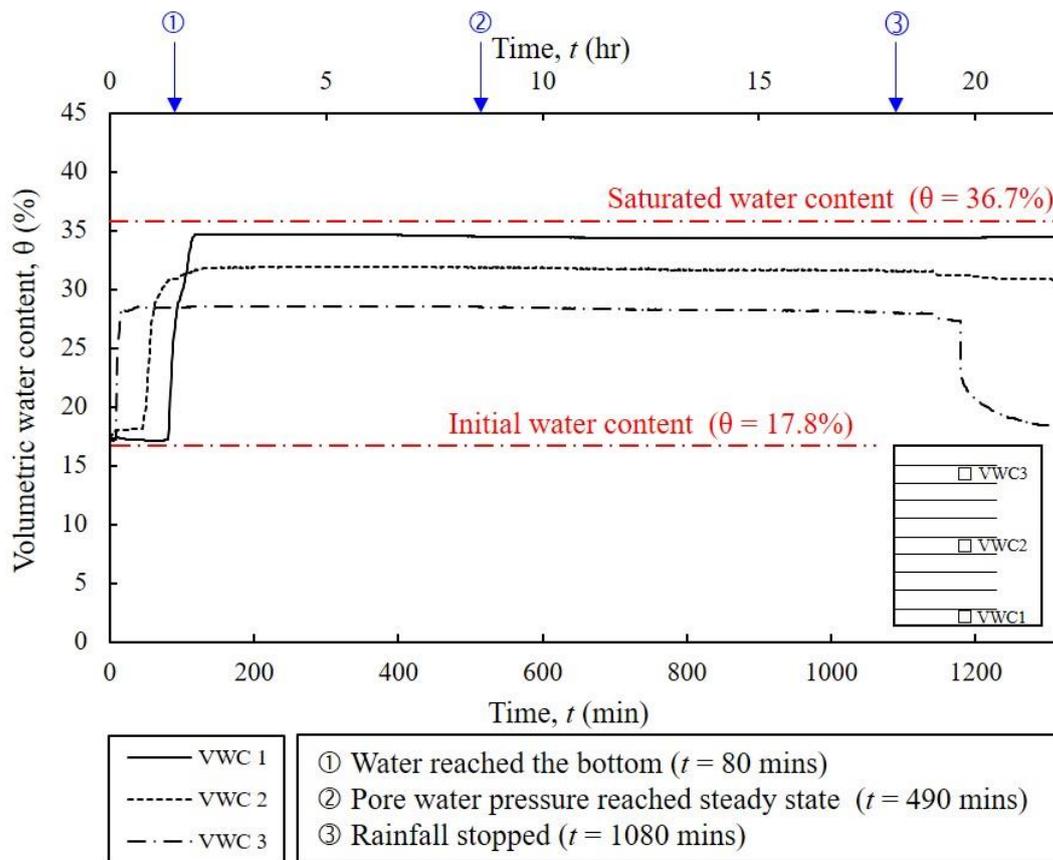
Figure 5.16 presents the change of the volumetric water content during the test. Clearly, VWC3, which was located at the top, sensed the wetting front first as the water infiltrated from the top to the bottom, followed by the increase at VWC2 and VWC1. Eventually, VWC1 registered the highest water content and reached saturation approximately.

Figure 5.16 VWC with time elapse

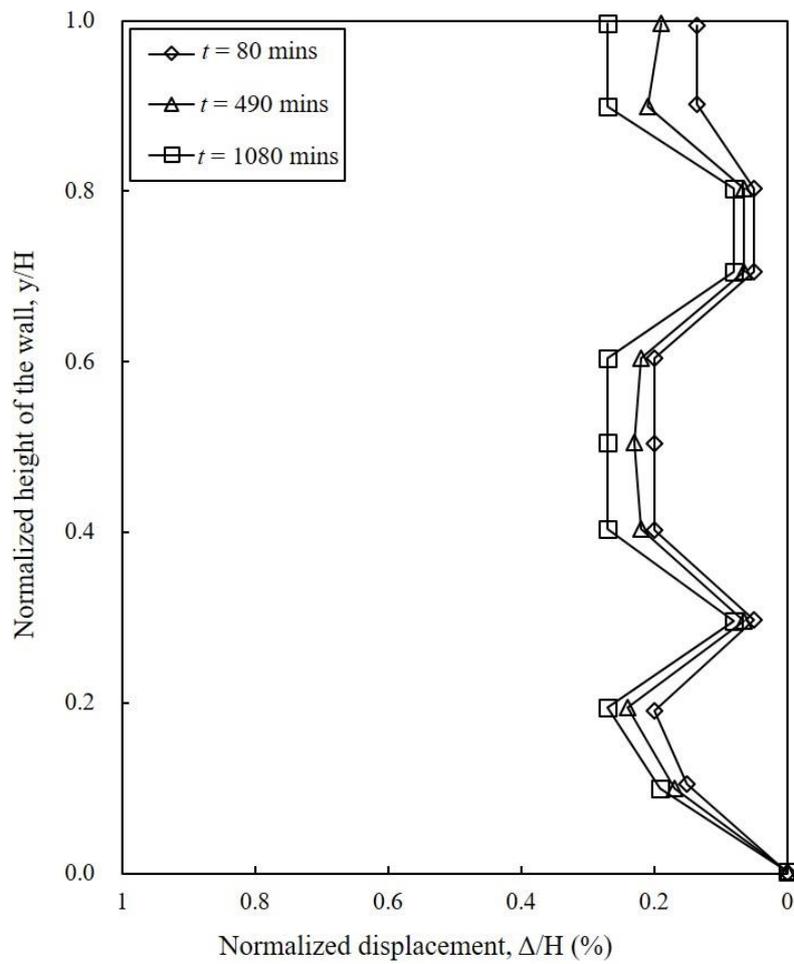
Figure 5.17 shows the wall displacement profile. The figure suggests that the maximum wall displacement was less than 0.3% of the wall height, which is considered too small to be observed by visual investigation. Since the reinforcement spacing is very small, the wall is stable enough to experience only minor displacement less than 1 cm.

Figure 5.17 Wall displacement

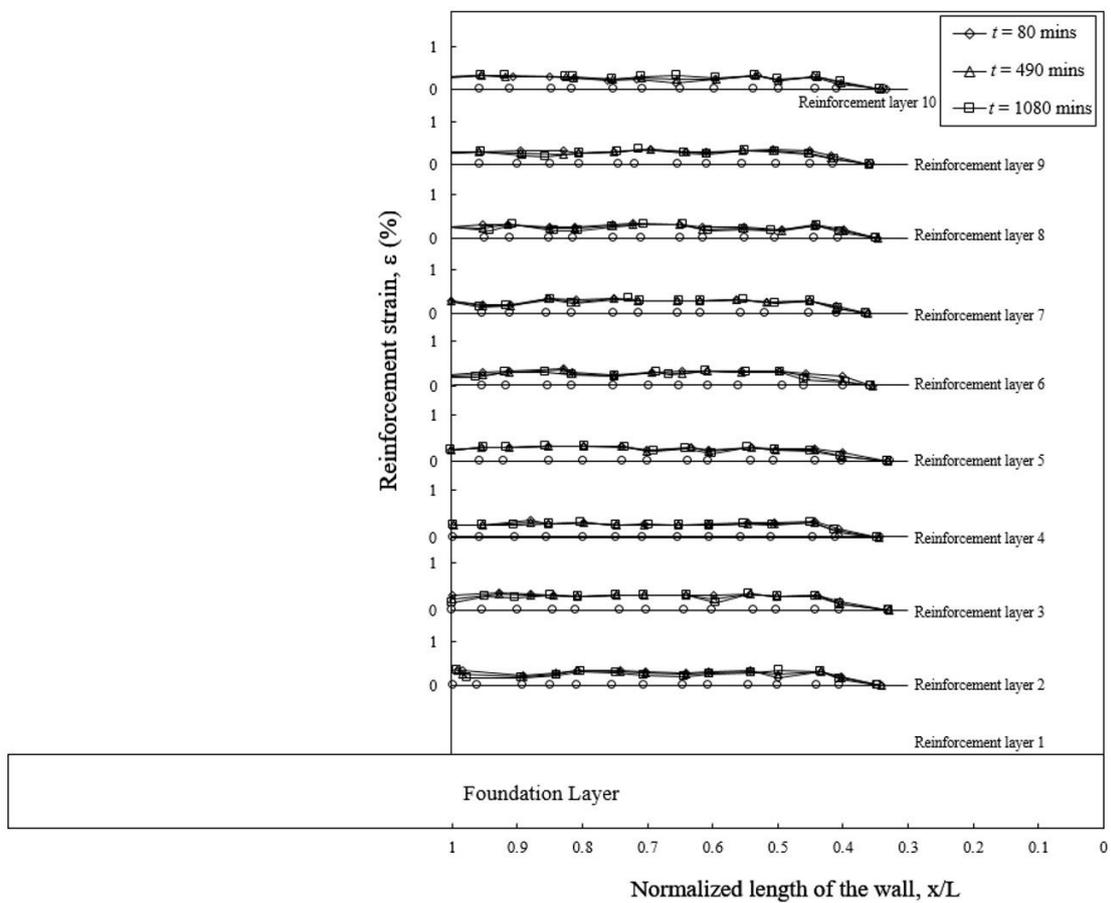
Figure 5.18 demonstrates the mobilized reinforcement strain in each layer. Little reinforcement strain was mobilized (less than 0.4%) since there was no significant relative displacement, as indicated by the wall displacement curve. Moreover, the shear strain contour and Rankine's failure surface were not plotted on the figure because only small displacement was investigated, and no potential sliding surface was observed as the reinforcement strain is minor.

Figure 5.18 Reinforcement strain

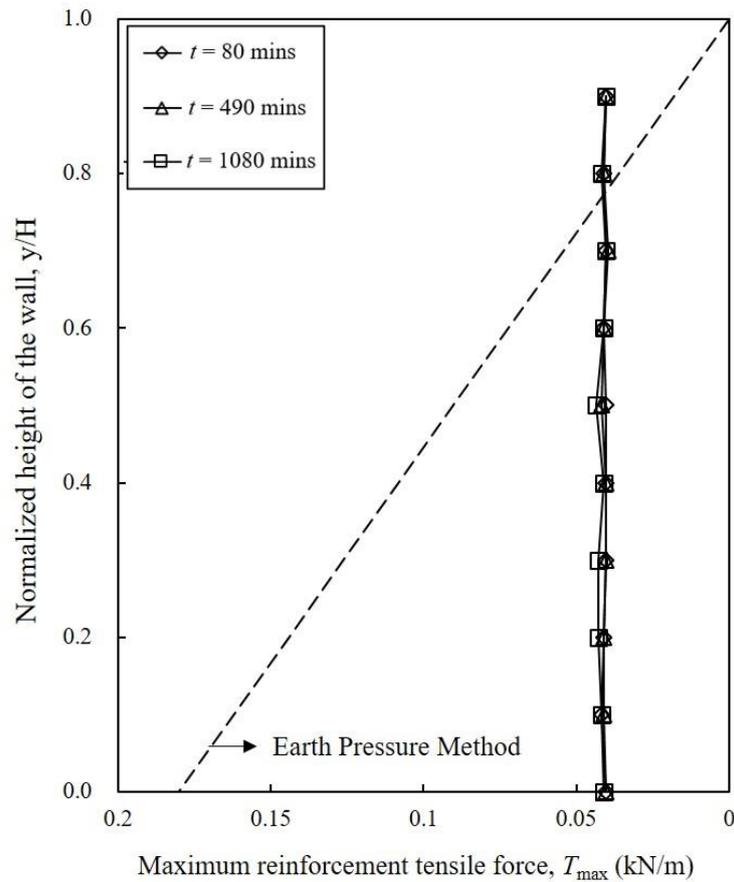
Figure 5.19 displays the maximum reinforcement tensile force profile. The mobilized reinforcement tensile strain was smaller than the values indicated by the earth pressure method since the wall hardly moved. The mobilized reinforcement tensile strain was uniformly small; the earth pressure method overestimated the tensile strain at the bottommost layer by 3.5 times.

Figure 5.19 Maximum reinforcement tensile force profile

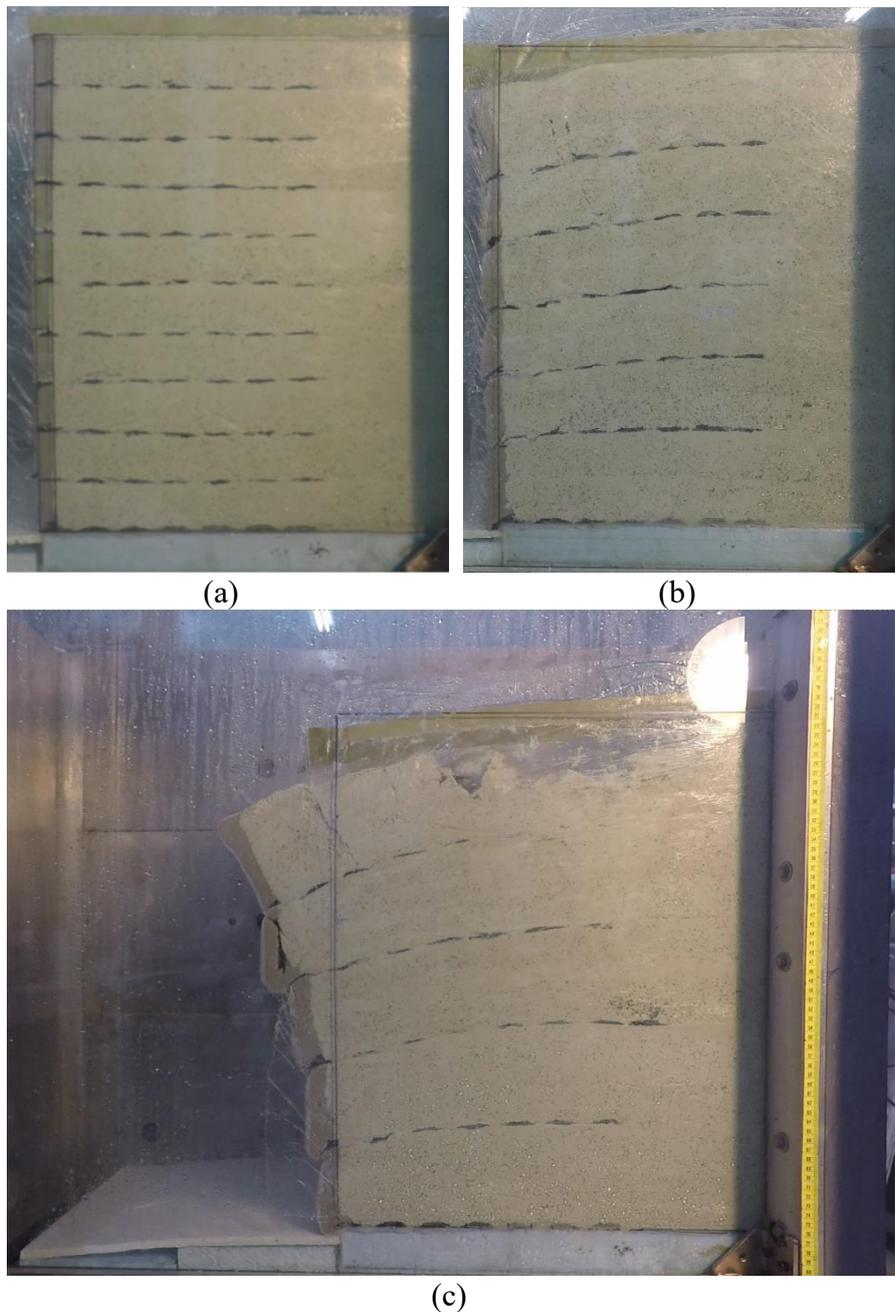
The test results of reinforced walls with three different spacing,  $S_v = 6, 9,$  and  $12$  cm, were compared in this section. Figure 5.20 shows the pictures of the three wall models at the end of the tests. The comparison of the  $FS$ , wall displacement, and the overall performance of the three tests is provided in this section.

Figure 5.20 Pictures of tests: (a) SM-S<sub>v</sub>6; (b) SM-S<sub>v</sub>9; (c) SM-S<sub>v</sub>12

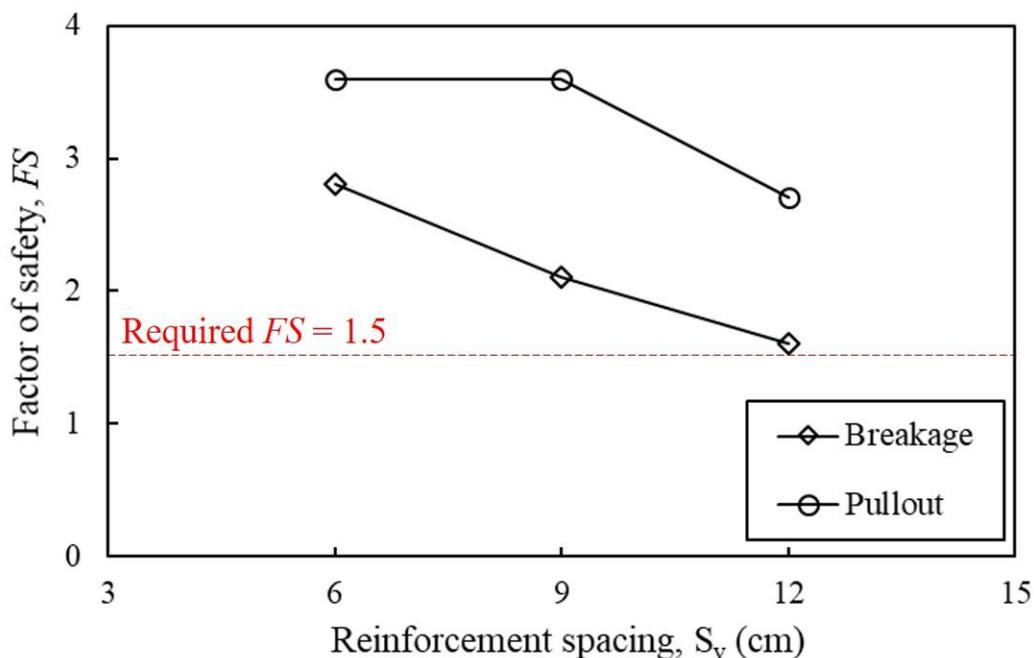
Figure 5.21 presents the factor of safety against breakage and pullout failure for the three cases. The factor of safety increases with the decrease of the reinforcement spacing. The  $FS$  in the test SM-S<sub>v</sub>6 is the highest ( $FS_{\text{breakage}} = 2.8$  and  $FS_{\text{pullout}} = 3.6$ ) whereas the  $FS$  in the test SM-S<sub>v</sub>12 is the lowest ( $FS_{\text{breakage}} = 1.6$  and  $FS_{\text{pullout}} = 2.7$ ).  $FS_{\text{breakage}}$  in the test SM-S<sub>v</sub>12 is only slightly larger than the required value ( $FS = 1.5$ ). Notably, the required  $FS$  was designed under normal condition. The test SM-S<sub>v</sub>12 failed under the prescribe rainfall condition, therefore indicating that the  $FS$  under rainfall conditions needs further modification.

Figure 5.21 Factor of safety under different reinforcement spacing

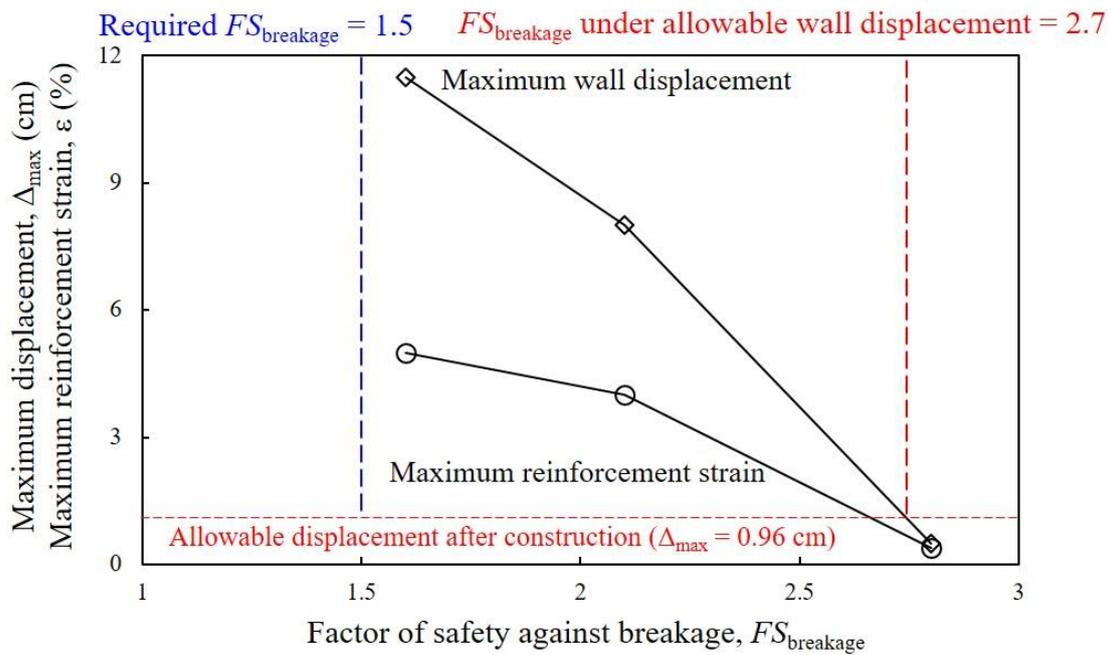
Figure 5.25 indicates the corresponding  $FS$  with different maximum displacement and reinforcement tensile strain. The figure shows that the  $FS_{\text{breakage}}$  is very sensitive to the wall displacement. The  $FS$  significantly increases with the decrease of the maximum wall displacement. When the wall displacement is large (11 cm),  $FS_{\text{breakage}} = 1.6$ , only slightly larger than the required value ( $FS_{\text{breakage}} = 1.5$ ). When  $FS_{\text{breakage}}$  was very large, the wall would only experience little displacement. Hence, this figure can serve as an indicator for GRS walls with marginal backfills under rainfall conditions. The designed  $FS$  should be increased 1.8 times under rainfall conditions in accordance with the allowable wall displacement.

Figure 5.25  $FS_{\text{breakage}}$  versus maximum displacement and reinforcement tensile strain

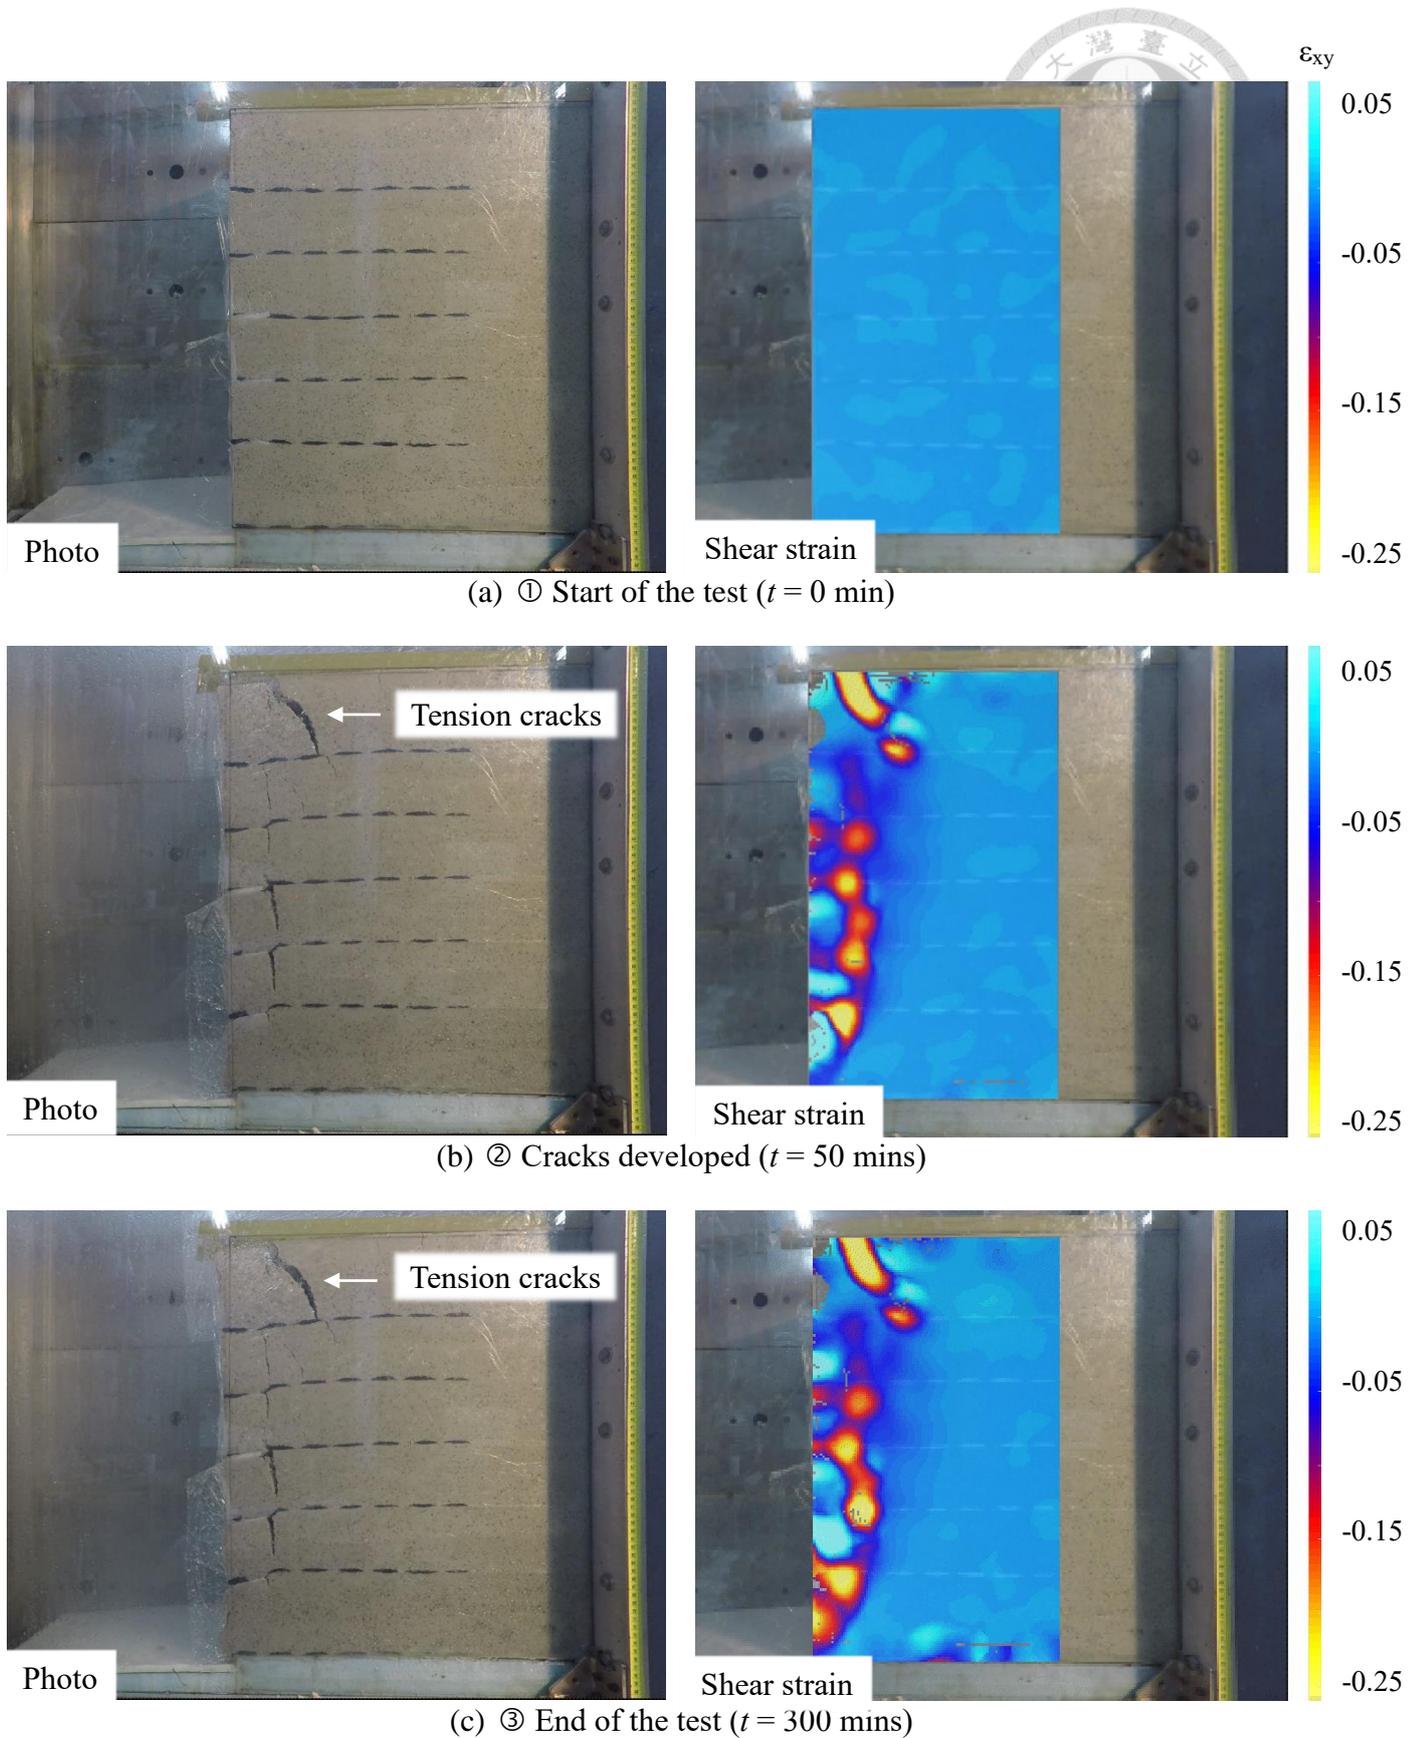
Figure 6.1 presents the photos of the model test SP-S<sub>v</sub>9. Cracks appeared at  $t = 50$  mins and thereafter no further significant deformation was observed. Notably, the location of the crack corresponds to where the reinforcement was embedded to form the wrap-around facing.

Figure 6.1 Pictures of the model test SP-S<sub>v</sub>9

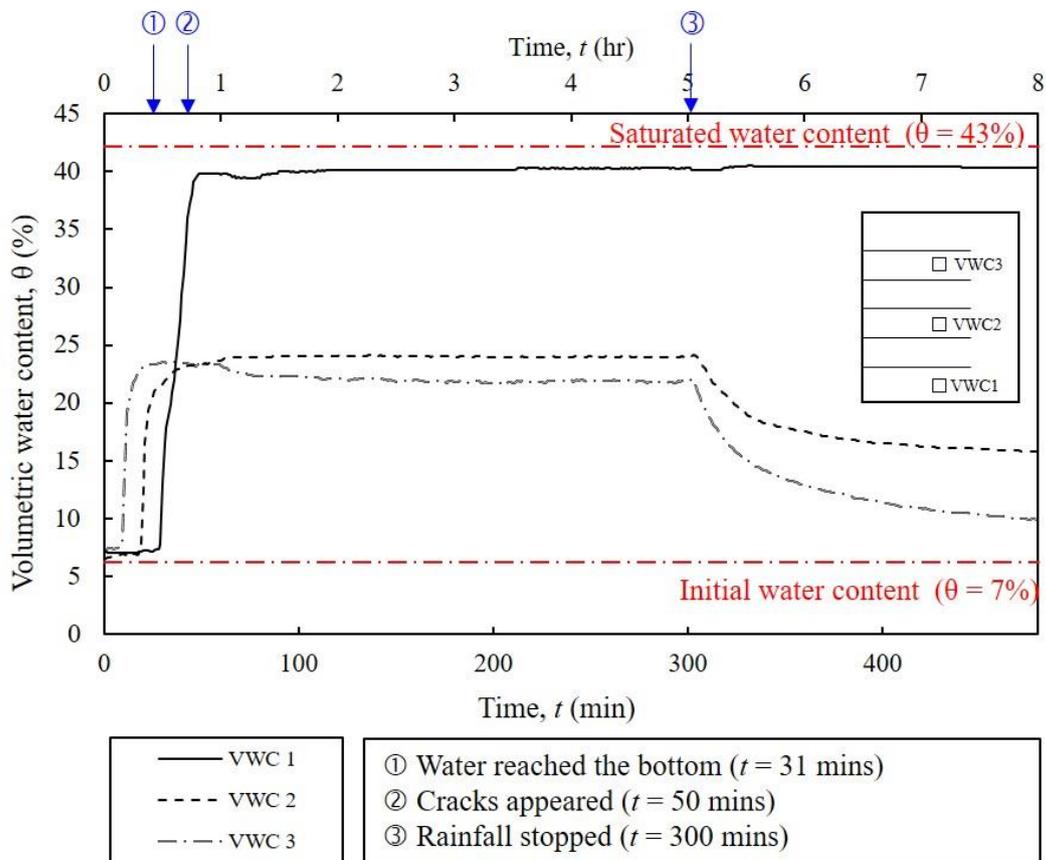
Figure 6.2 presents the variation of the volumetric water content throughout the test. Water infiltrated from the top to the bottom as the increase of the VWC gauges initiated from VWC3, VWC2, to VWC1. Since the permeability of the backfill soil is much larger than the rainfall intensity, the water was able to flow to the bottom, making VWC1 the sensor that registered the highest water content.

Figure 6.2 VWC with time elapse

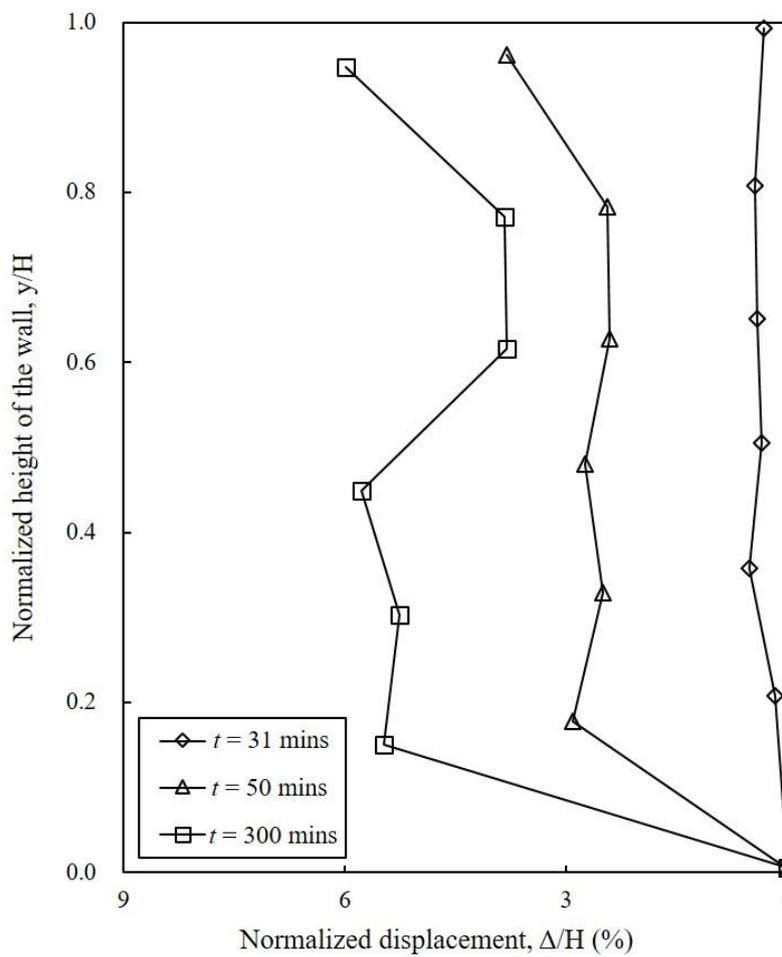
Figure 6.3 Wall displacement profile

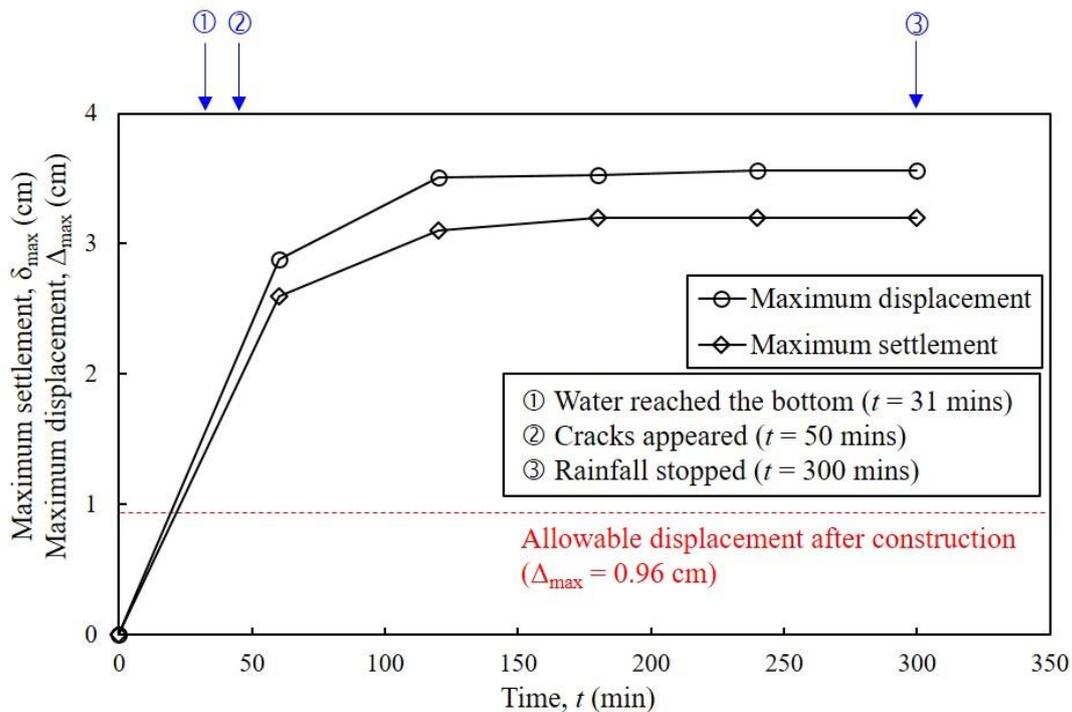
Figure 6.4 Maximum wall displacement and settlement versus time

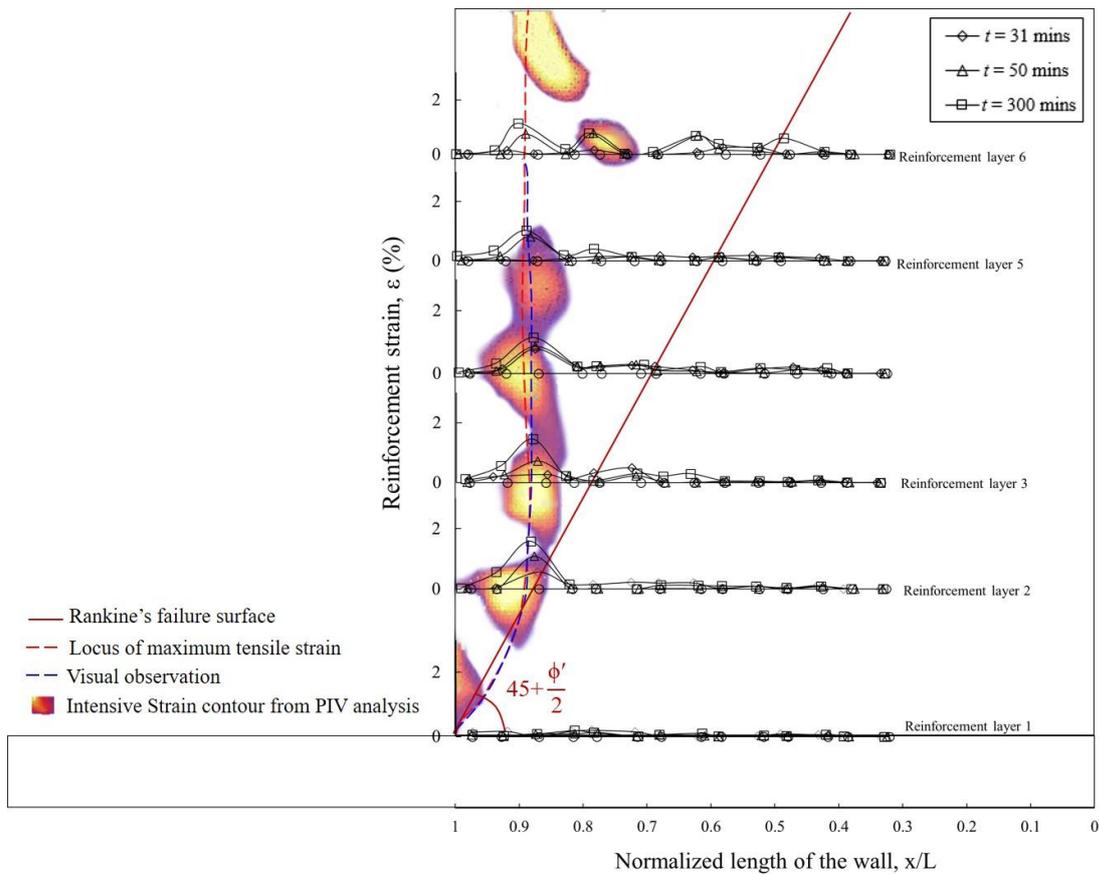
Figure 6.5 Reinforcement tensile strain and comparison of potential sliding surface

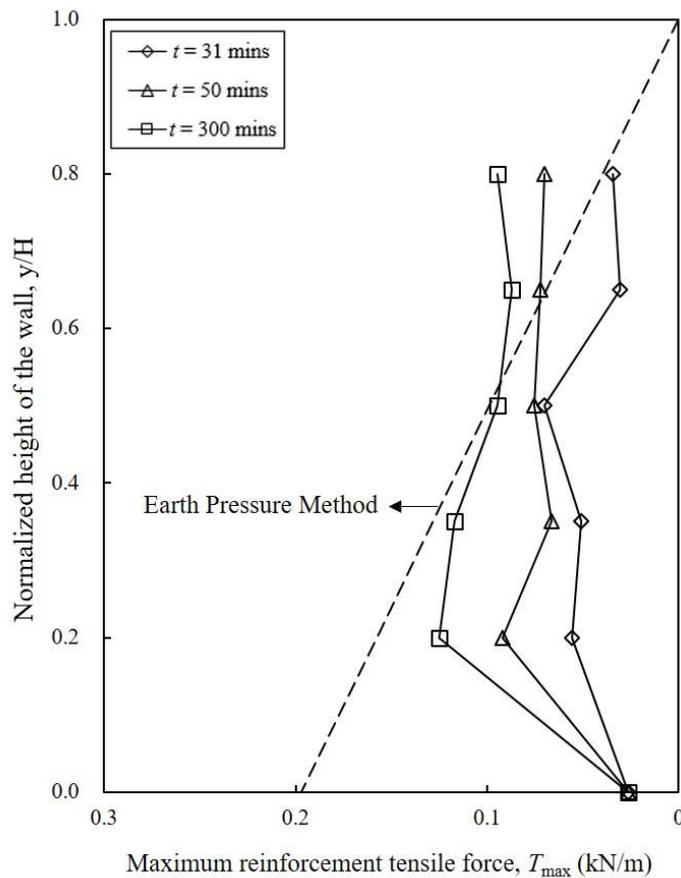
Figure 6.6 Maximum reinforcement tensile force profile

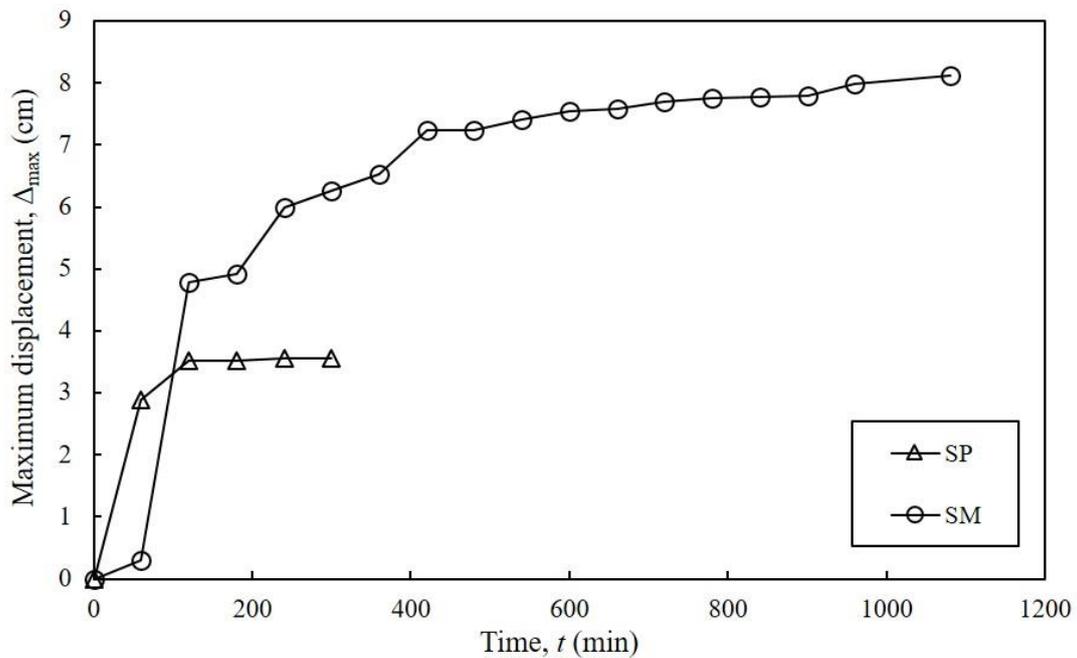
Figure 6.9 Maximum wall displacement versus time

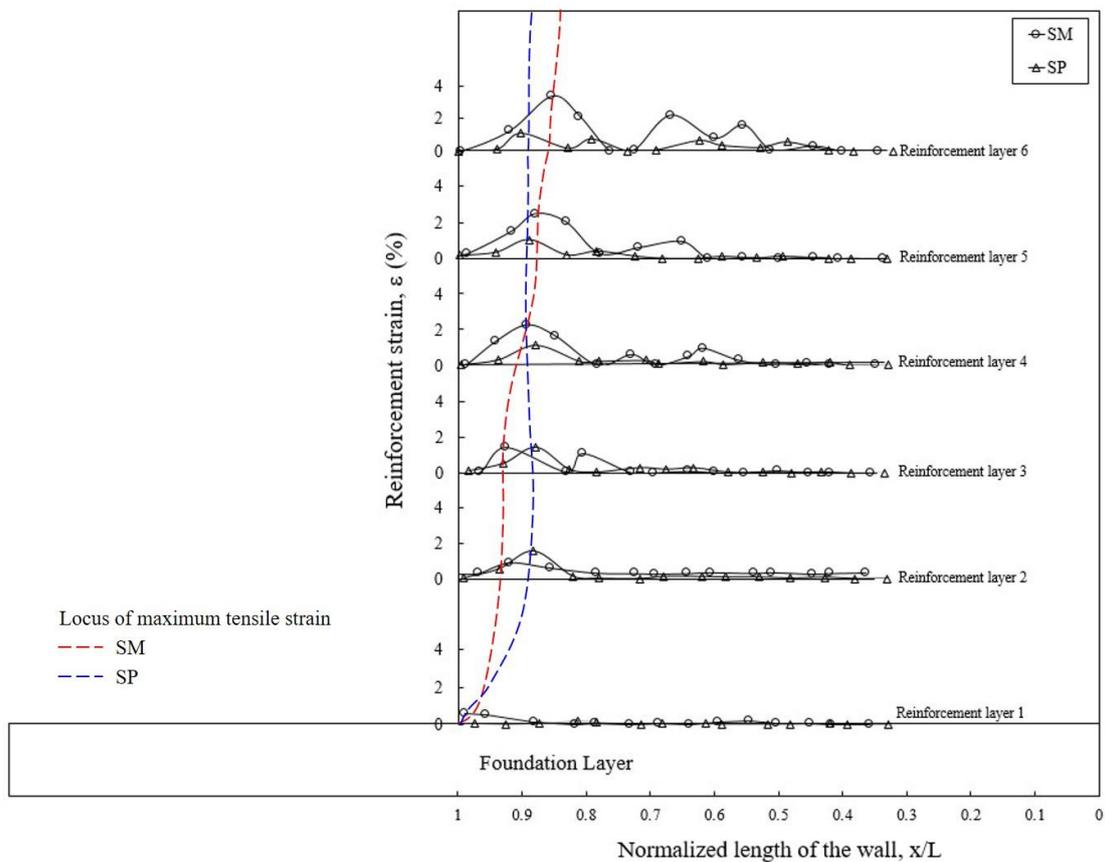
Figure 6.10 Reinforcement tensile strain

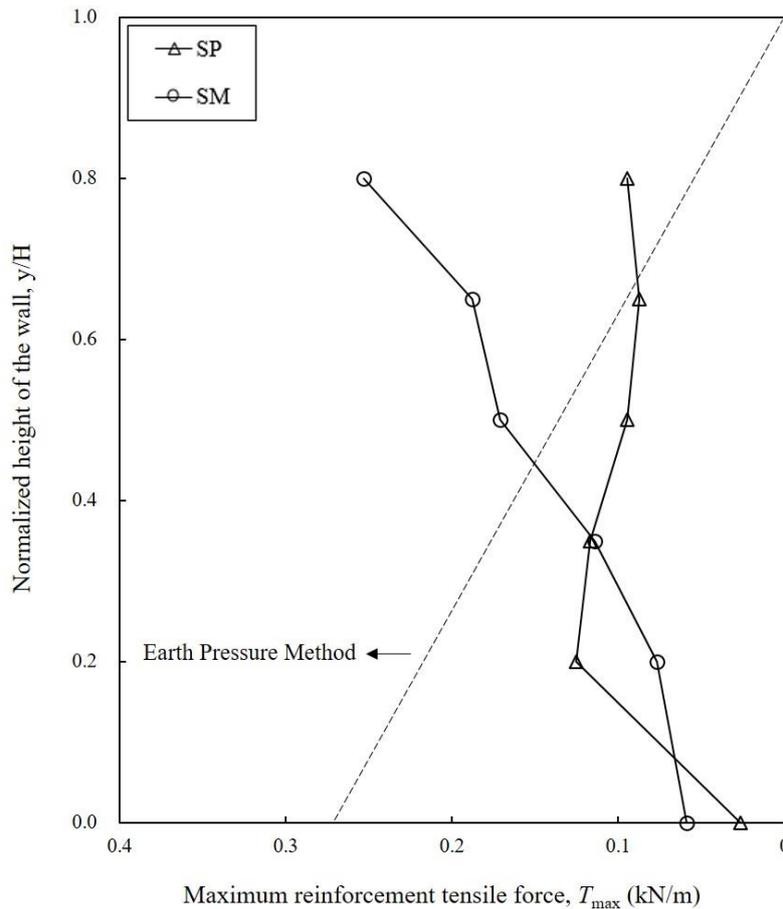
Figure 6.11 Maximum reinforcement tensile force profile

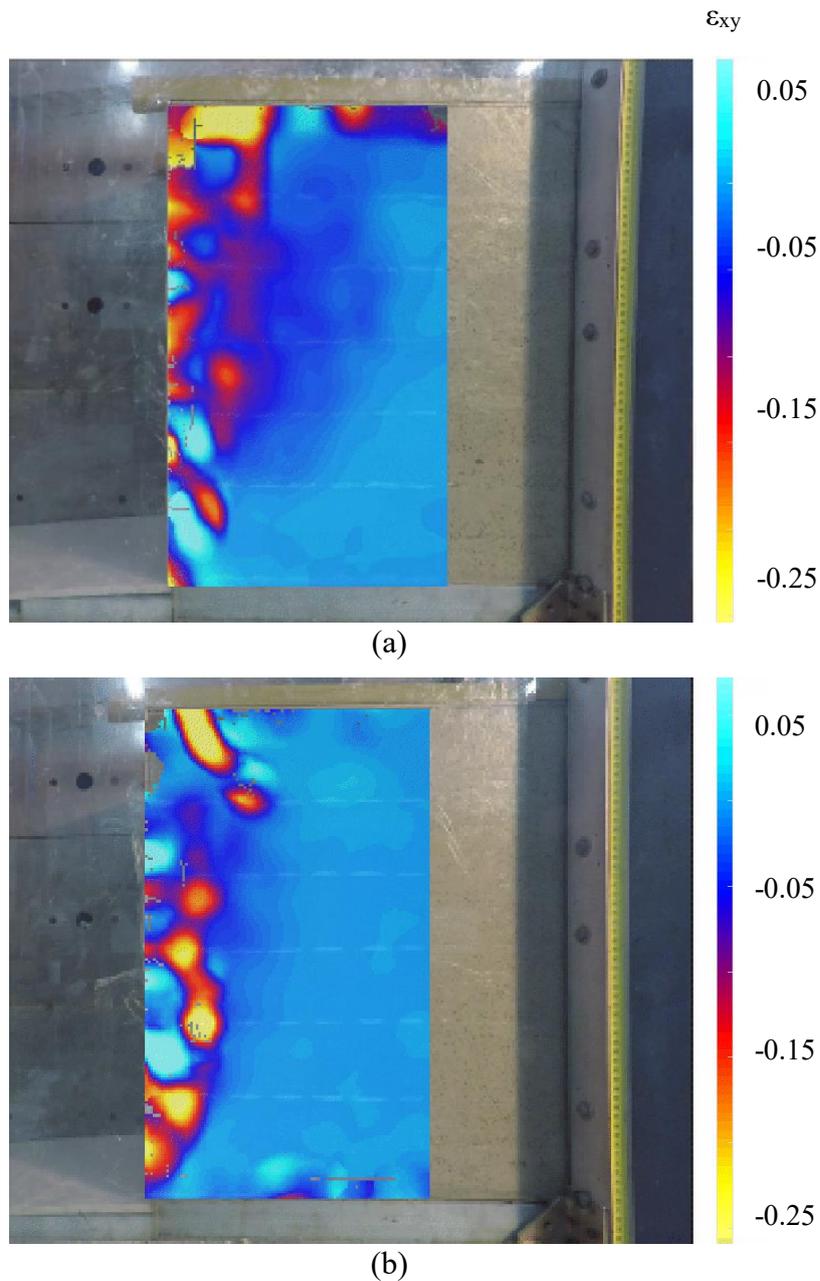
Figure 6.12 Strain contour from PIV analysis: (a) SM-S<sub>v</sub>9; (b) SP-S<sub>v</sub>9

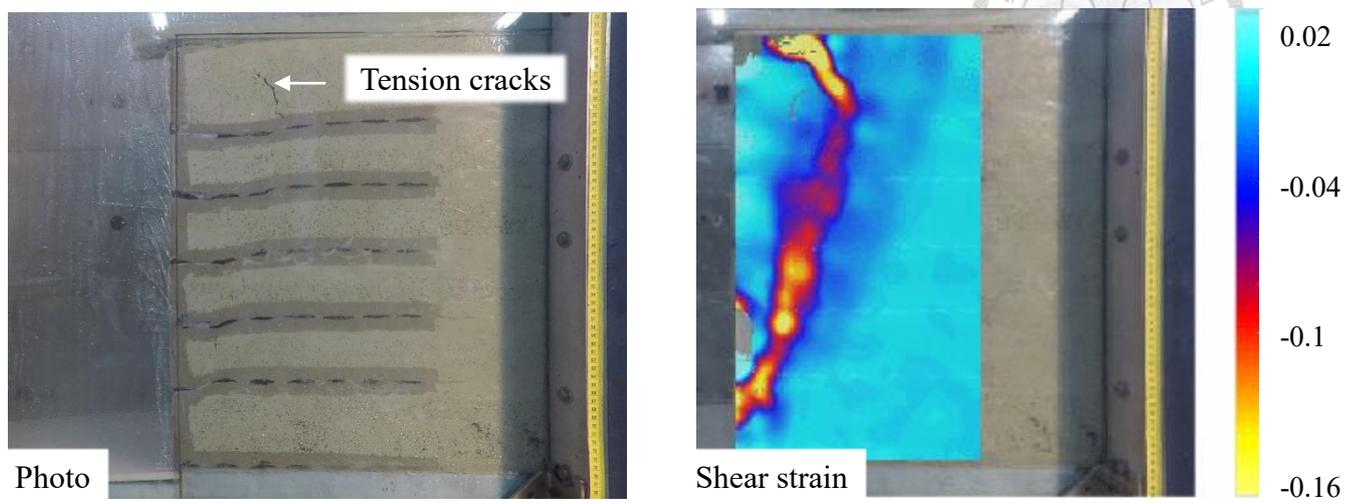
(c) ③ Water reached the bottom ( $t = 100$  mins)

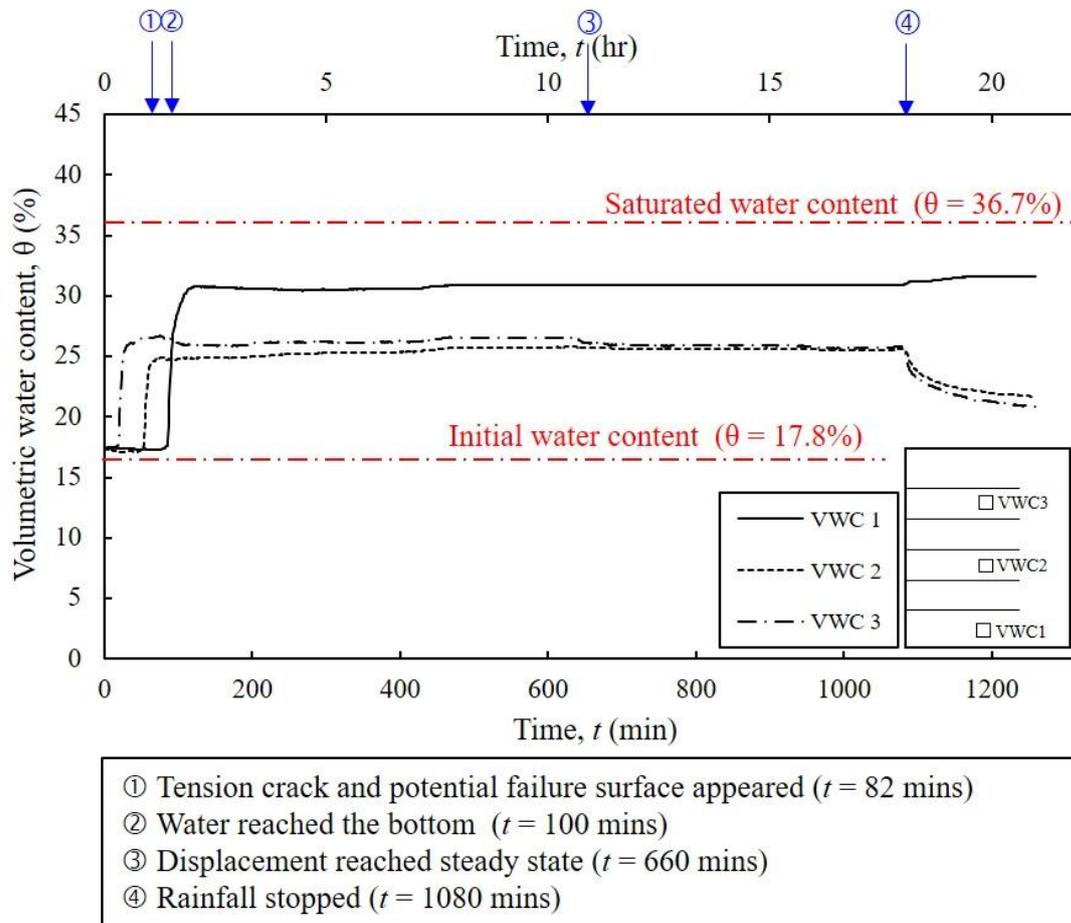
Figure 6.14 VWC with time elapse

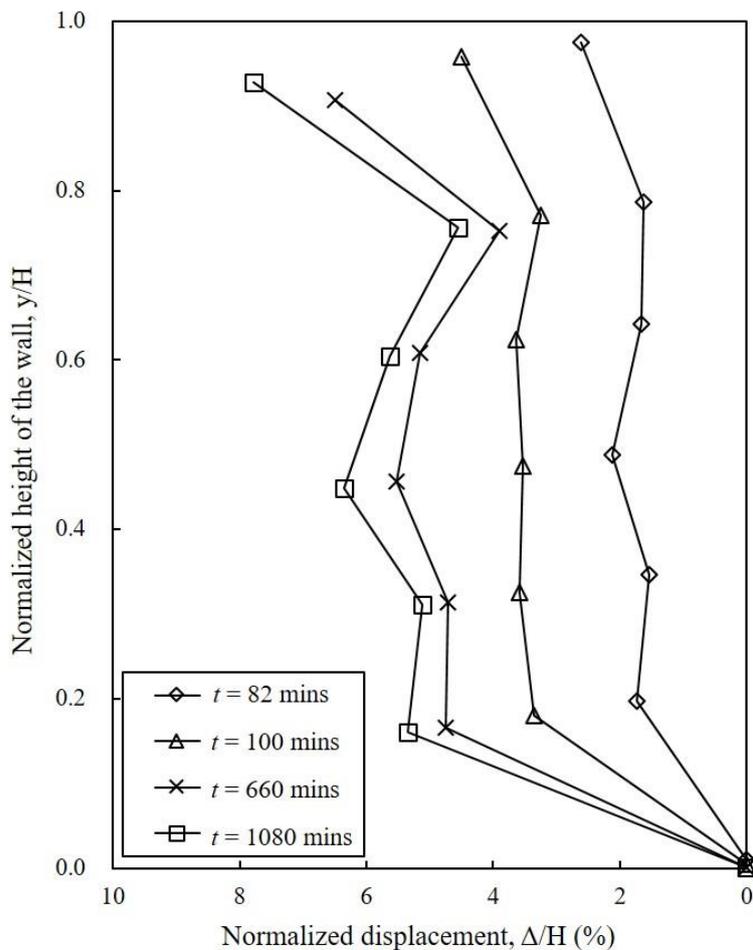
Figure 6.15 Wall displacement profile
