國立臺灣大學工學院土木工程研究所

碩士論文

加勁擋土牆以含細粒料之回填土在降雨作用下之行為及改善方法評估

Evaluation of Improved Methods for Geosynthetic-Reinforced Soil Walls  
with Marginal Backfills subjected to Rainfall

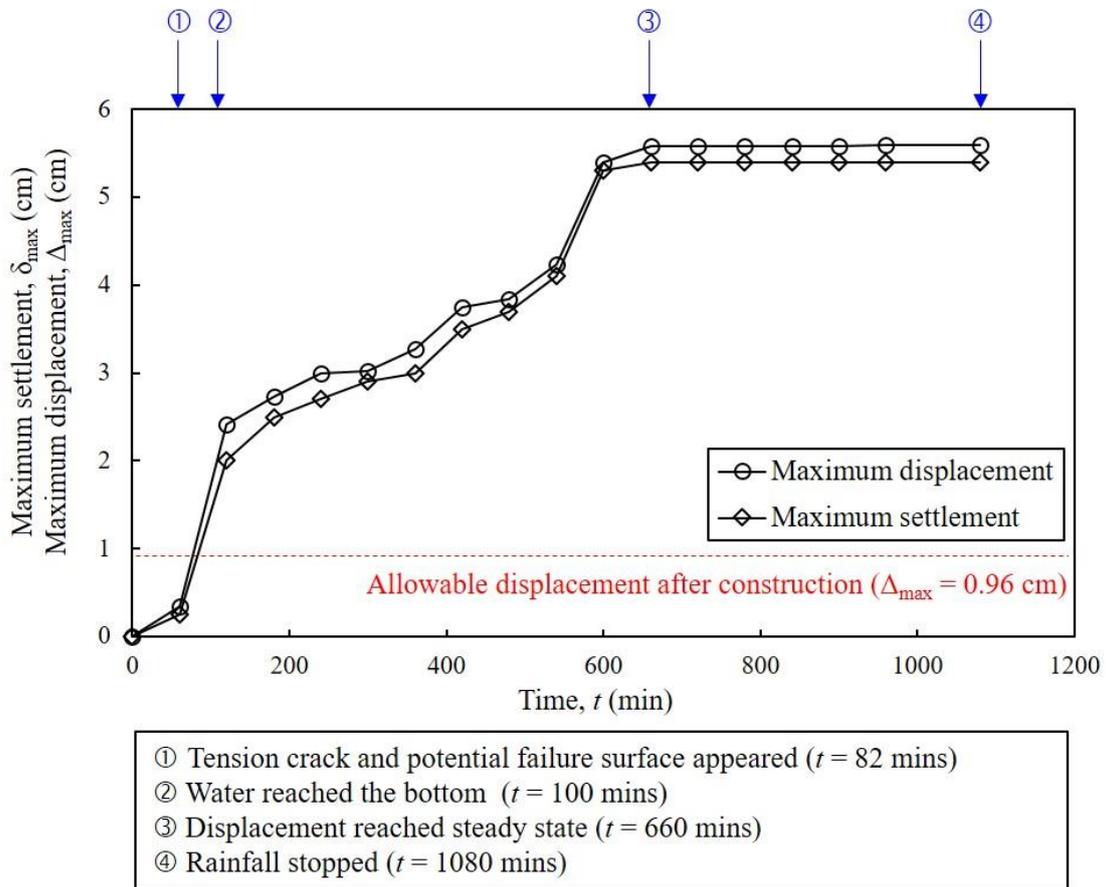
Figure 6.16 Maximum wall displacement and settlement versus time

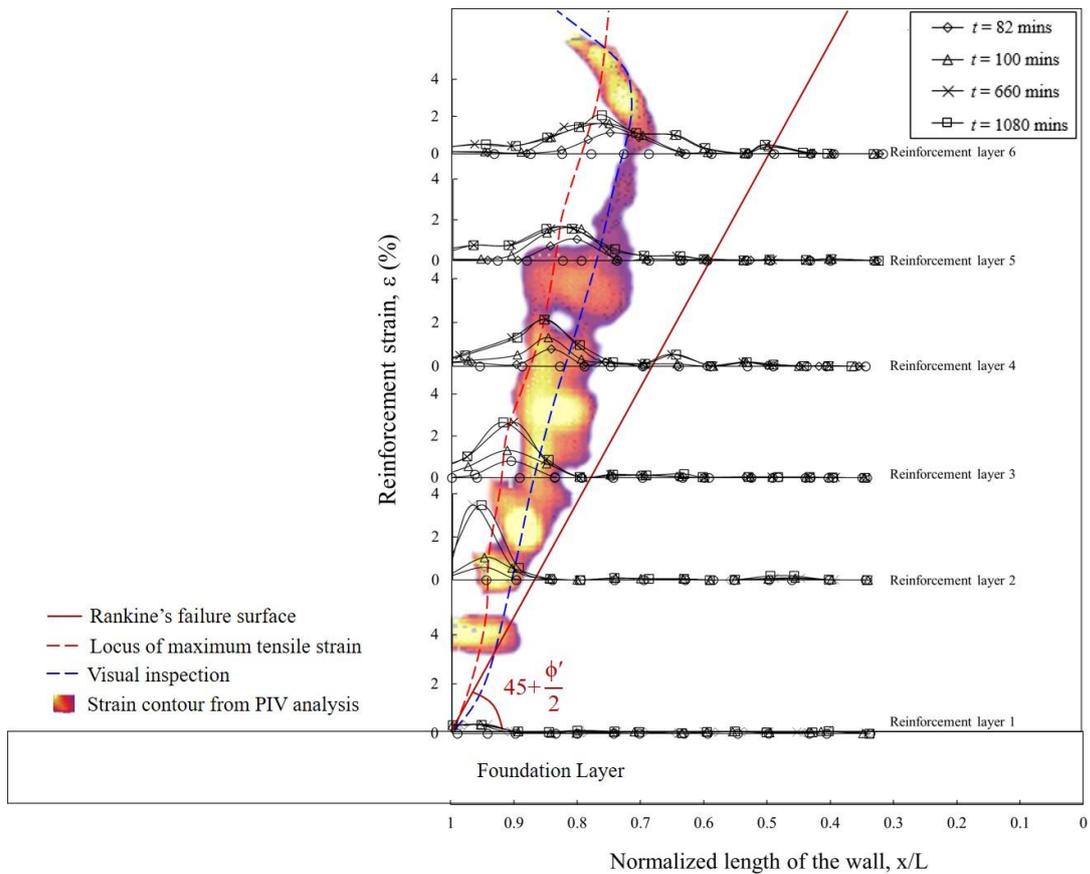
Figure 6.17 Reinforcement tensile strain and comparison of potential sliding surface

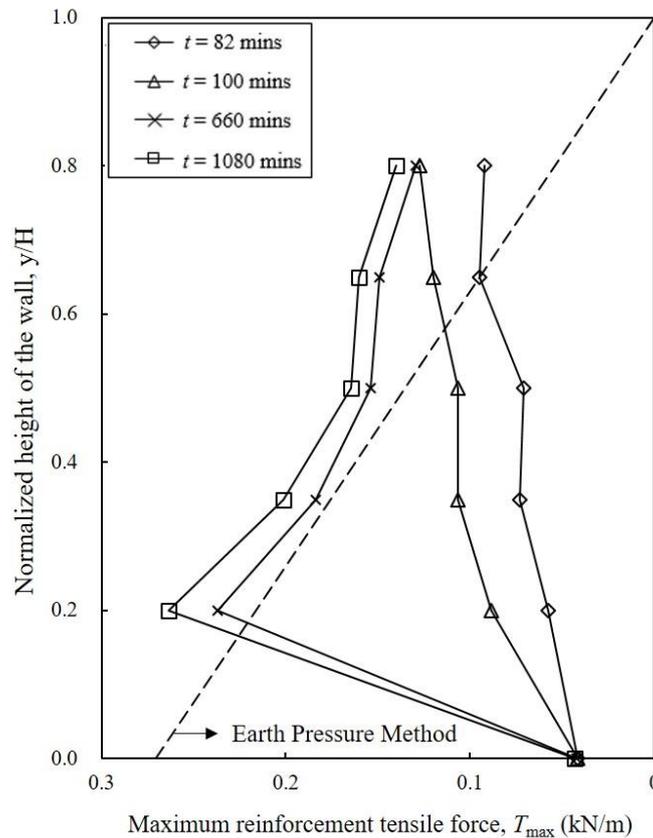
Figure 6.18 Maximum reinforcement tensile force profile

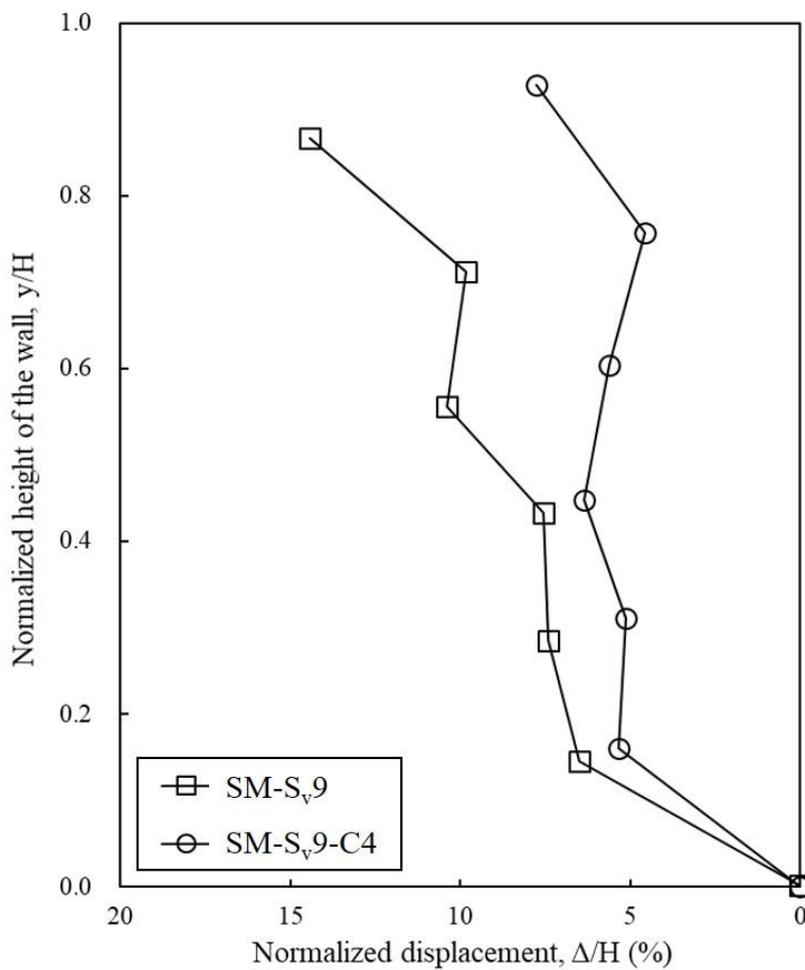
Figure 6.20 Wall displacement profile

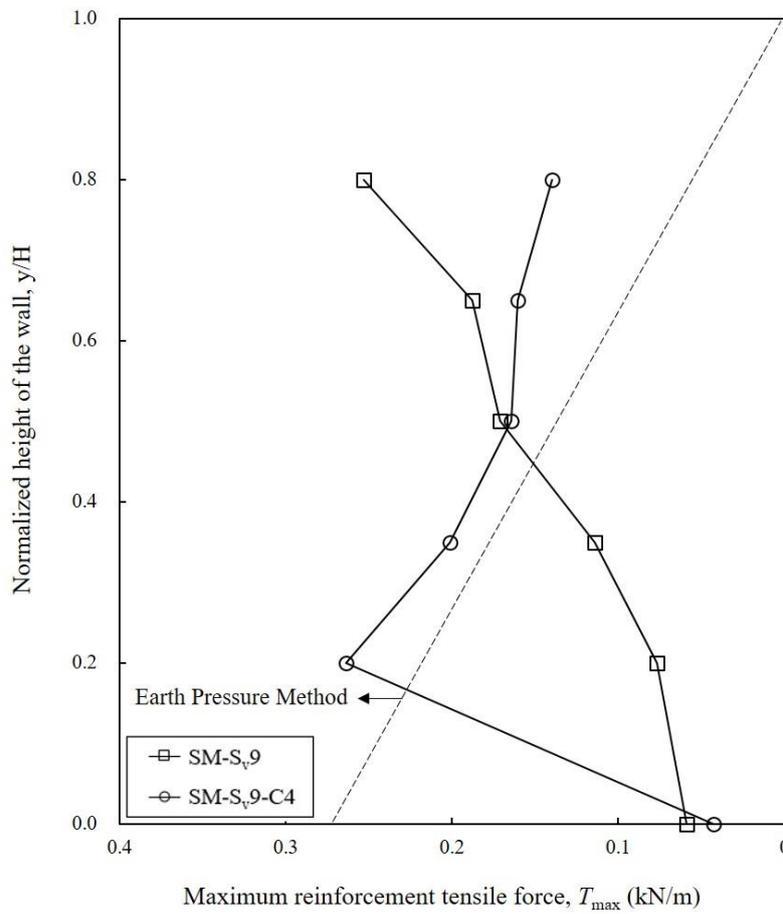
Figure 6.23 Maximum reinforcement tensile force profile

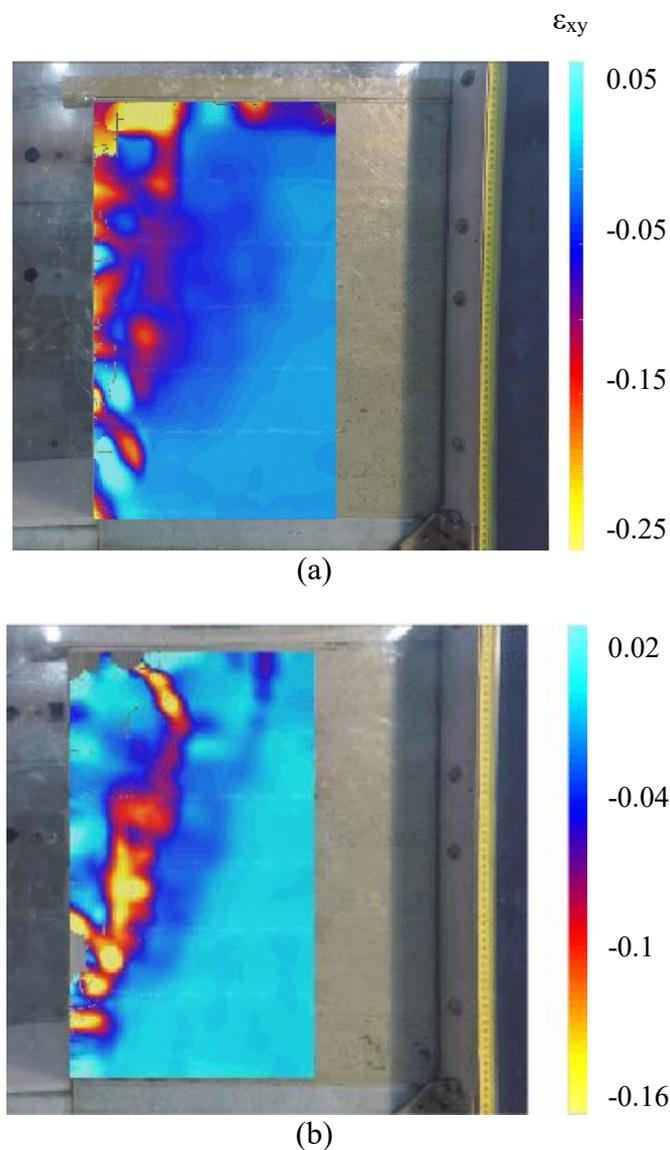
Figure 6.24 Strain contour from PIV analysis: (a) SM-S<sub>v</sub>9; (b) SM-S<sub>v</sub>9-C4

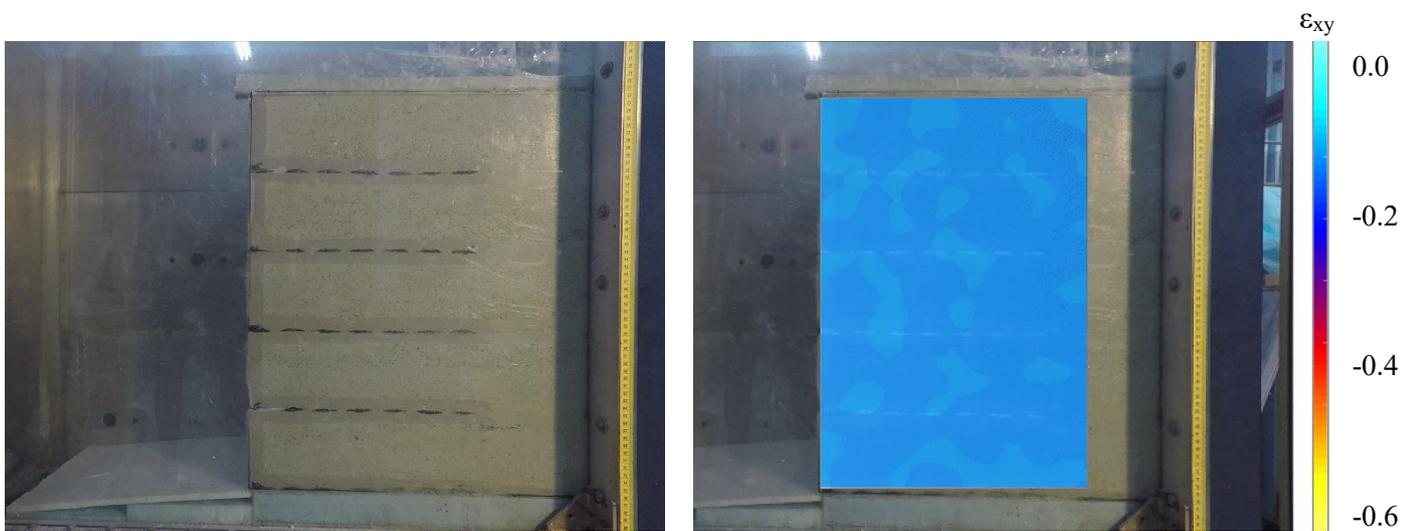
(a) ① Start of the test ( $t = 0$  min)

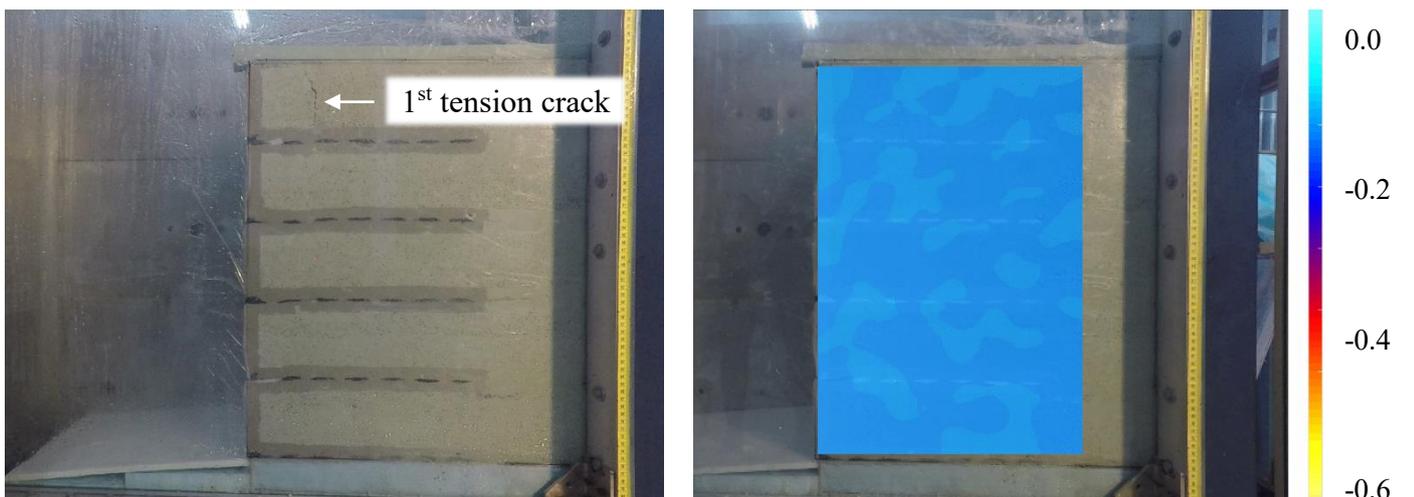
(b) ② Water reached the bottom and first tension crack developed ( $t = 88$  mins)

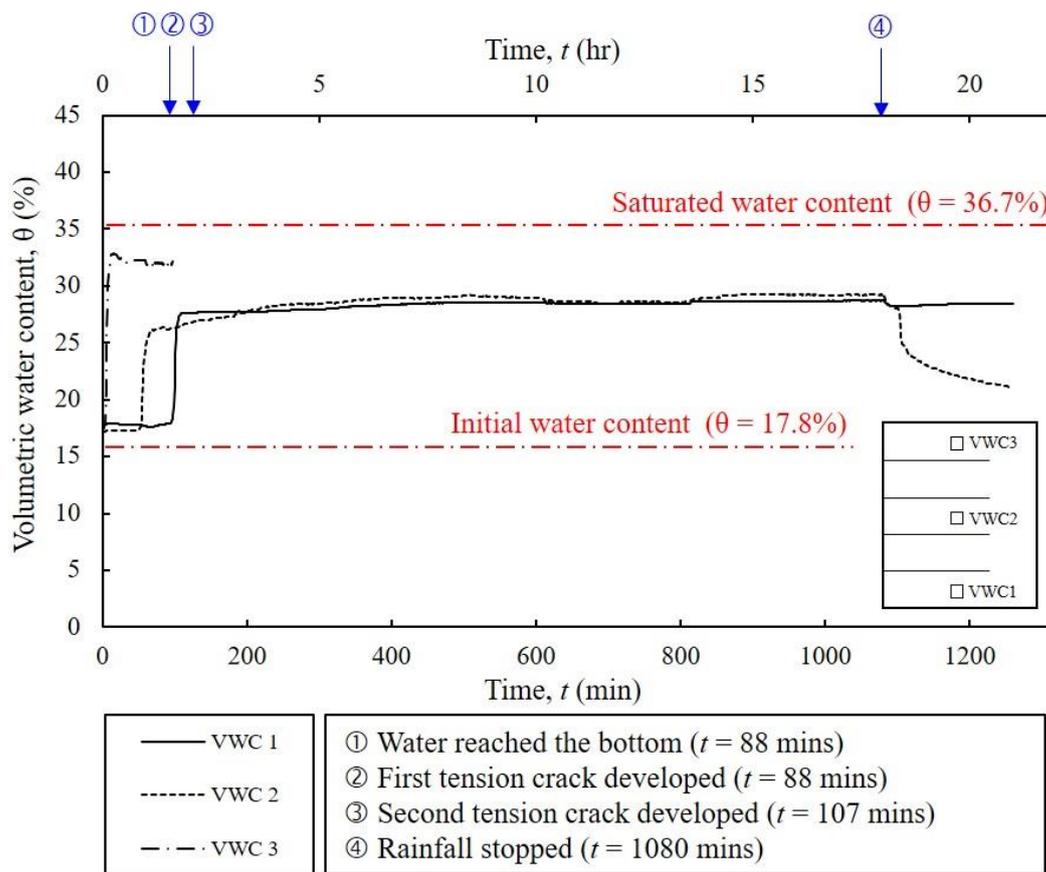
Figure 6.26 VWC with time elapse

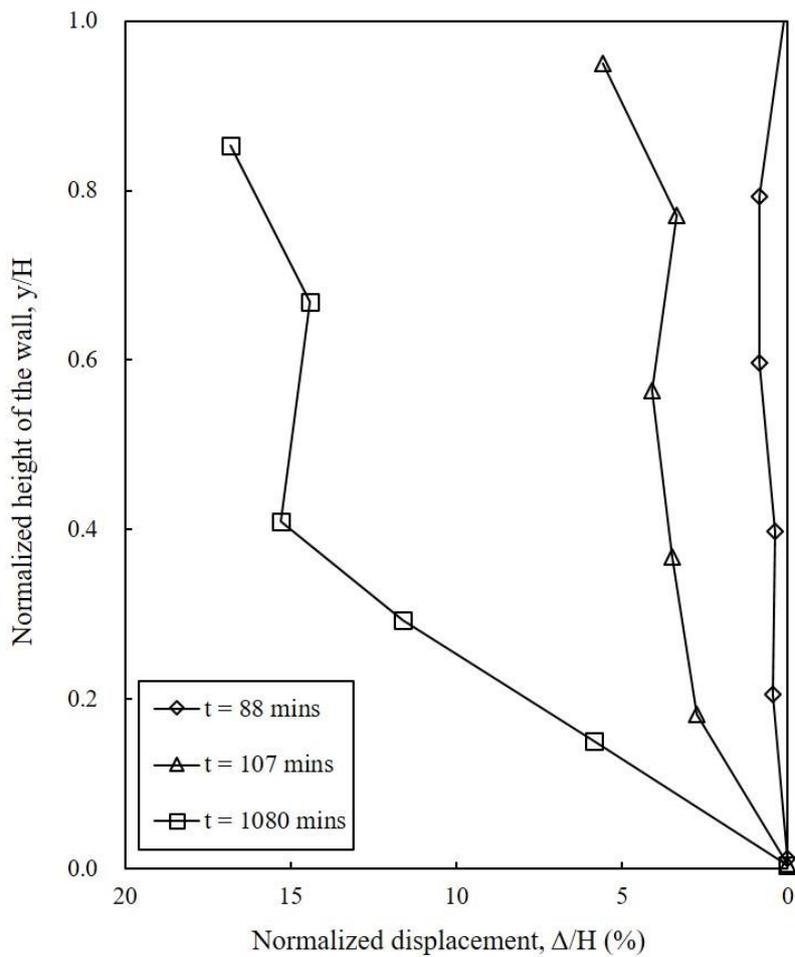
Figure 6.27 Wall displacement profile

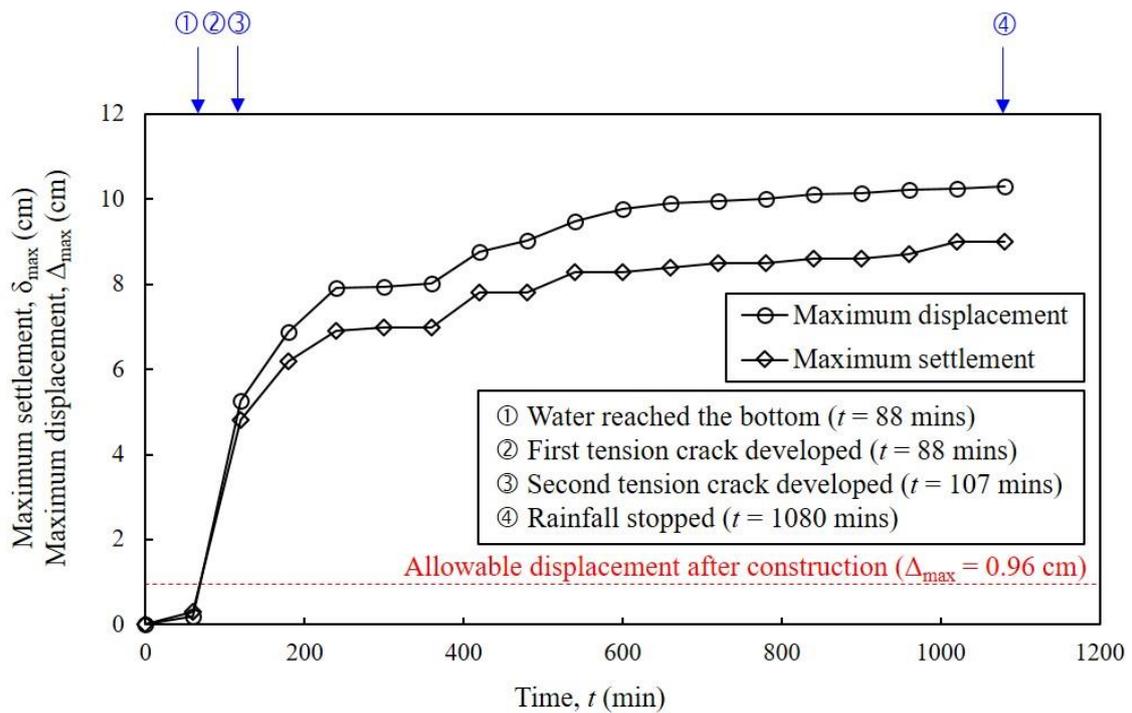
Figure 6.28 Maximum wall displacement and settlement versus time

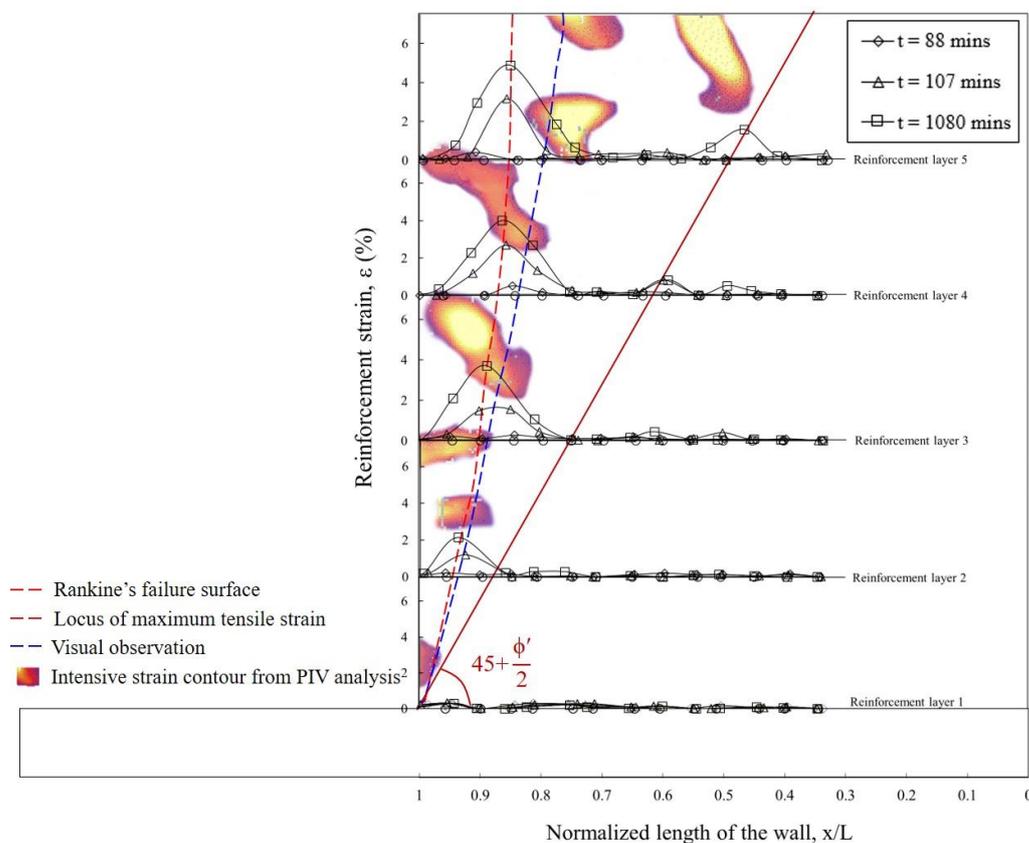
Figure 6.29 Reinforcement tensile strain

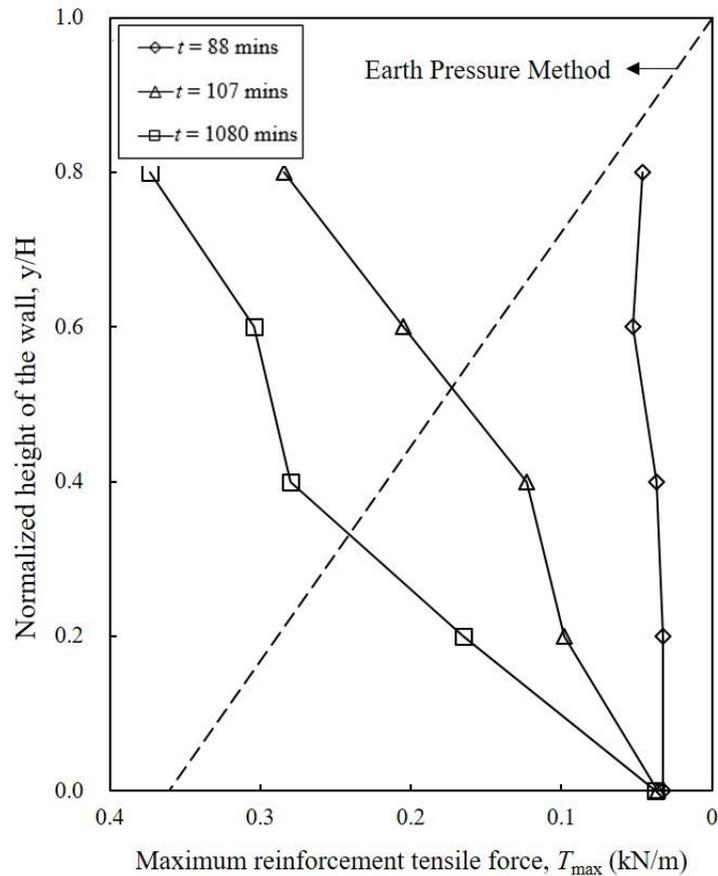
Figure 6.30 Maximum reinforcement tensile force profile

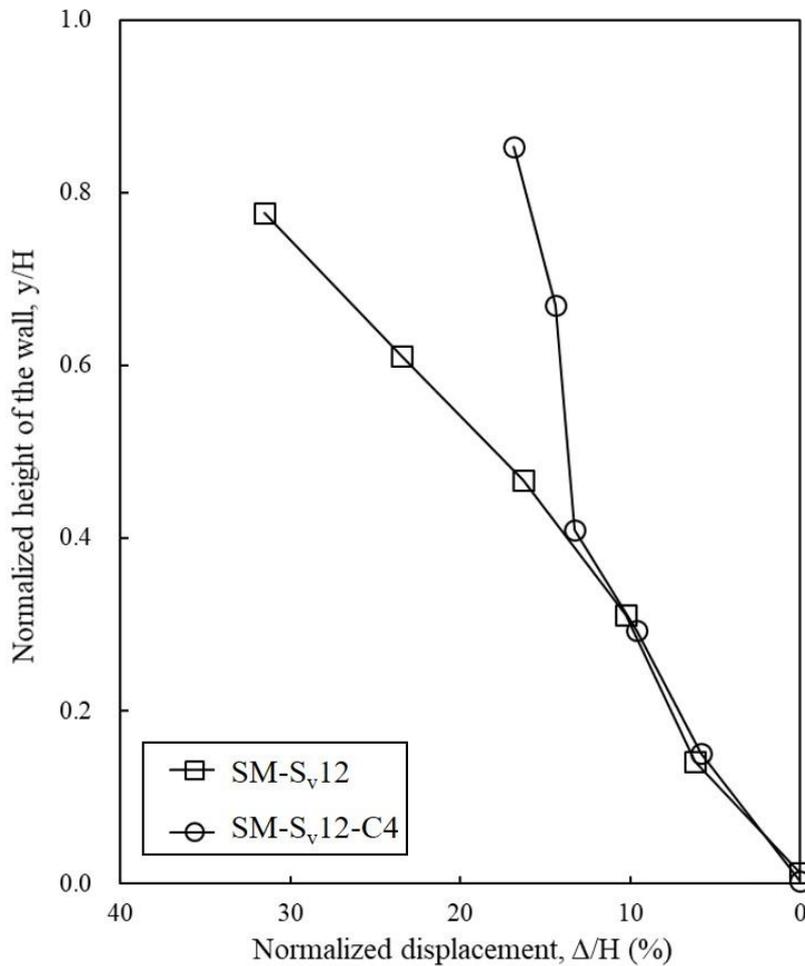
Figure 6.32 Wall displacement profile

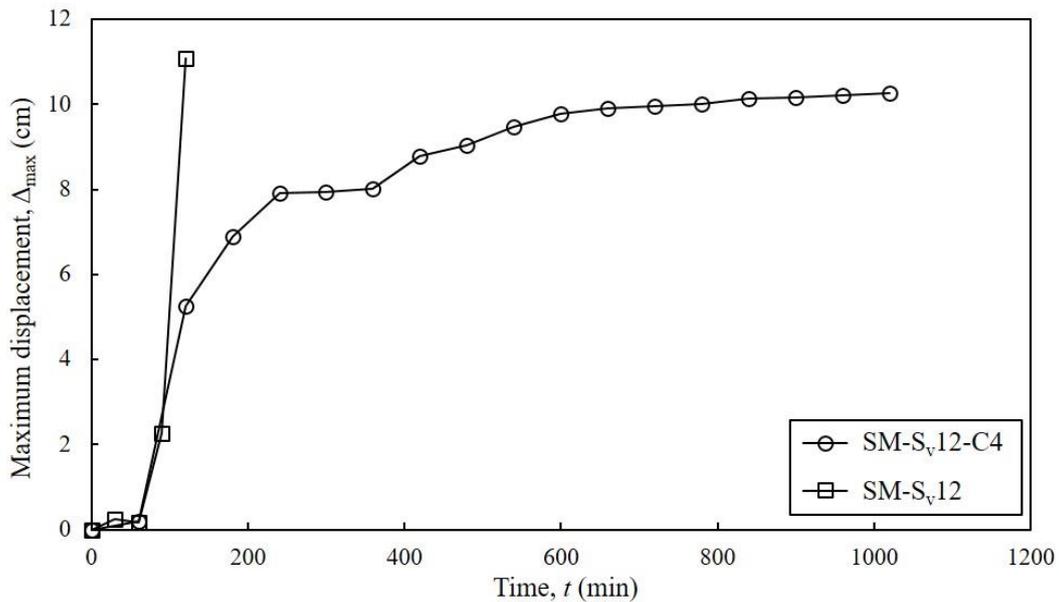
Figure 6.33 Maximum wall displacement versus time

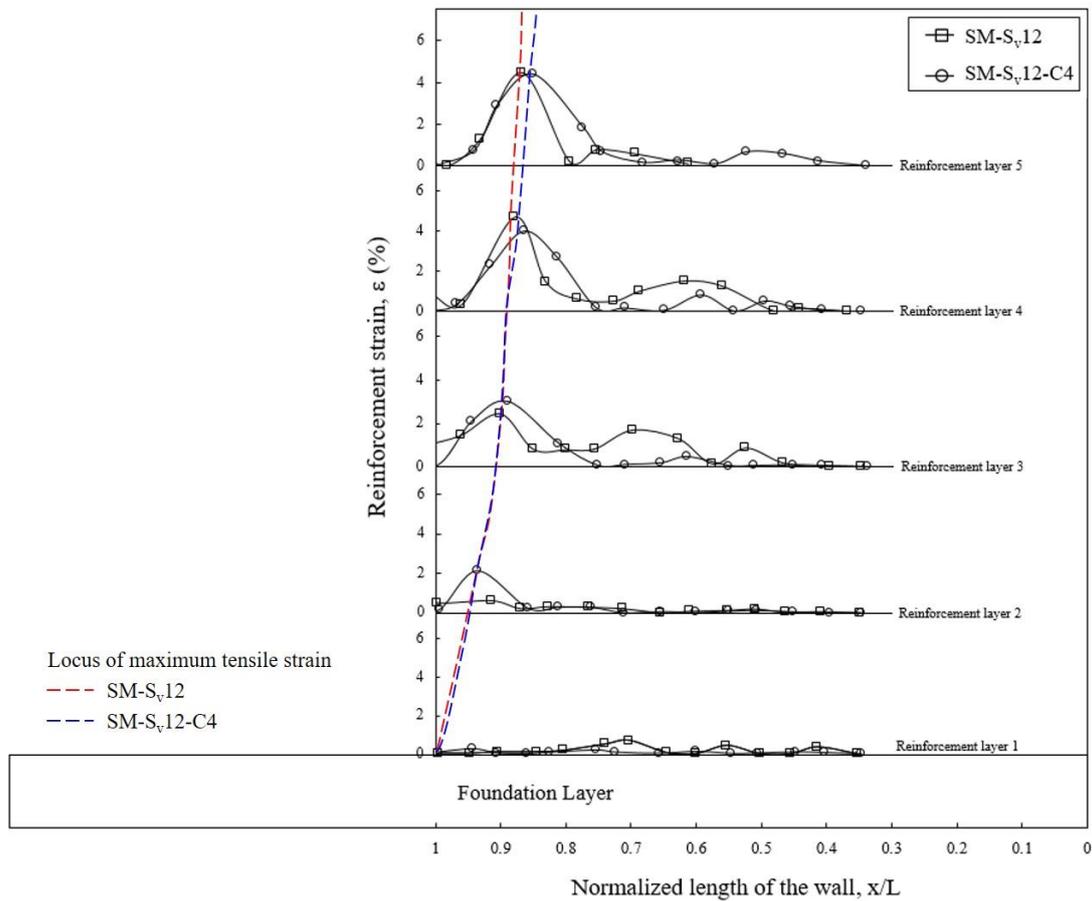
Figure 6.34 Reinforcement tensile strain

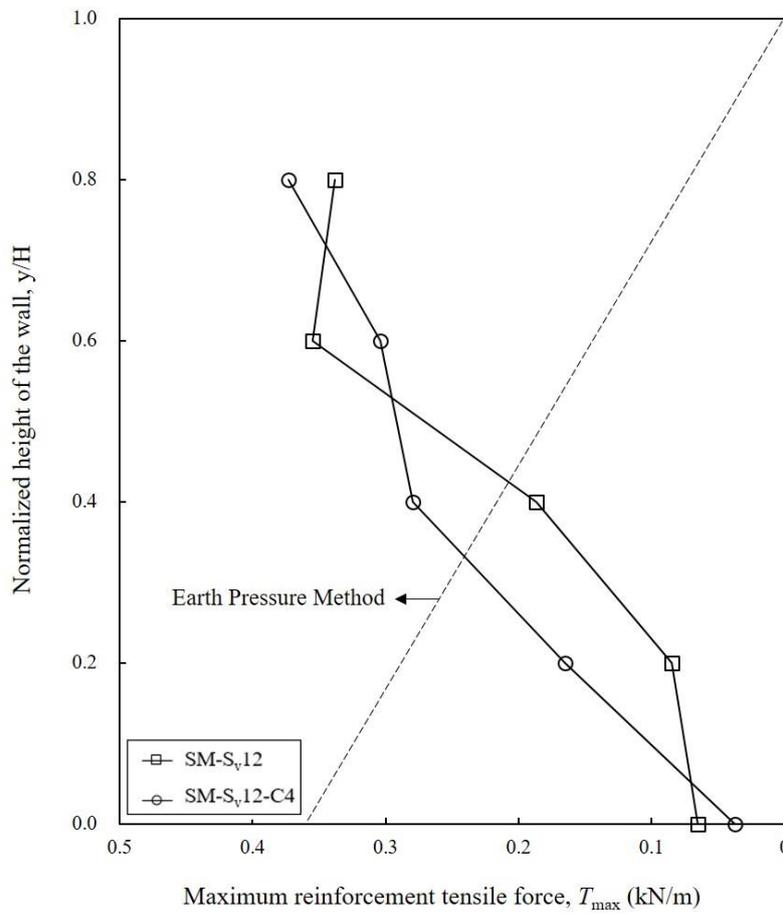
Figure 6.35 Maximum reinforcement tensile force profile
