國立臺灣大學電機資訊學院資訊網路與多媒體研究所
碩士論文

軌道缺陷檢測系統
Railroad Defect Inspection System

This thesis presents an implementation of inspecting railroads of Mass Rapid Transit by image processing which includes binary thresholding, morphology, histogram equalization, and template matching. Furthermore, we design specific algorithms to handle specific inspection objectives. Finally, we integrate all methods into complete inspection logic.

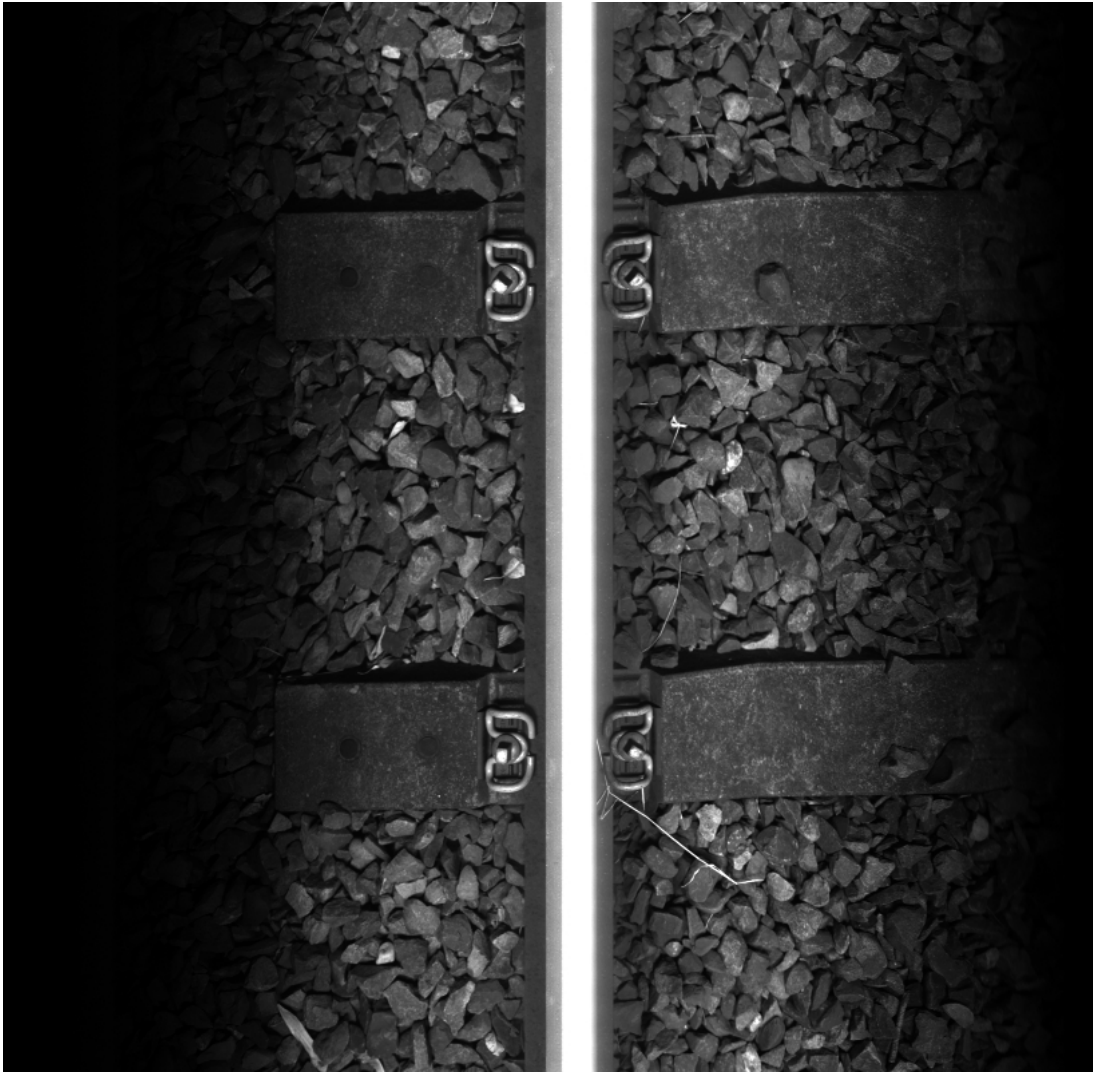
Figure 2.2 Captured image page (1:2 size).

For a complete inspection, engineering train could travel for 10 or more kilometers, thus the file could be very titanic. For width of 816 pixels at 1.971mm/pixel, 10-kilometer image information will be about 3.856GB file size. This fact shows that it is nearly impossible to load the whole file into memory at one time, so we need to load the file page by page and integrate defect information after individual page inspection. Out typical page height is 800 pixels, which is adequate for rail head bound detection. Each page can be considered as an image. Our system inspects each page to find defects using the following inspection processes. Figure 2.2 is a sample page.

However, page inspection has a problem that some fastenings could be cut into different pages, so that these fastenings are impossible to detect across boundary. Thus, the next page should keep a part of rows from the current page to avoid fastening misdetection. The number of rows to keep is estimated by fastening detection process. Moreover, we will not inspect the whole page to prevent repeated inspection of the kept part.

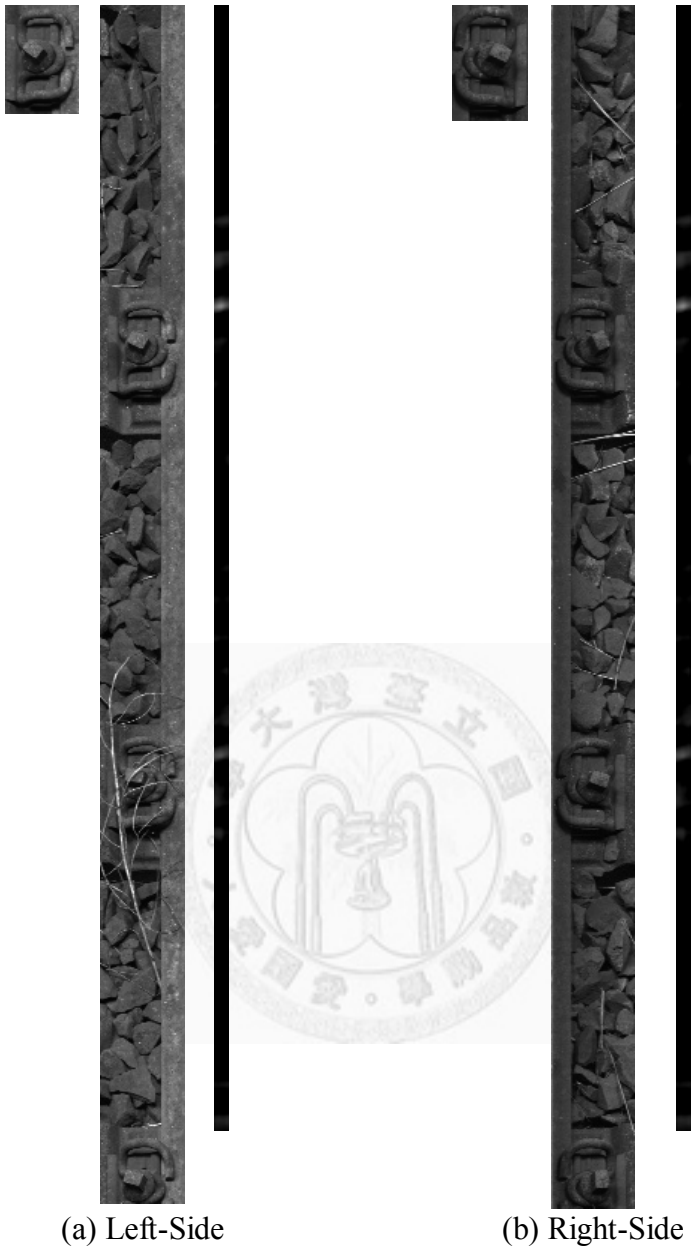
Figure 3.3 NCC result images. From left to right: the template, the interested image, and the NCC image.

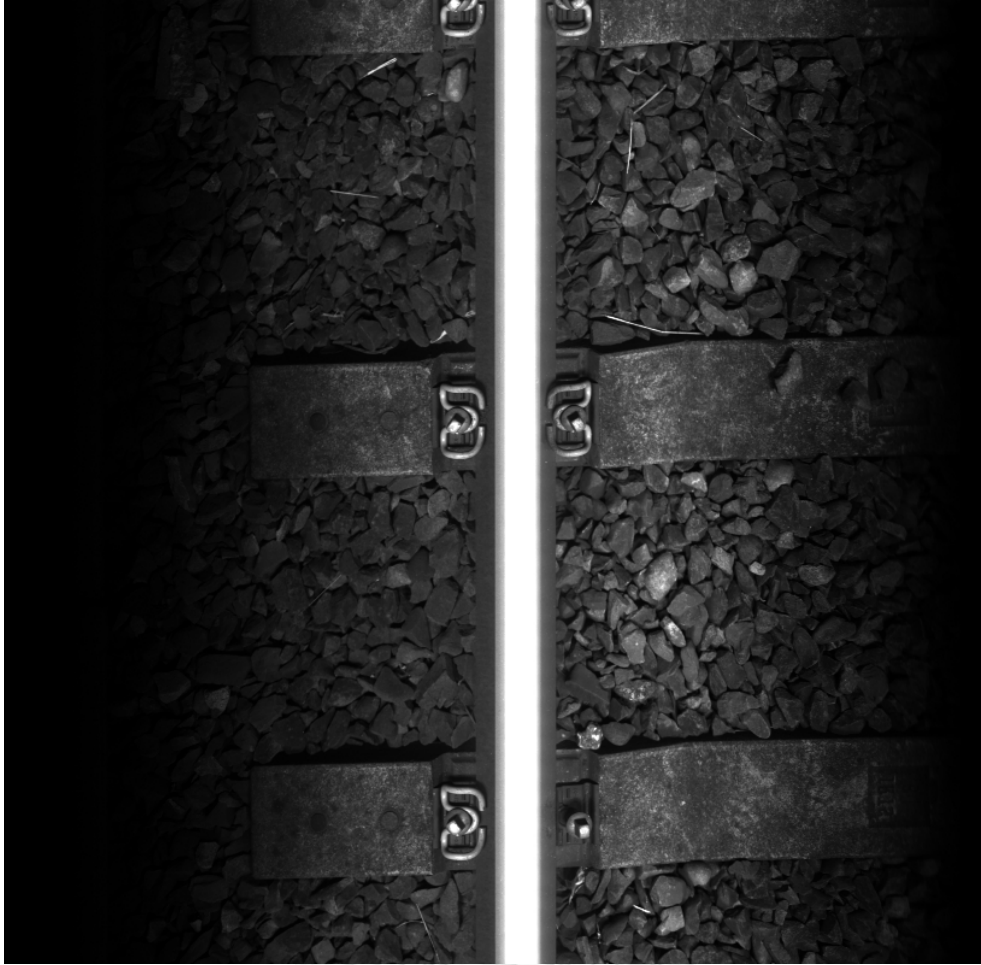
Figure 4.1 The sample page of the ground section.

We test our inspection system at three MRT sections twice: both up and down directions. These sections have their own characteristics. The first is the ground section from Fuxinggang to Zhongyiyi. The second is the elevated section from Jiantan to Shilin. The third is the underground section from Zhongshan to Minquan West Road. The target artificial defects are placed in each section with arbitrary numbers in each inspection zone. The result statistics, shown in the following, depend on the inspection rate of these artificial defects.

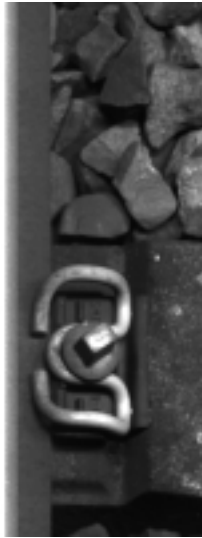
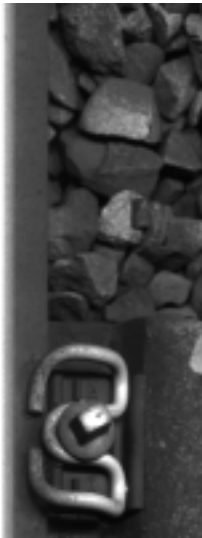
Figure 4.21 Inspected defects in the ground section. Down direction left rail (VII).

(37) Rail head

(38) Tie

(39) Rail head

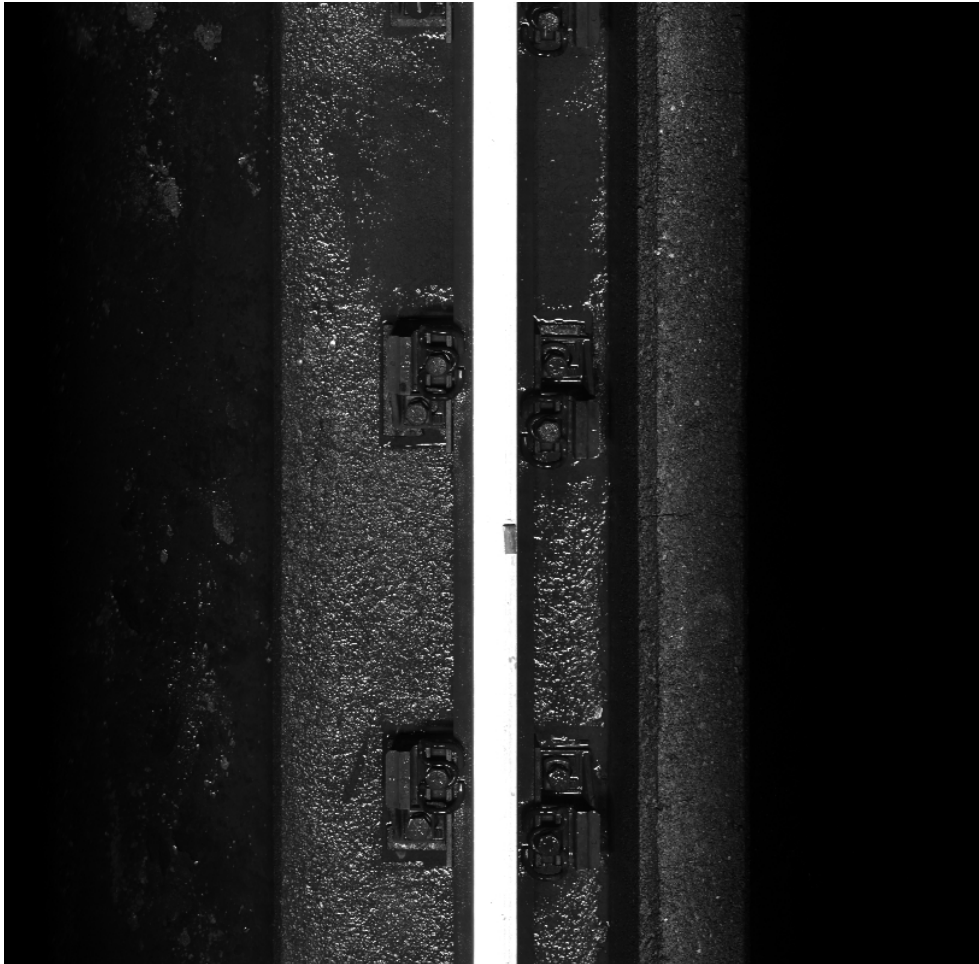
Figure 4.29 The sample page of the elevated section.

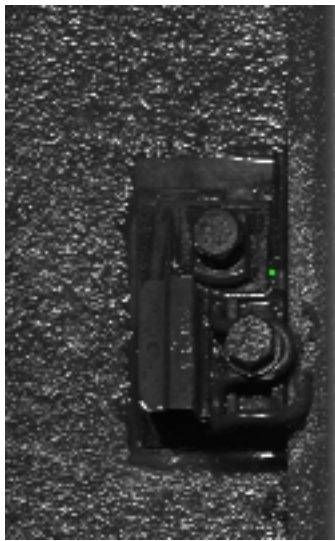
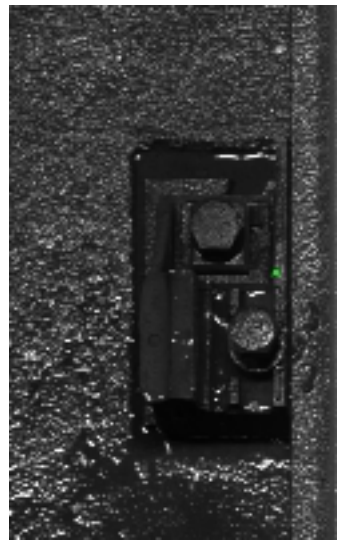
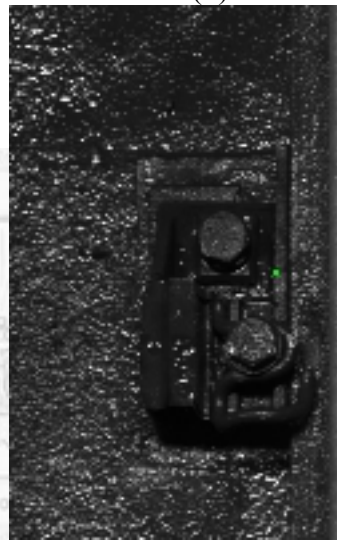
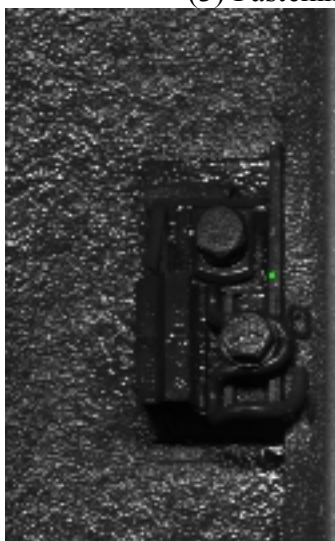
Figure 4.51 Inspected defects in the elevated section after rain. Down direction right rail (I).

| Figure 4.51 Inspected defects in the elevated section after rain. Down direction right rail | |

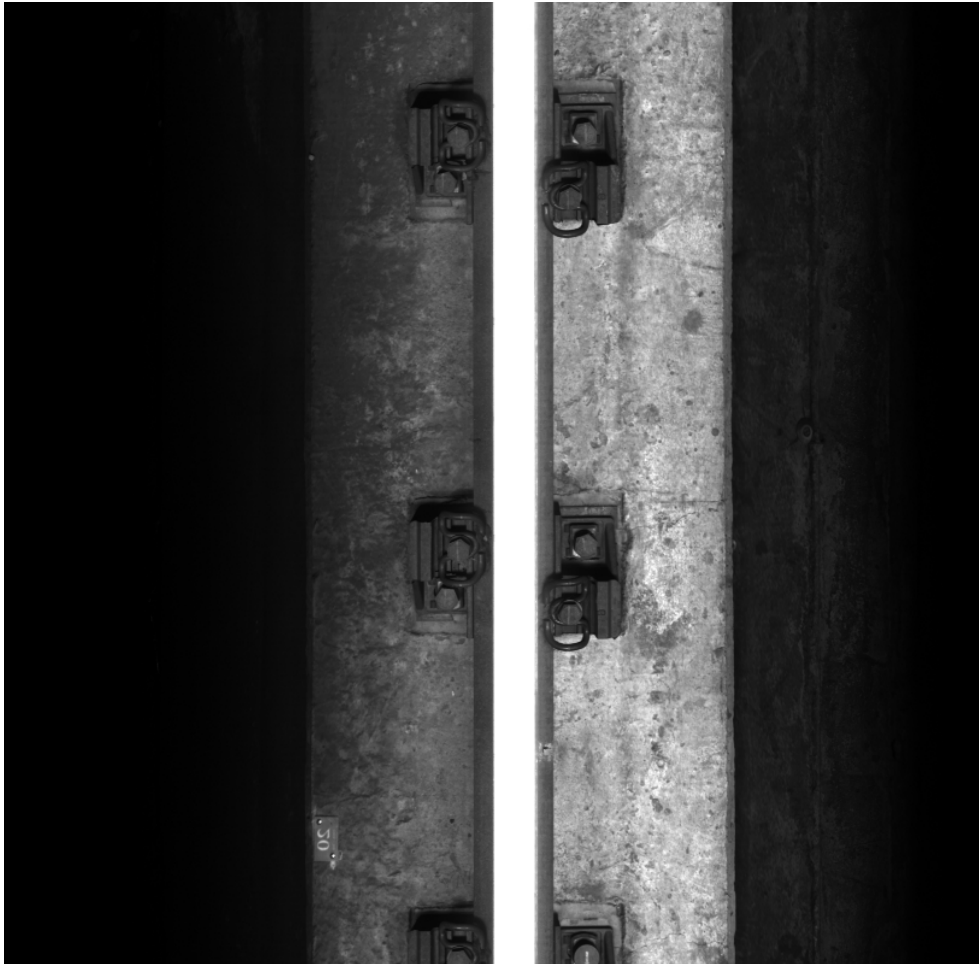
Figure 4.58 The sample page of the underground section.

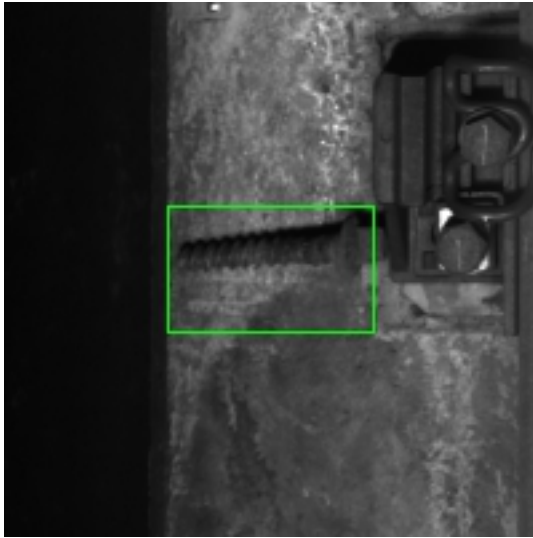
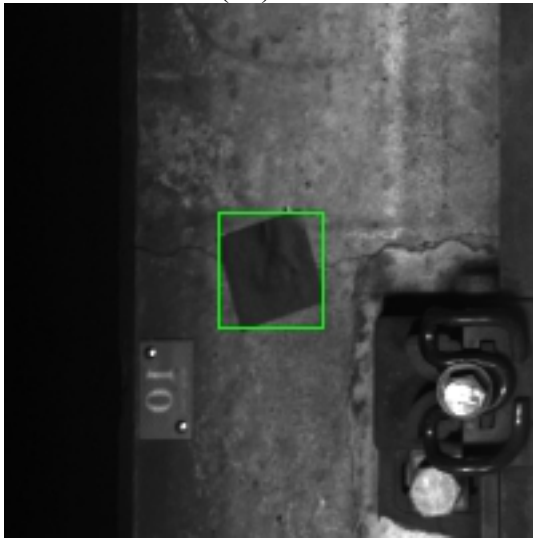
Figure 4.65 Inspected defects in the underground section. Up direction left rail (V).

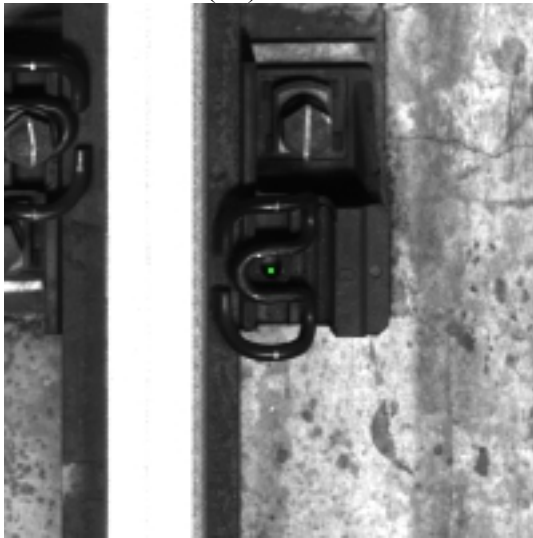
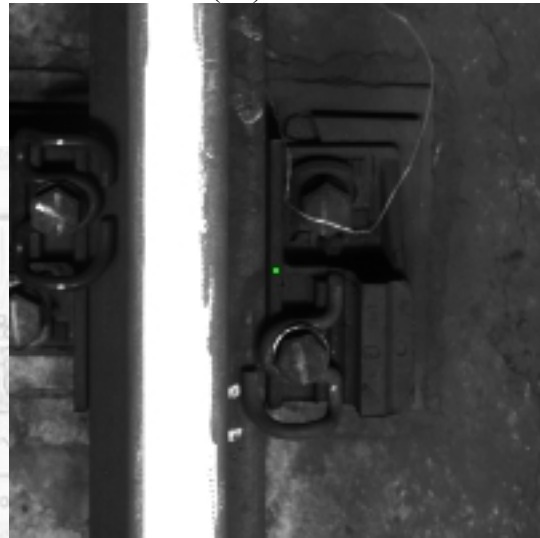
Figure 4.66 Inspected defects in the underground section. Up direction left rail (VI).

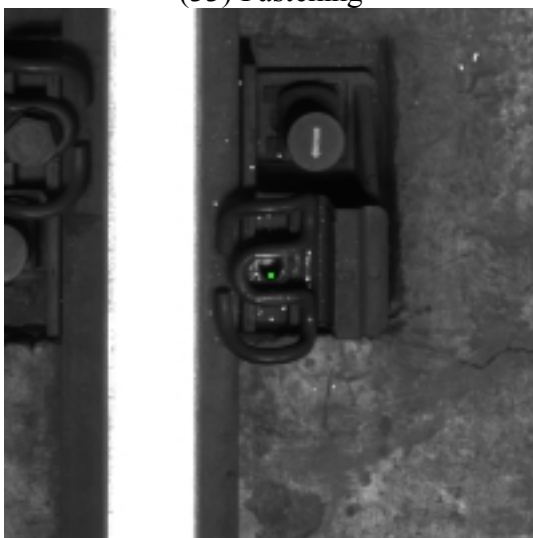
(35) Fastening

(36) Fastening

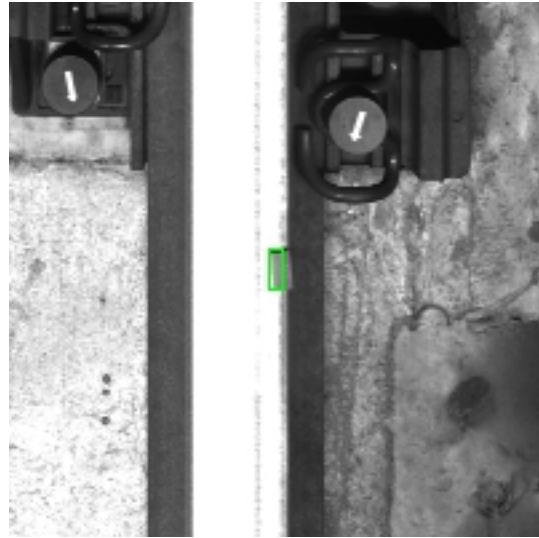
(7) Rail head

(8) Rail head

(9) Rail head

(10) Rail head

(11) Rail head

(12) Rail head

Figure 4.69 Inspected defects in the underground section. Up direction right rail (II).

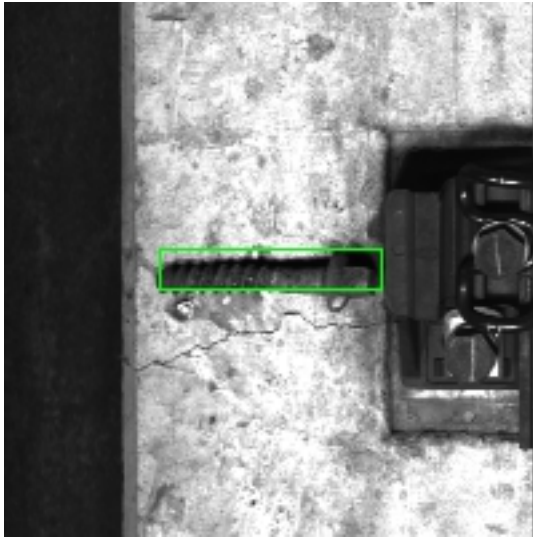
(19) Tie

(20) Tie

(21) Tie

(22) Tie

(23) Tie

(24) Tie

Figure 4.71 Inspected defects in the underground section. Up direction right rail (IV).

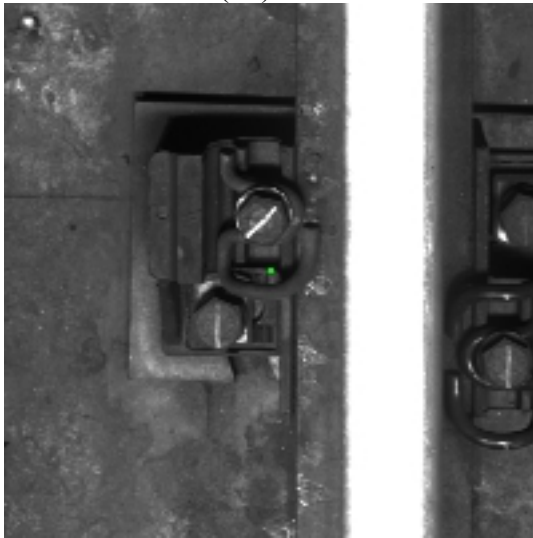
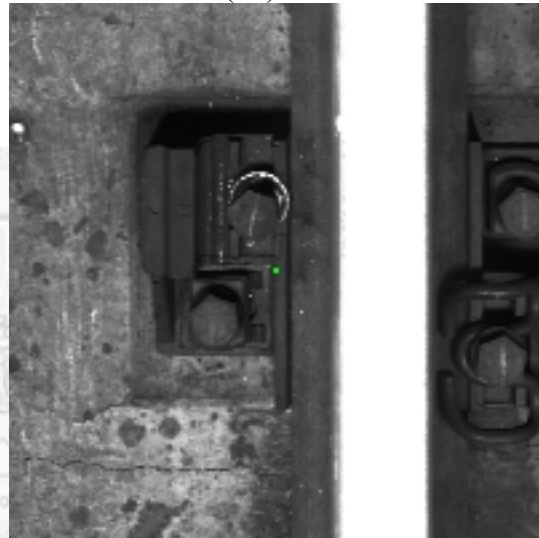
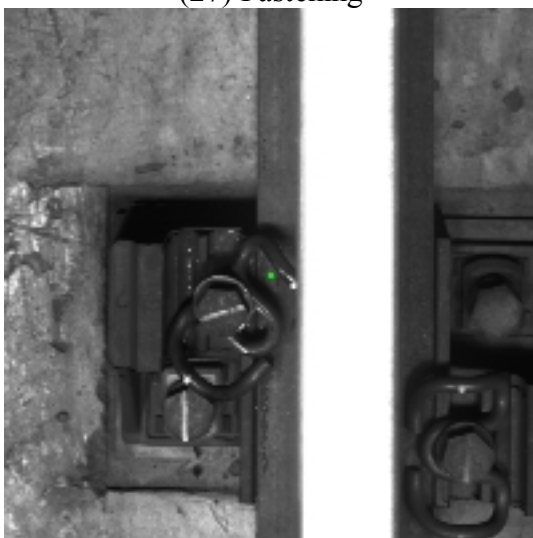
(25) Tie

(26) Tie

(27) Fastening

(28) Fastening

(29) Fastening

(30) Fastening

Figure 4.72 Inspected defects in the underground section. Up direction right rail (V).

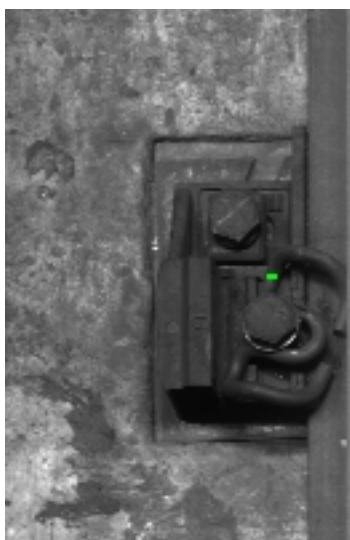
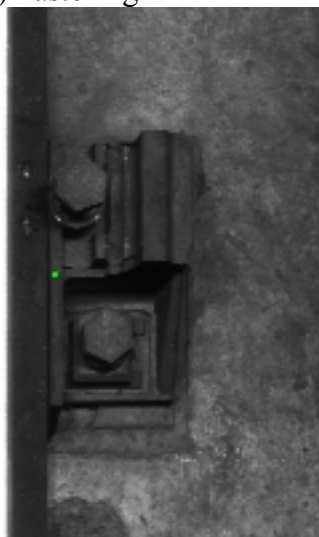
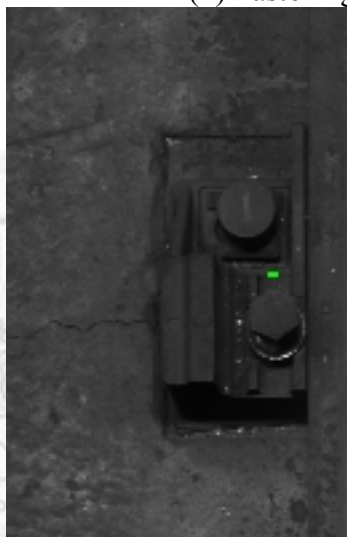
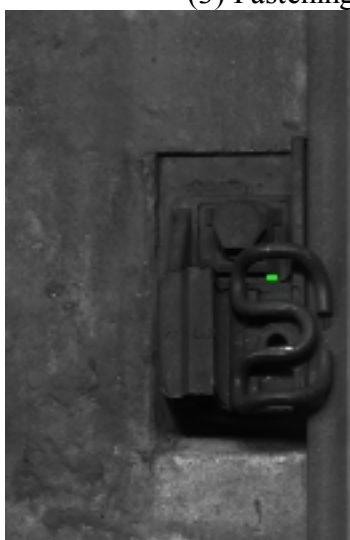
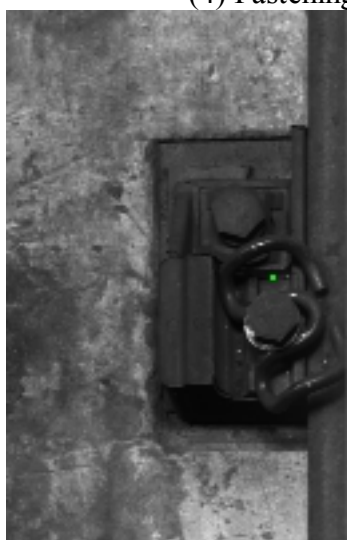
Figure 4.82 Inspected defects in the underground section. Down direction right rail (I).

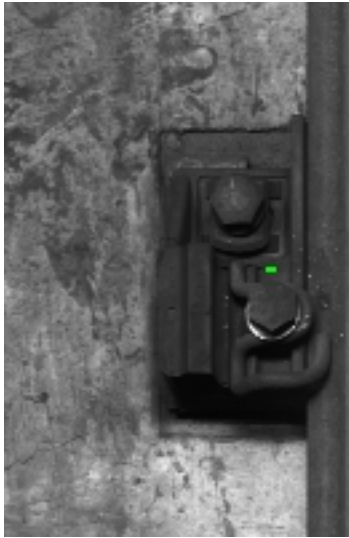
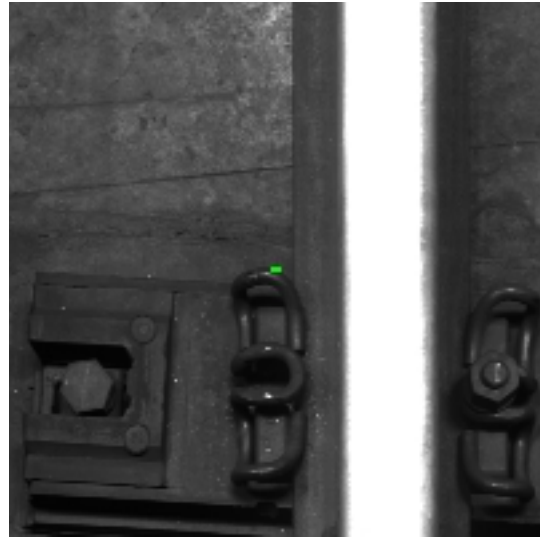
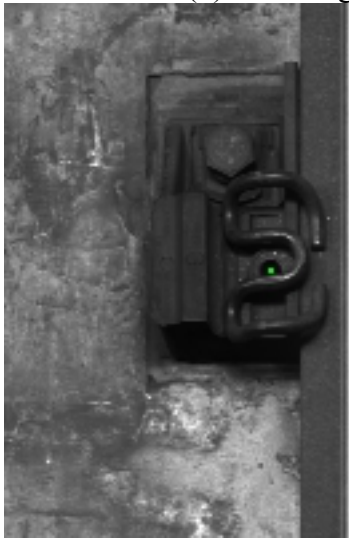
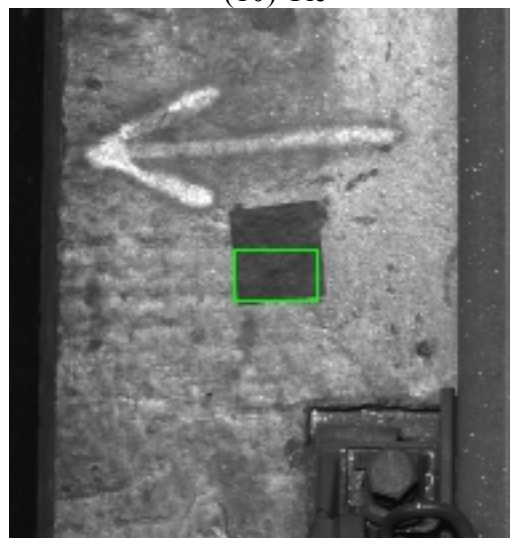
Figure 4.83 Inspected defects in the underground section. Down direction right rail (II).

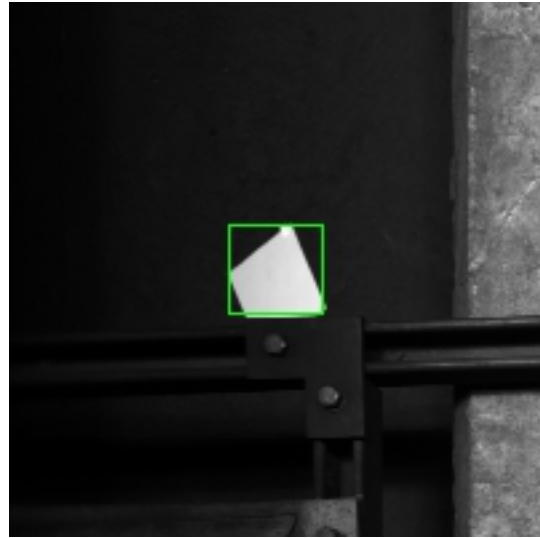
Figure 4.84 Inspected defects in the underground section. Down direction right rail (III).

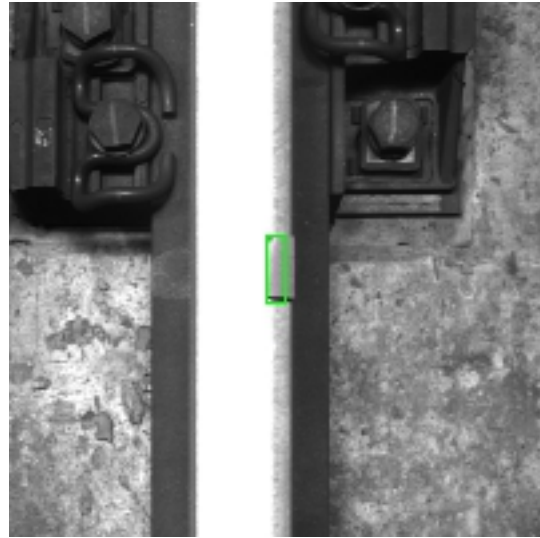
(25) Floor

(26) Rail head

(27) Rail head

(28) Rail head

(29) Rail head

(30) Rail head

Figure 4.86 Inspected defects in the underground section. Down direction right rail (V).

| Figure 4.87 Inspected defects in the underground section. Down direction right rail (VI). | 95 |
