碩士論文

以內埋式光纖光柵感測器監測碳纖維複合材料衝擊及

Application of Investigating the Impact and Fatigue Damage in

Carbon Fiber Composite by Using Pre-embedded Fiber Bragg

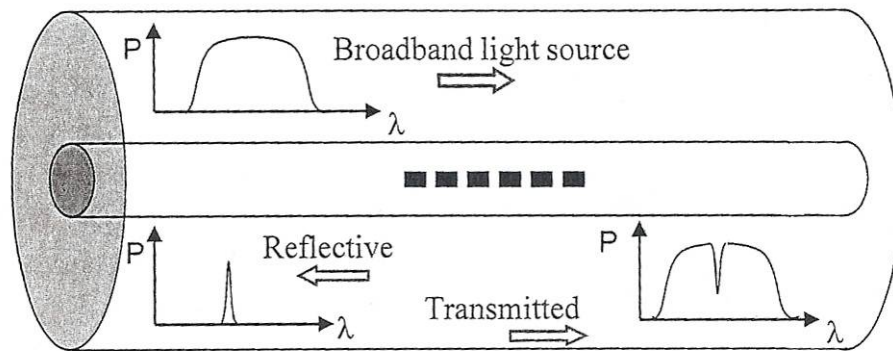
Fig. 2-1: Reflective and transmitted spectra of the Single-mode fiber Bragg gratings [2]

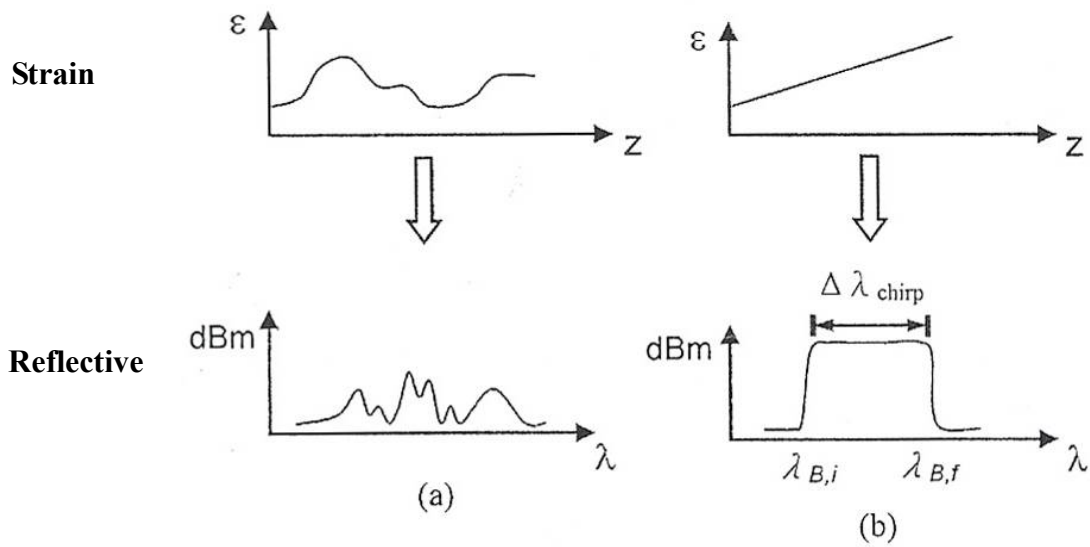
Fig. 2-3: Reflective spectra of FBGs under non-uniform strain fields [2]

When a structure is subjected to impact, the damage caused by the impact often induces non-uniform strain fields inside the structure. If the FBGs are under the non-uniform strain fields, it causes each segment of the FBGs to have a differential shift in wavelength. Depending on the span of each strain value over the grating length, the reflective spectrum shows that the original wavelength peak broadens and separates into several peaks, as Fig. 2-3 (a) shown [2]. In an extreme case, the spectrum gives a chirp distribution if the grating is under a gradient strain field, see Fig. 2-3 (b). Therefore, the shape of reflective spectrum depends on the strain distribution [9].

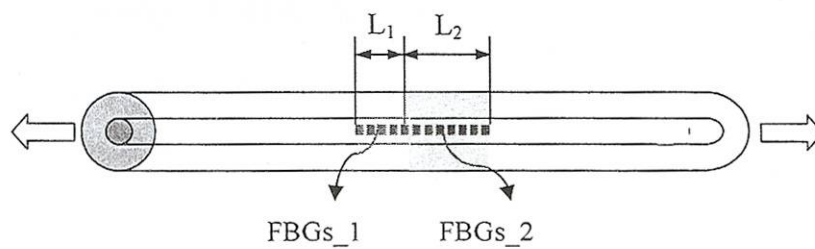
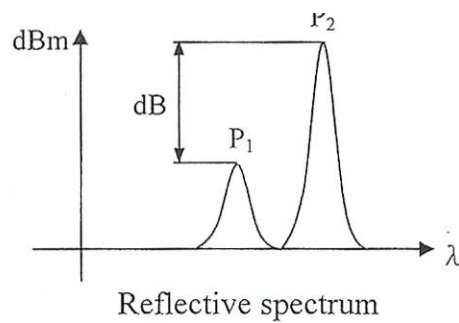
L_1 and L_2 are subjected under different piecewise-uniform strains

Fig. 2-4: A simple situation where the strain distribution is piecewise-uniform over the lengths L_1 and L_2 of the FBG sensors. [2]

where κ is coupling coefficient, L is grating length. If the FBG is under a non-uniform strain field which varies with each different grating length, the grating length can be considered as a number of “partial-FBGs”, each of them with a partial grating length, as Fig 2-4 illustrated [2]. In this situation, the peaks have different intensities due to the different lengths of strain distribution.

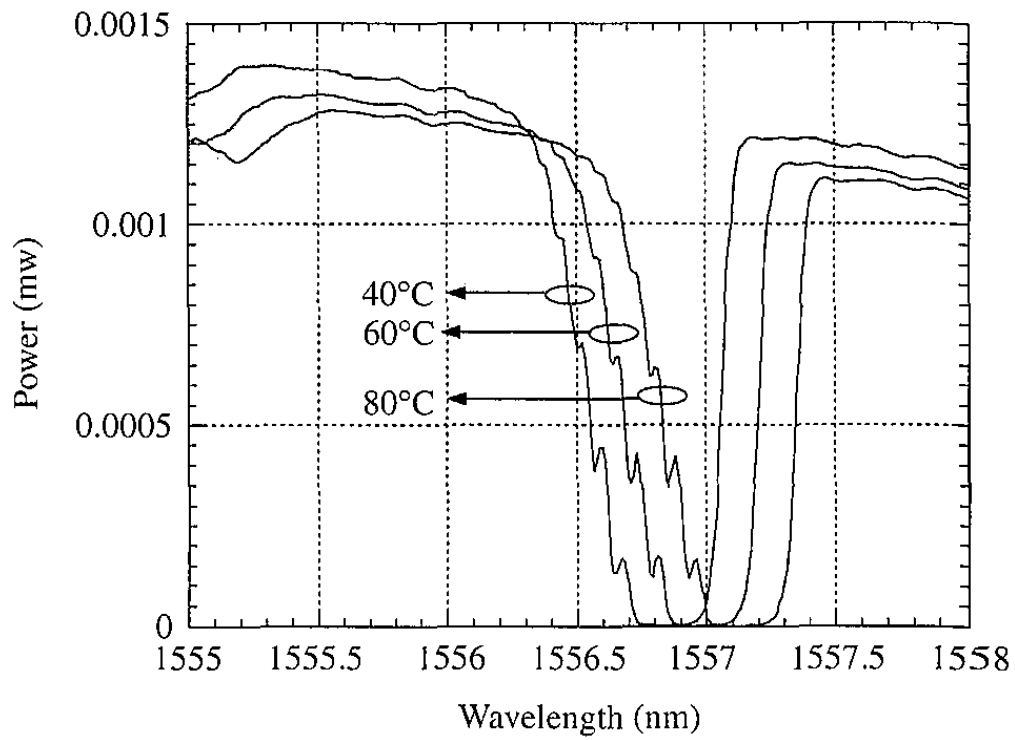
Fig. 2-5: Temperature variation induced Bragg wavelength shift [11]

When the FBGs are applied in the measurement of mechanical parameters, such as stress, strain, curvature...etc, one must consider the issue that the sensing element is sensitive to both temperature and mechanical parameters. The temperature sensitivity of Bragg wavelength is about 10 pm/C°. Fig. 2-5 shows the relationship between Bragg wavelength and temperature. A previous study has reported that the temperature reduced shift of a fiber Bragg grating can be reduced from 10 pm/C° to below 1 pm/ C° [11].

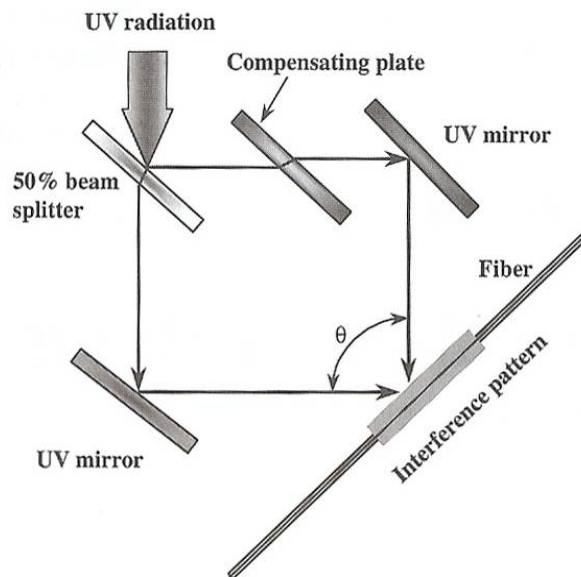
Fig. 2-6: Bulk interferometer method: UV interferometer for writing Bragg Gratings in optical fibers. [10]

The bulk interferometer method for the side writing technique of FBG was first demonstrated by Meltz *et al* [13]. As Fig. 2-6 [10] shows, the UV beam divided into two at a beam splitter and then the two UV mirrors bring the two divided UV beam together at a mutual angle to the interference pattern, where the fiber is held. The interferometer is suitable for single-pulse writing of short gratings. However, a simpler component, phase mask, had been developed to fabricate FBG sensors more easily.

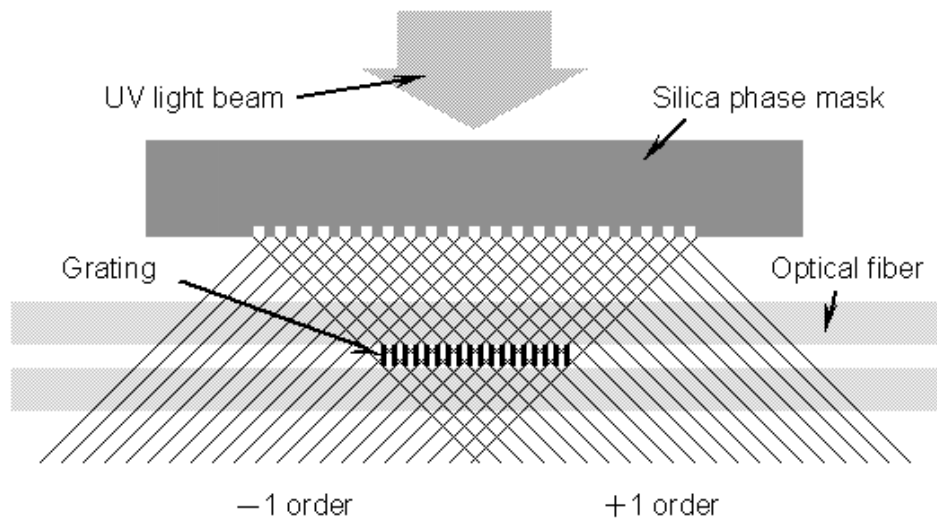
Fig. 2-7: Phase mask method to fabricate FBG [14]

Another easier inscription of fiber gratings was made possible by the application of the phase mask as a component of the interferometer. A phase mask is a UV-transmitting silica plate etched grooves with a carefully controlled mark-space ratio. The gratings can be inscribed in the photosensitive fiber by exposing the fiber to UV beam through a phase mask, as Fig 2-7 [14] illustrates. Now this method has been regarded as a most common technique to fabricate FBGs.

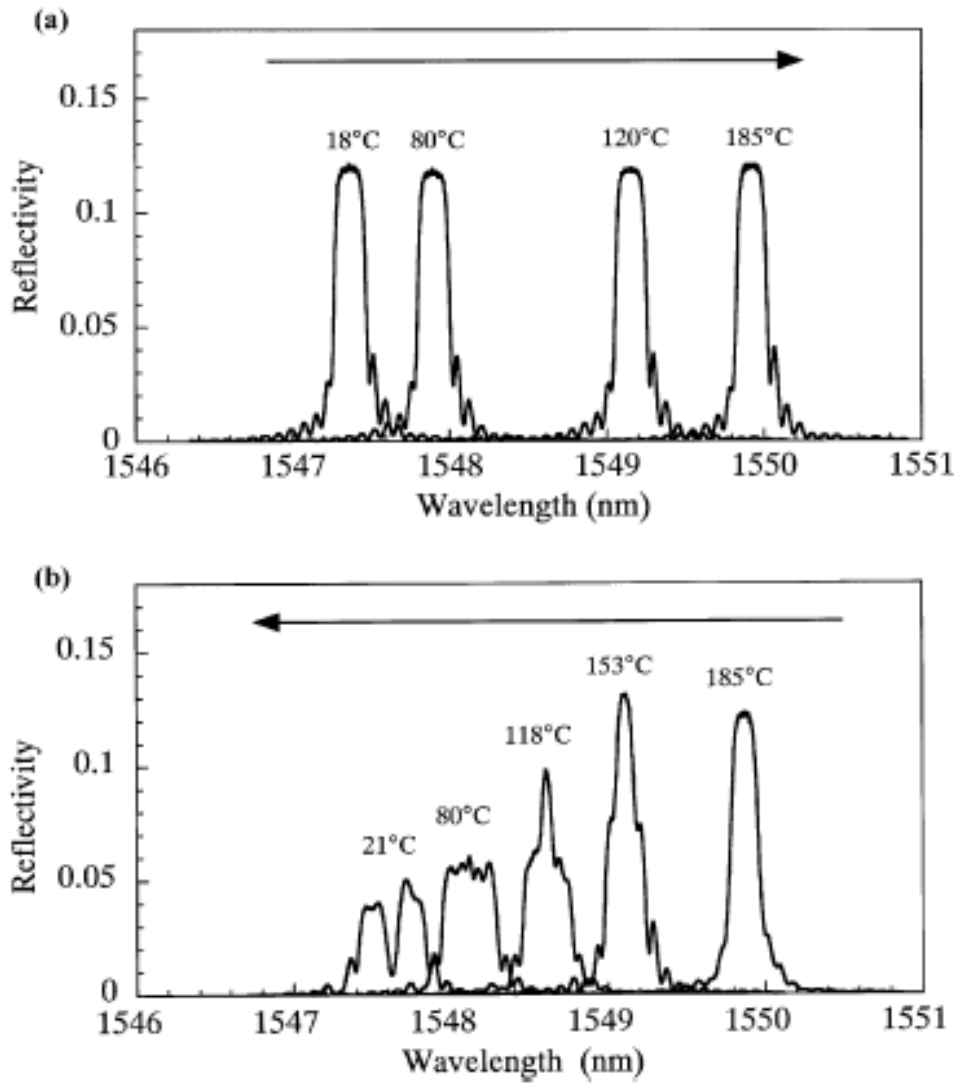
Fig. 2-9: Reflection spectra from the uncoated normal FBG sensor, which was embedded into the CFRP laminate, measured during the cure cycle (a) heating process (b) cooling process [16]

Provided FBG sensors are embedded in composite laminates, it will be under a biaxial residual strain field caused by thermal residual stress, and the reflection spectrum from FBGs splits in to two distinct peaks. This is due to non-axisymmetric thermal residual stress which induces birefringence effect in the optical fiber [15]. Fig. 2-9 [16] illustrates the reflective spectra from uncoated normal FBG sensor embedded in CFRP laminates during the cure cycle. The Bragg wavelength just shifted but without significant deformation while the temperature was increasing. This is because the laminates are in a liquid state before solidification. But during the cooling process, the reflective spectra started deforming. In this stage, the laminates are solid state, and therefore the thermal residual stress appears in it. As the temperature drops from 185C° to room temperature, the form was disturbed, and finally split into two peaks.

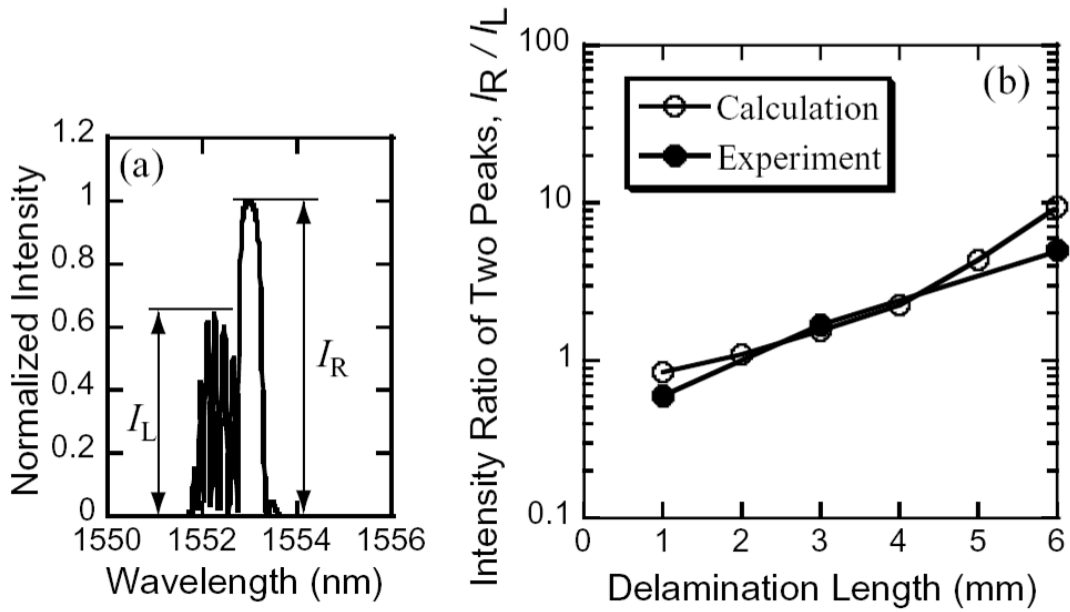
Fig. 2-11: Evaluation of delamination size. (a) Definition of intensities for two peaks and (b) logarithmic curves of intensity ratio against delamination size [20]

Takeda examined the impact-induced delamination in CFRP laminates using small-diameter FBG sensors [20]. He used FBG sensors to detect the effect caused by a delamination as monotonic tension loading was applied. The change in reflection spectra from the FBG sensor depends on the delamination size. When the form of the spectrum was mainly characterized by two peaks, the intensities of the two peaks could be good indicator of delamination size. The delamination length was evaluated through the intensity ratio of the two peaks in the spectrum, as Fig 2-11 shows [20]. From the relationship between the delamination size and form of the spectrum, it could effectively predict the delamination length in composite structure.

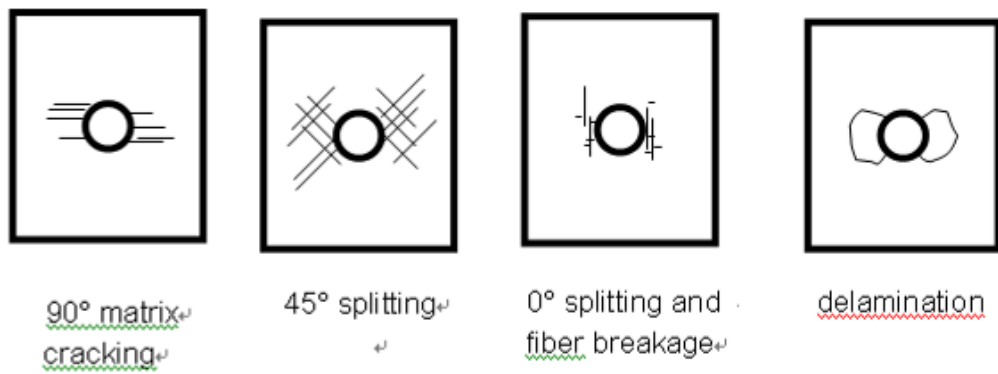
Fig. 2-13: Schematic fatigue damage modes of quasi-isotropic composite laminate [21]

Many composite structures are subjected to cyclic loading during their normal life expectancy. This can induce the propagation and development of insidious defects in the composite structure and eventually lead to destructive failures. The primary failure modes caused by fatigue testing include: matrix cracking, fiber splitting and breakage and delamination. The schematic diagram of fatigue damage is shown in Fig. 2-13 [21].

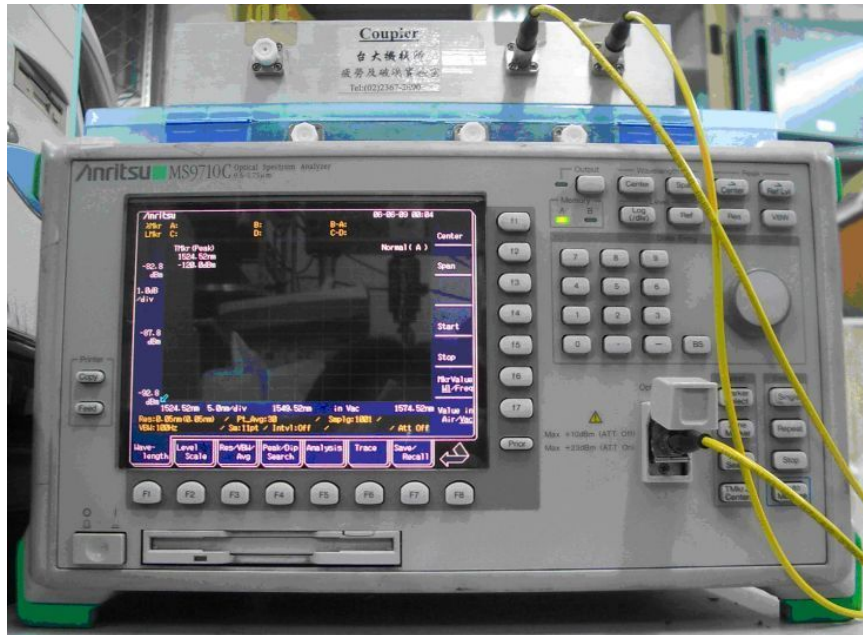
Fig. 3-1: Optical spectrum analyzer (MS9710C)

(1) Optical spectrum analyzer (see Fig. 3-1)

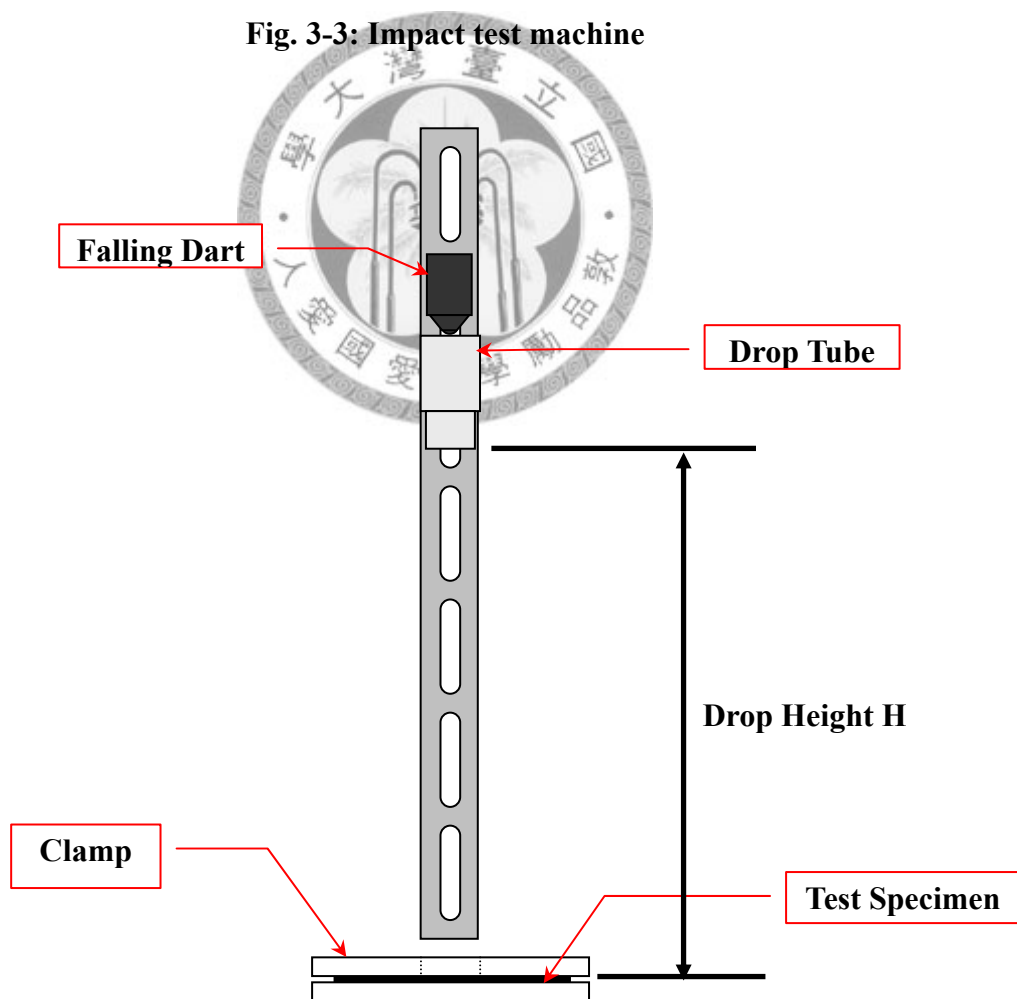
Fig. 3-3: Impact test machine

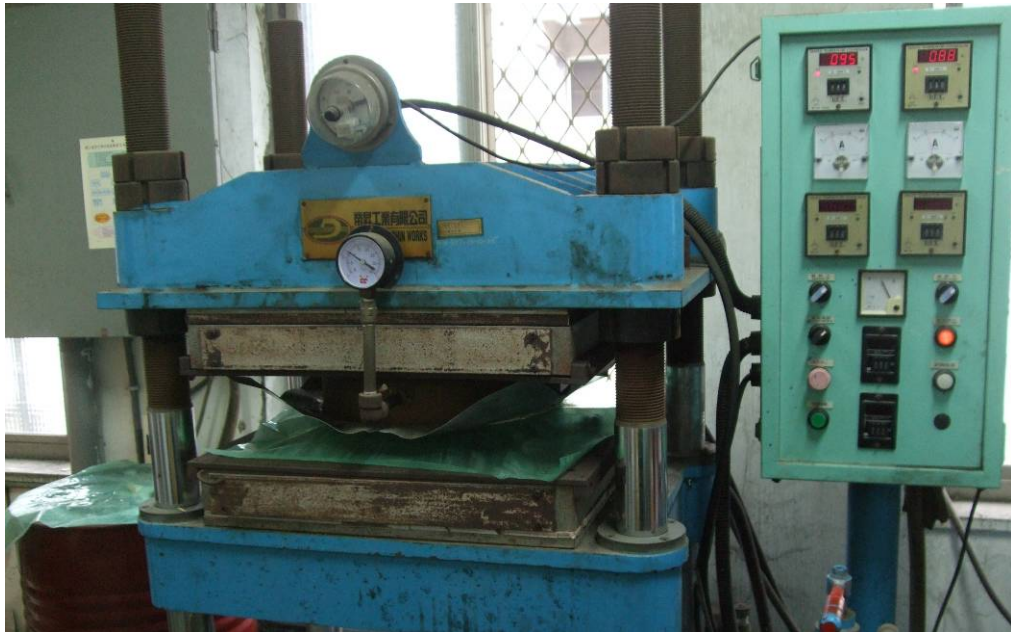
Fig. 3-8: Abrasive diamond-coated wheel cutting machine

(7) Hot press molding system (see Fig. 3-9)

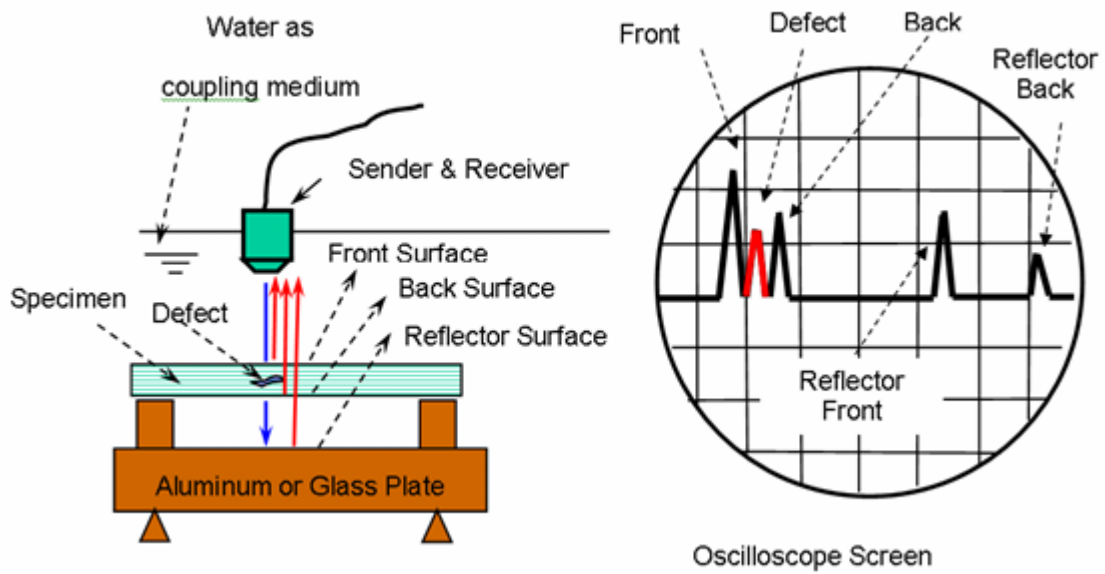
Fig. 3-10: Ultrasonic imaging system

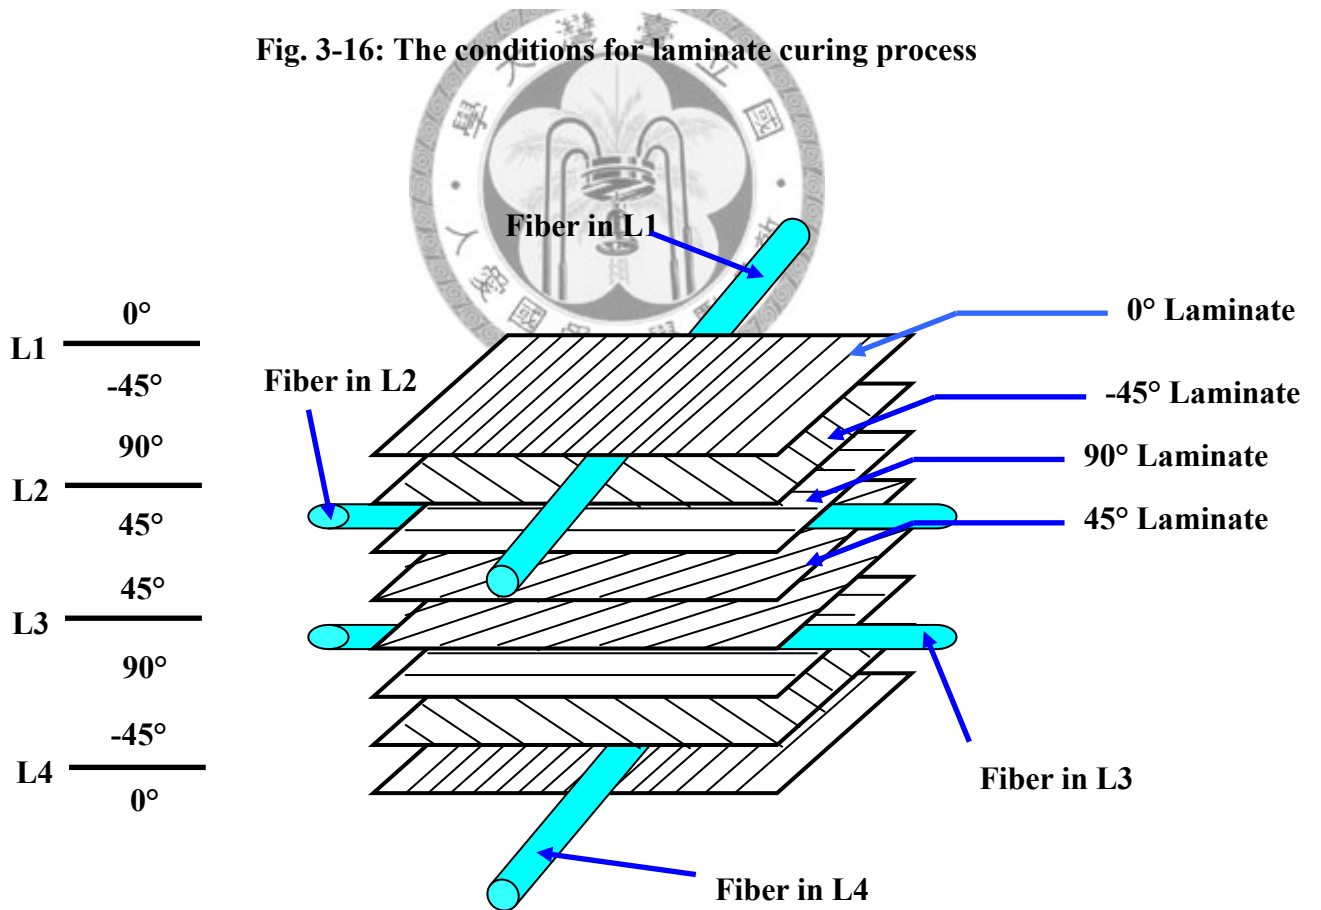
Fig. 3-16: The conditions for laminate curing process

as Fig. 3-17 illustrated. The two FBGs embedded in L1 and L4 oriented at 0° and were parallel but separated with each other by 6mm. The same is also true for the two embedded in L2 and L3 (Fig. 3-18). All the FBG sensors in each layer were located in the center of the plate specimen, and the fibers pierced through the plate to reach outside, at 30mm away from the edge of the plate.

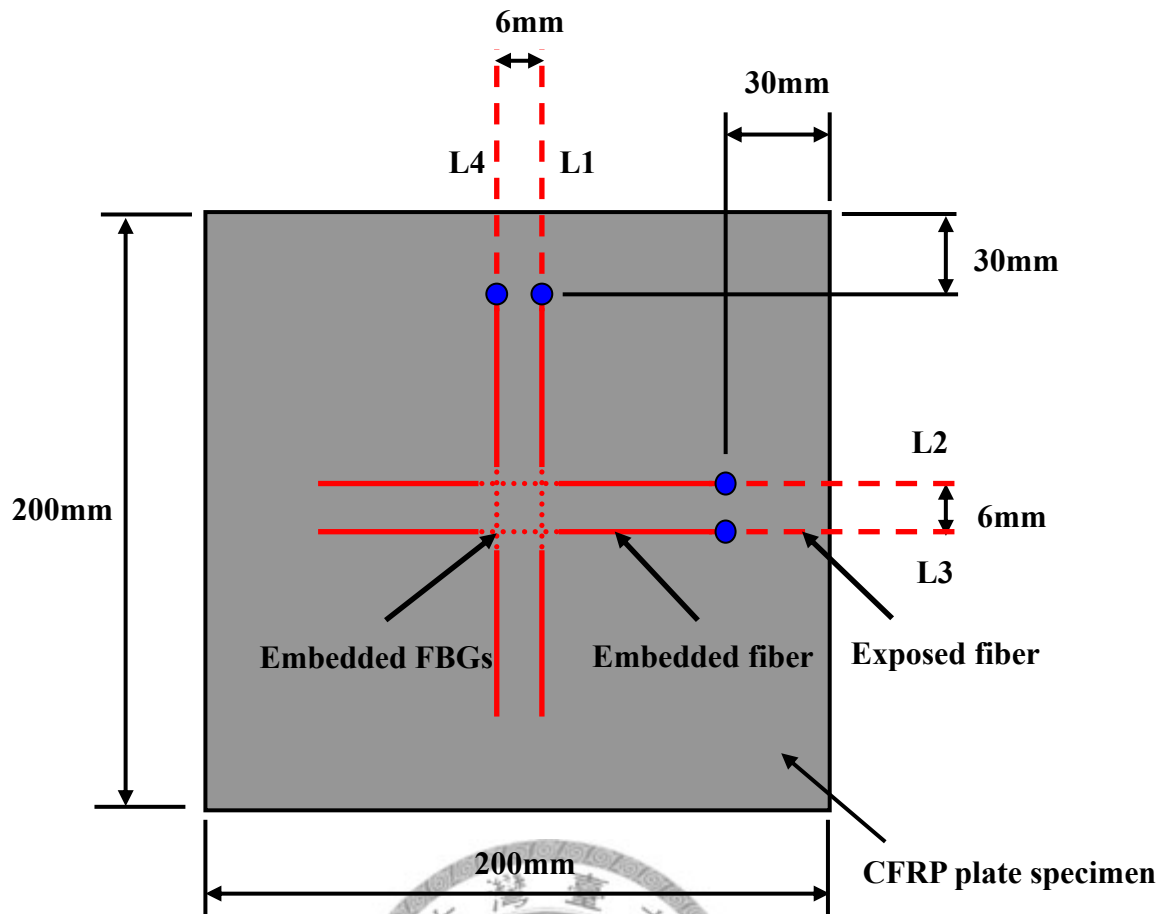
Fig. 3-17: Schematic of fiber-embedded method and laminates stacking sequence

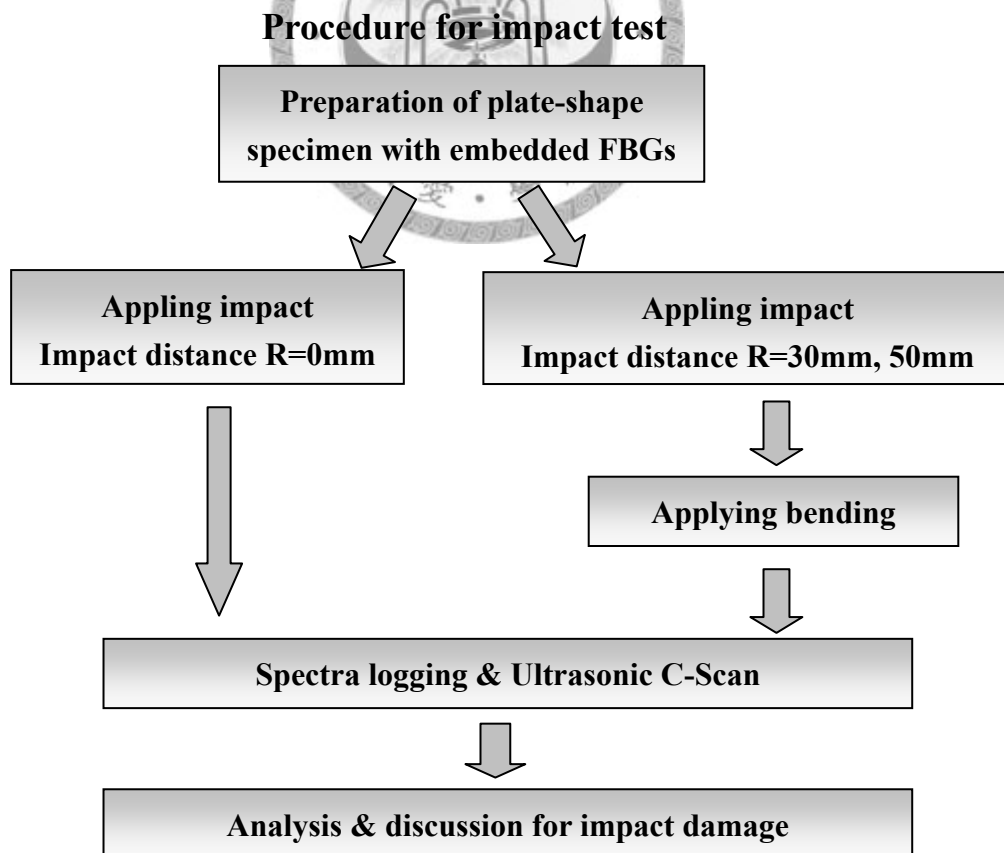
Fig. 3-18: Configuration of embedded FBGs in CFRP plate specimen

The purpose of the impact test was to investigate possibility of using FBG to monitor impact-induced damage in the CFRP composite structure. Fig. 3-19 indicates the procedures for impact test in this study. Impact damages were produced at specific drop heights H (80cm and 140cm) on the CFRP plate specimen. The points of impact were arranged as shown in Fig. 3-20, in order to find to find out the sensitivity of measurement region for FBG sensors. A combination of three different distances R (0mm, 30mm, and 50mm) and three different angular positions (A0, A45, and A90) were employed. For impact distance R=0mm, each specimen was applied only one impact on the center, the drop heights were 80cm and 140cm respectively. For impact distance R=30mm and drop height H=80cm, the impacts were applied at A0 first, then A45, finally A90 in one specimen, and we recorded the reflective spectrum as each impact was completed. For impact distance R=30mm and drop height H=140cm, the spectra was recorded after all the impacts were completed at A0, A45, and A90, in

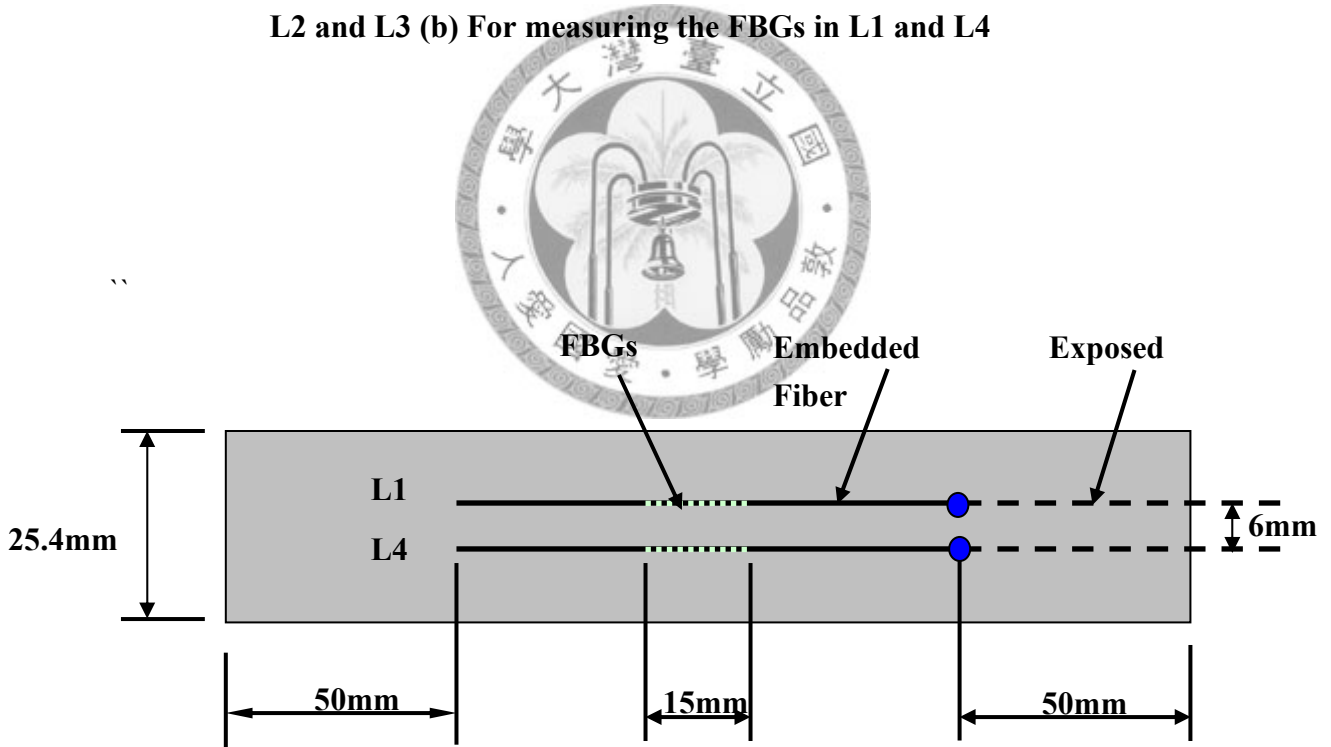
Fig. 3-22: Bending test was conducted in different directions for measuring embedded FBG sensors in each layer. (a) For measuring the FBGs in L2 and L3 (b) For measuring the FBGs in L1 and L4

Due to the geometric restriction in the post-impact fatigue specimen, the FBG sensors could only be embedded in L1 and L4. Fig. 3-23 illustrates the location where the FBG sensors were installed. The distance between two FBG sensors was 6mm. To avoid the optical fibers being clamped by the grips during fatigue test, they were surfaced at 50mm away from the center of specimen.

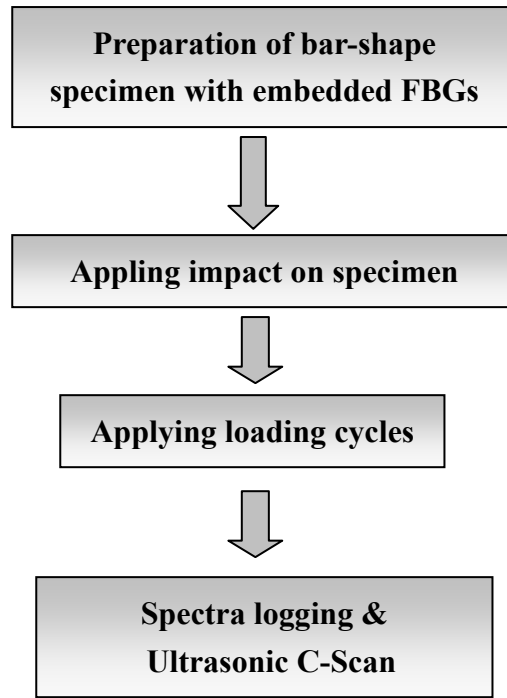
Fig. 3-23: Configuration of test specimen for post-impact fatigue test

The procedure and setup in post-impact fatigue test were shown in Fig. 3-24 and Fig. 3-25, respectively. First of all, the specimen would be impacted at a drop height of 80cm or 140cm. The 260g iron falling dart used in this test and the impact positions was designated A, B, and C, as shown in Fig. 3-26. Position B was at the center of the specimen (the location where FBGs were embedded), while positions A and C were respectively in the upstream and downstream of the gratings based on the route of the light propagation. When the light was routed through the gratings, it would reach position A first, via the gratings through to position C.

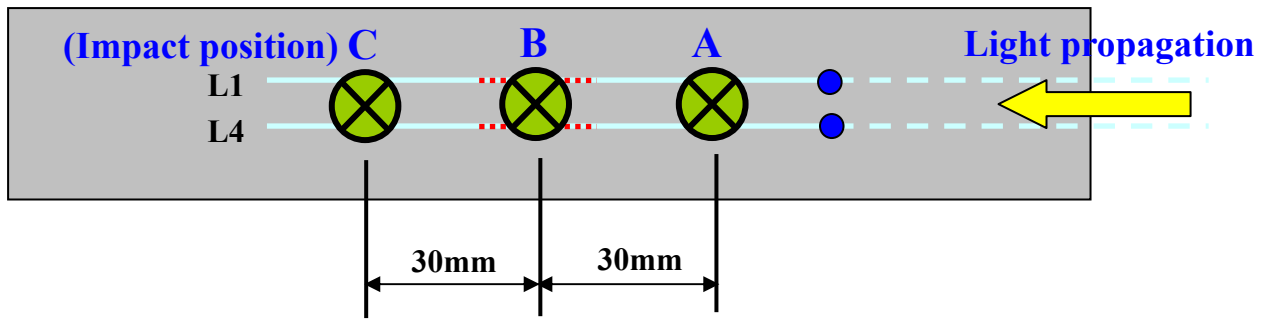
Fig. 3-25: Schematic of experimental setup in post-impact fatigue test

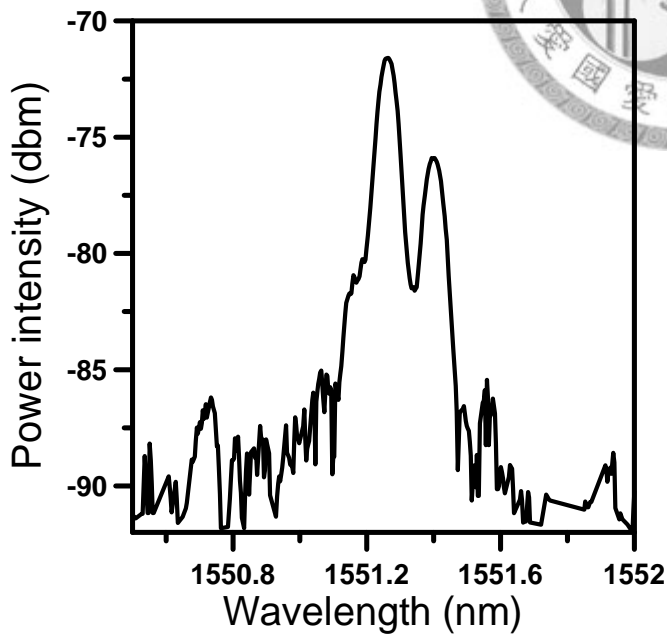
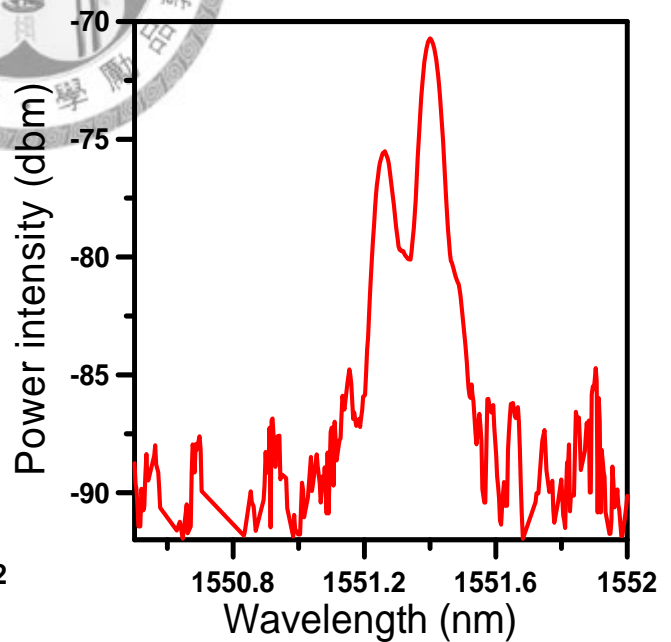
(a)

(b)

Fig. 4-2: Energy exchange between two peaks due to birefringence effect. (a) Initial state of the fiber (b) On bending

Furthermore, from the spectra, we could observe that the left peak had a higher power intensity than the other one. However, the power of each peak would reverse as the fiber was bent. In Fig. 4-2 (a), the intensity of the left peak was originally higher than the right one. However, on bending, the intensity of left peak was degenerated, as shown in Fig. 4-2(b), and the loss power was transferred to the right peak. Therefore the right side peak became higher and the left side peak became lower. From the discussion in chapter two, this phenomenon can be best explained by birefringence effect [17].

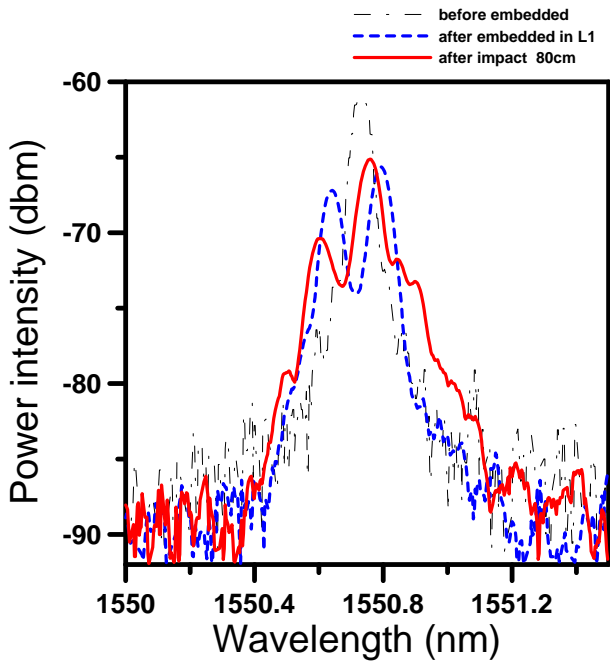
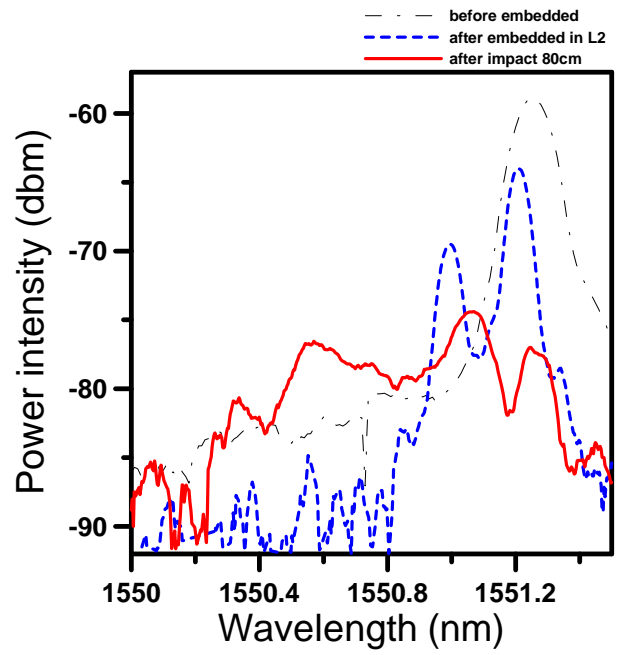
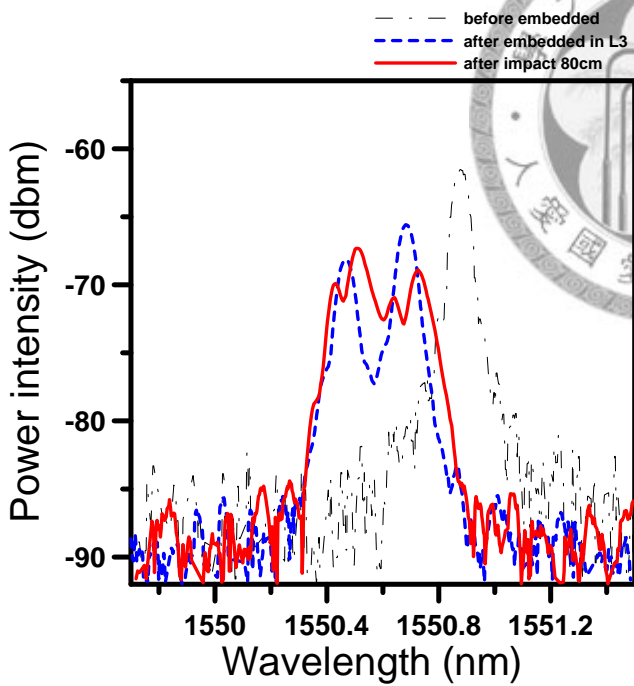
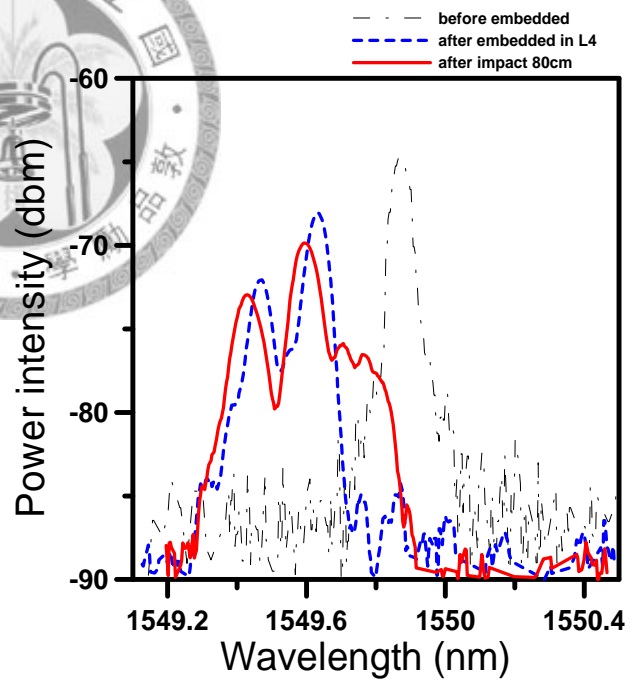
(a) FBG in L1

(b) FBG in L2

(c) FBG in L3

(d) FBG in L4

Fig. 4-3 (a)-(d): Comparison of spectra from FBG sensors in each layer between before and after impact under a 80cm drop-height.(a) Embedded in L1 (b) Embedded in L2 (c) Embedded in L3 (d) Embedded in L4

In this test, the impact was applied at the center of the specimen under 80mm drop height, ensuring the arranged FBG sensors in the vicinity of the impact source. Fig. 4-3 shows the reflective spectra from FBG embedded sensors in each layer between before and after impact under 80cm drop height. The deformation of spectra of FBG embedded in L1 between before and after impact was not matched, nonetheless the width of the reflective peak became widened. The result best explained that the impact damage had affected the embedded FBG sensor, but the impact damage was relatively smaller in L1. Therefore, we could infer the impact load induced less damage on the most upper layer. For the FBG sensors in L2 and L3, there were significant changes in the spectra between before and after impact. The original waveform of the FBG embedded in L2 which almost deformed completely and the two peaks in the spectra of FBG embedded in L3 separated into four peaks. These significant changes indicate that the impact-induced damage in L2 and L3 were more serious than other layers. For the

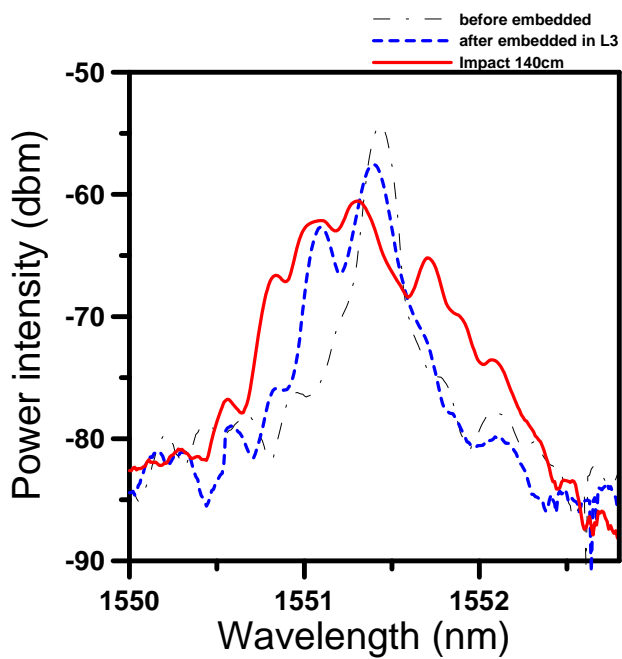
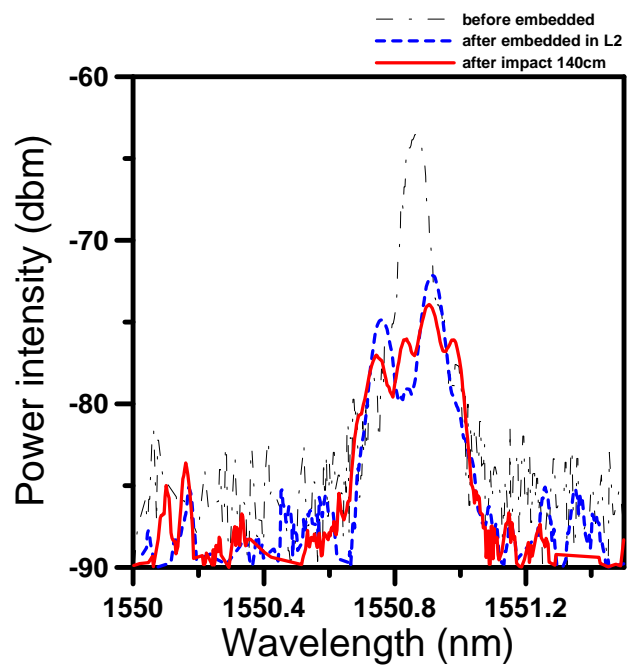
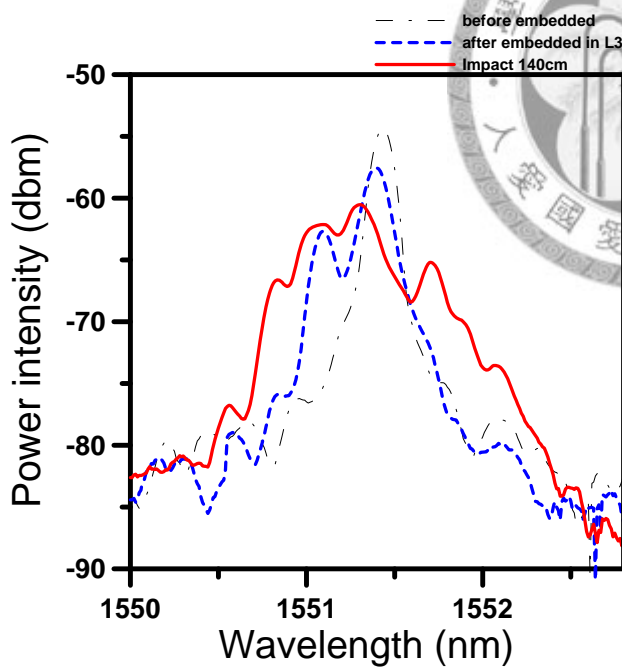
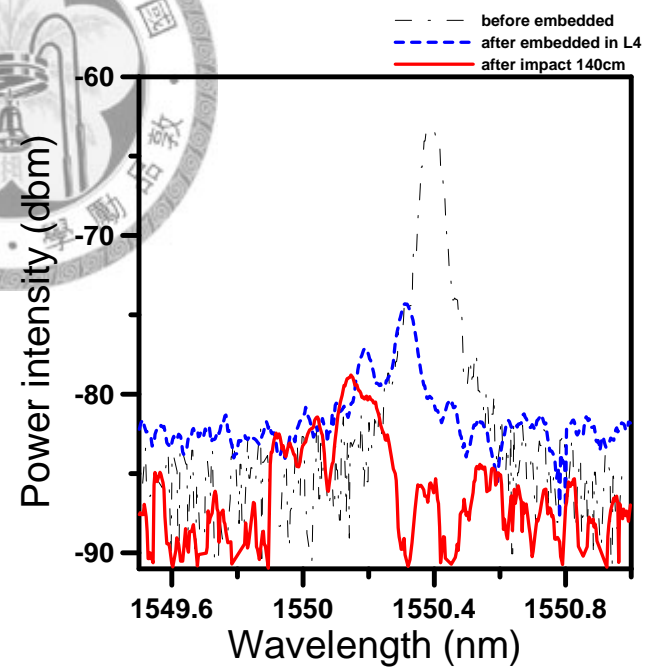
(a) FBG in L1

(b) FBG in L2

(c) FBG in L3

(d) FBG in L4

Fig. 4-4: Comparison of spectra from FBG sensors in each layer between before and after impact under a 140cm drop-height. (a) Embedded in L1 (b) Embedded in L2 (c) Embedded in L3 (d) Embedded in L4

Fig. 4-4 shows the reflective spectra from FBG sensors embedded in each layer before and after impact under a drop height 140cm. For the FBG sensor in L1, it was found that there was an alteration in the peak area, yet the deformation of spectrum was not significant. For the FBG sensors in L2 and L3, similarly to the previous condition, the original peaks broadened and separated into more peaks. For the FBG sensor in L4, due to the increase of impact energy, the spectra had significantly changed and the two peaks were separated into irregular forms. Based on the above mentioned, we found the power of reflective light which decreased due to the impact damage. Generally, the reductions of the power in each FBG were larger than previous ones.

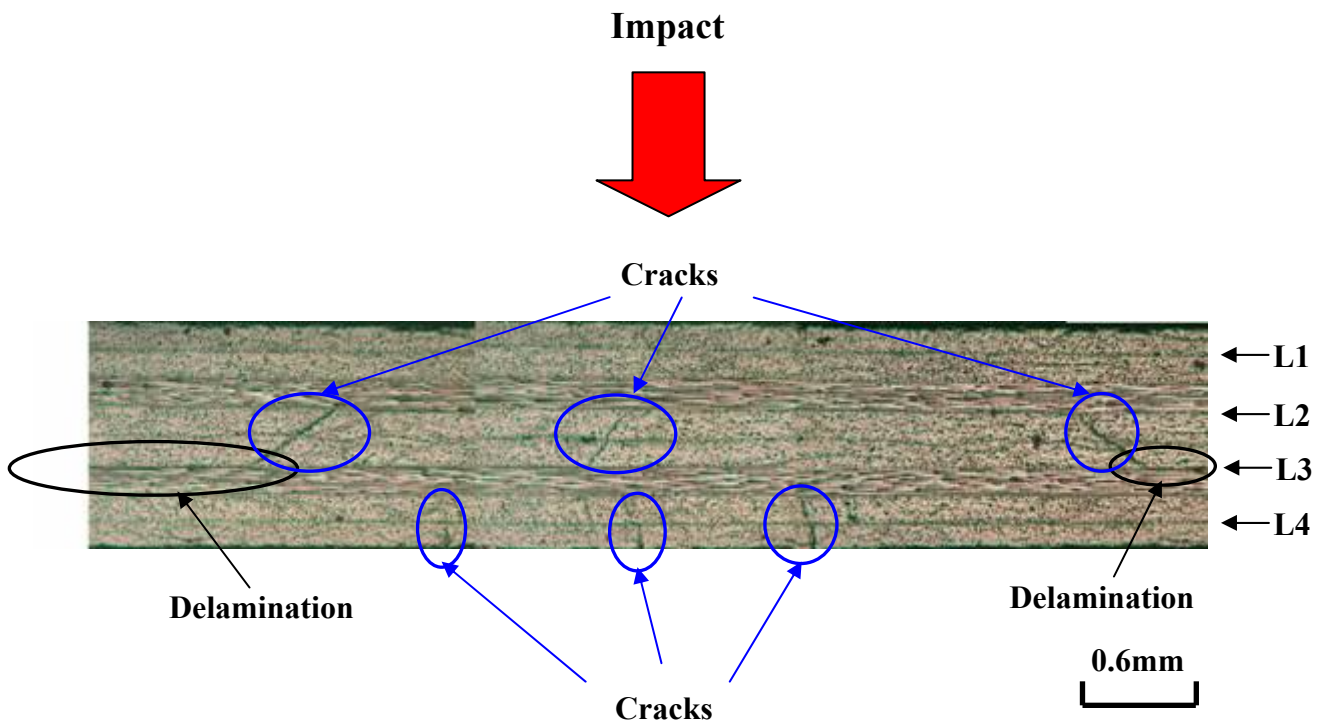
Fig. 4-5: Optical Micrographs of the impact-damaged specimen (drop height 80cm) [32]

One study [26] has shown the optical micrographs on the sectional view of the impact-damaged specimens (Fig. 4-5 and Fig. 4-6). Under the 80cm drop height, it could be observed that the delaminations in the middle laminates and some cracks in the middle and bottom laminate, as shown in Fig. 4-5. Although the up laminate faced
