碩士論文

以內埋式光纖光柵感測器監測碳纖維複合材料衝擊及

Application of Investigating the Impact and Fatigue Damage in

Carbon Fiber Composite by Using Pre-embedded Fiber Bragg

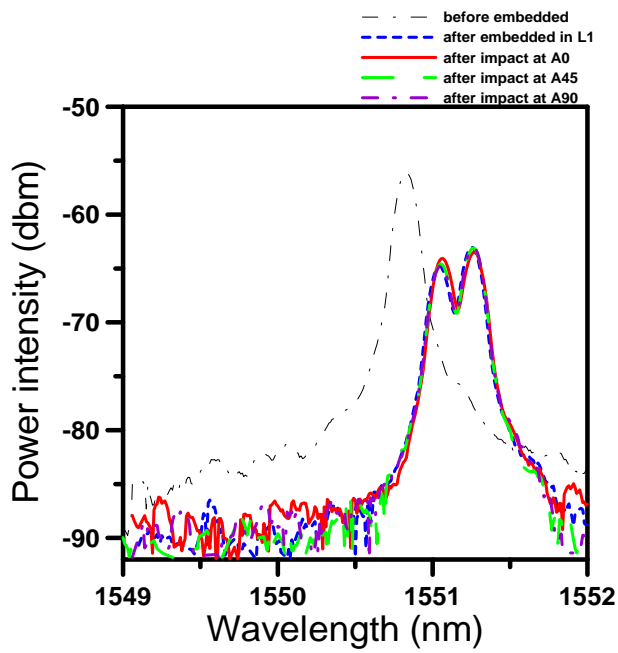
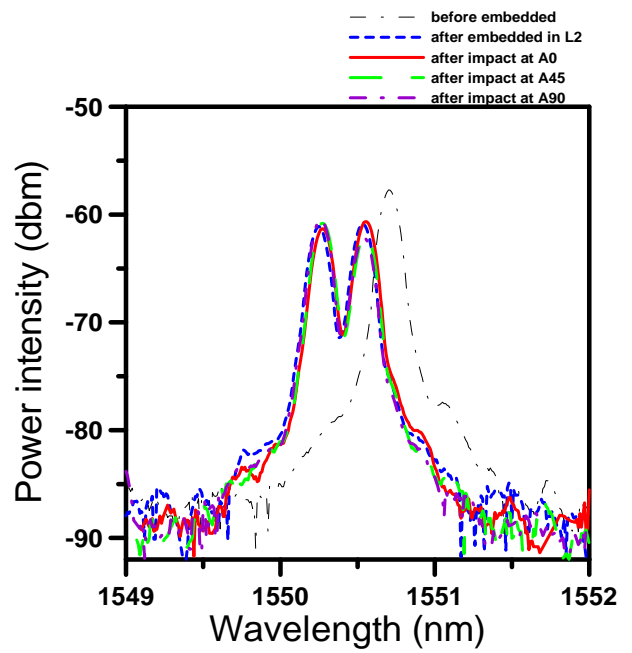
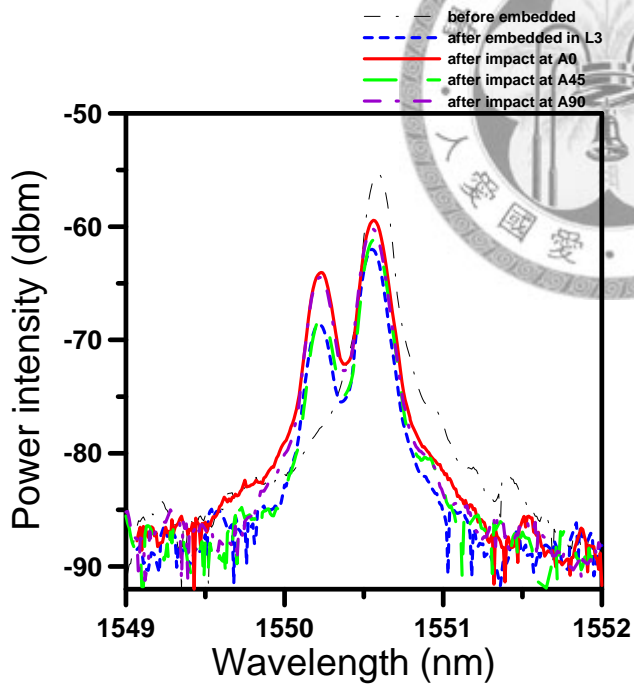
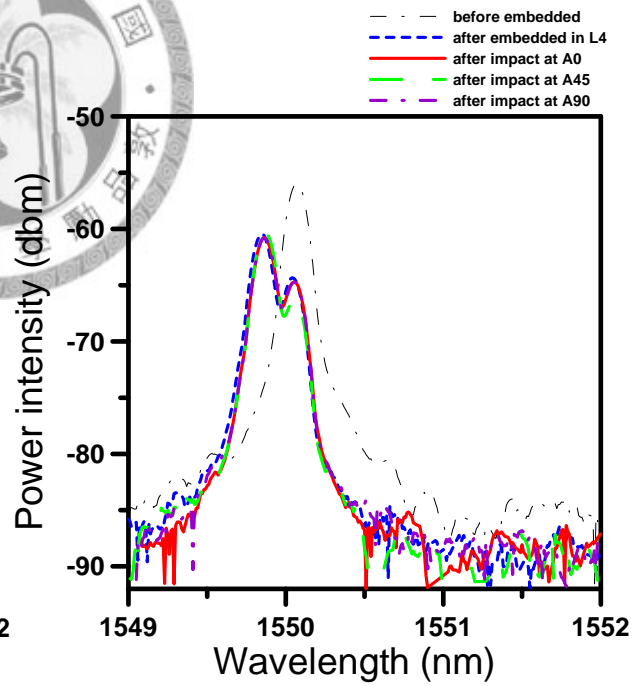
(a) FBG in L1

(b) FBG in L2

(c) FBG in L3

(d) FBG in L4

Fig. 4-7: Comparison of spectra from FBG sensors in L1 and L2 between before and after impact under a 140cm drop-height.

were recorded before and after each impact completed. Fig. 4-7 shows the reflective spectra from FBG sensors embedded in each layer between before and after impact under 140cm drop height and a distance 30mm away from FBG sensors. It could be seen that the deformations of waveform were not significant. This suggests the FBG sensor is not sensible to the impact damage at the current distance of 30mm under the load-free condition. For this reason, the bending test was conducted to review the deformation of waveform and shifts in wavelength.

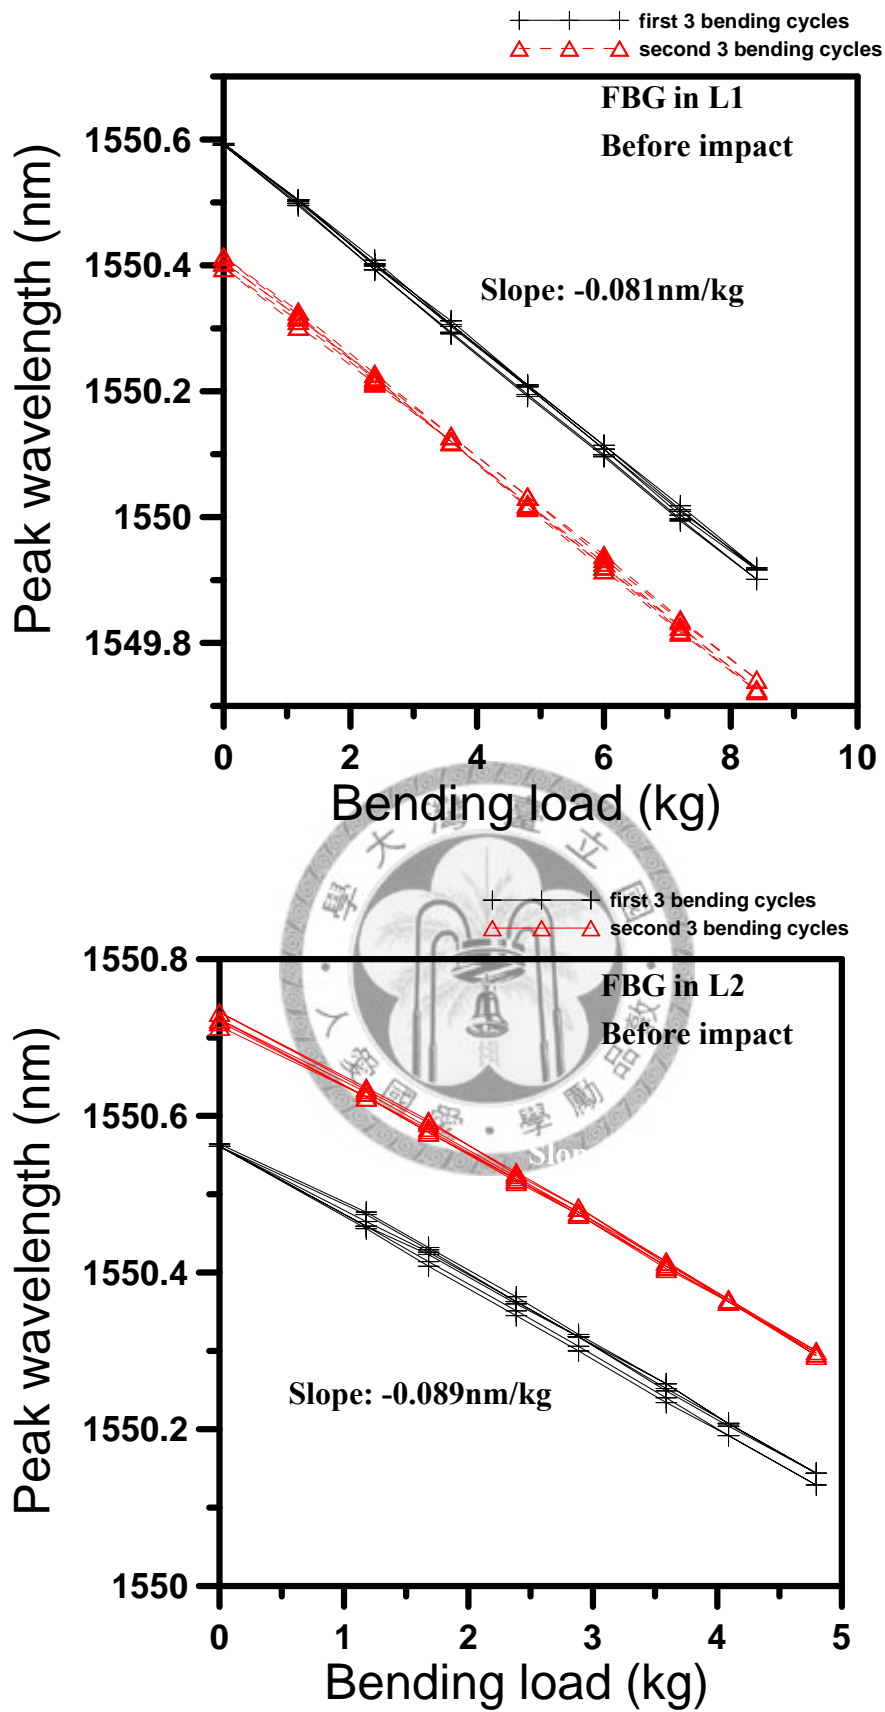
Fig. 4-10 (a): Wavelength shifts from the embedded FBG sensors in L1 and L2 along the bending test before impact.

For the quantitative evaluation, the wavelength shifts was plotted as a function of bending load. In each bending test, we conducted three bending cycle on the specimen. Fig. 4-10 (a) and (d) shows the wavelength shifts during the bending test before impact. Due to the resolution limitation of the OSA and variation of environmental temperature, the initial peak wavelength would change in each bending test. However, the comparison of the peak wavelength shifts during the bending test depends on the line deviation and slop, so the different initial peak wavelength would not affect the measurement. It was found from the charts that the peak wavelength shifts of the FBGs embedded in each layer could almost linearly increase or decrease during the bending test, and the slope had no significant change. To check reproducibility, we conducted another three bending cycles again on the specimen. The results showed that the bending did not substantially affect the CFRP specimen, and the embedded FBG

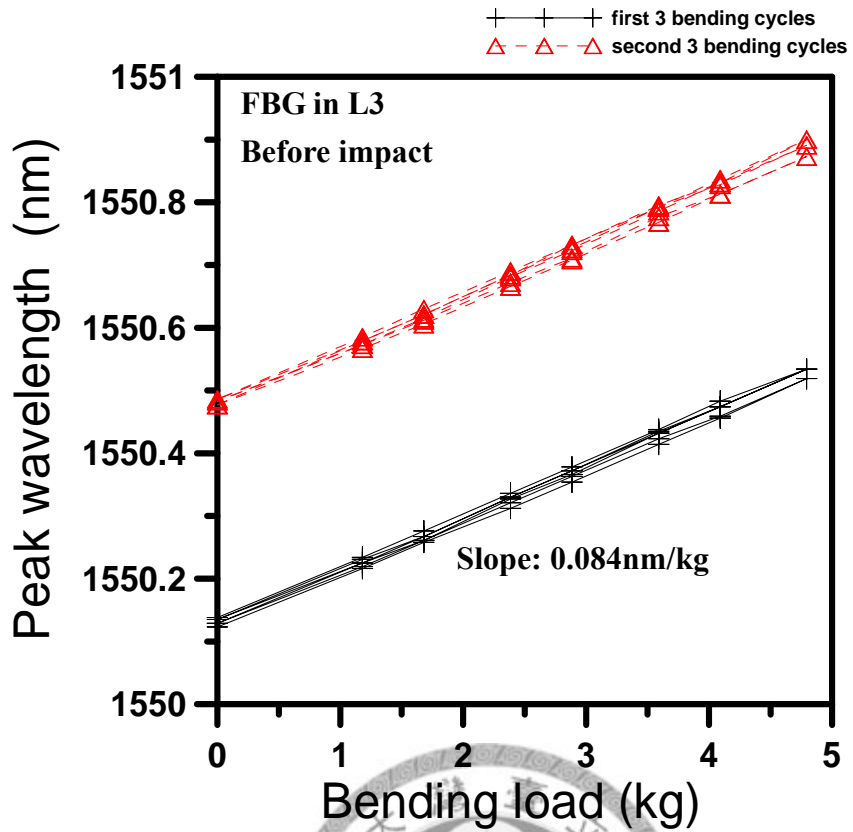
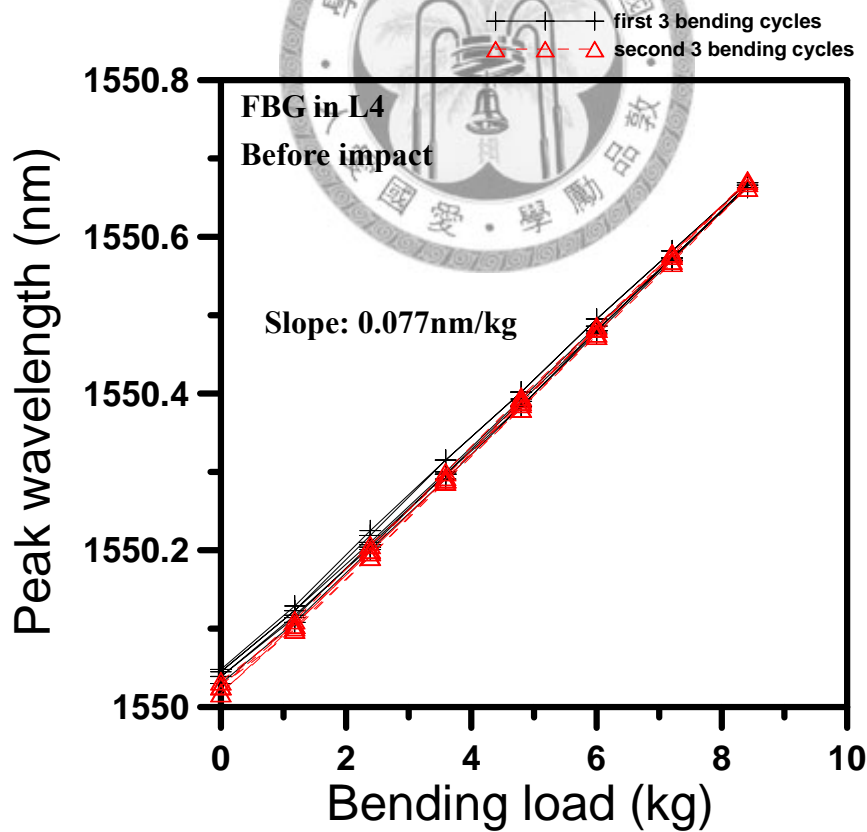
Fig. 4-10 (b): Wavelength shifts from the embedded FBG sensors in L3 and L4 along the bending test before impact.

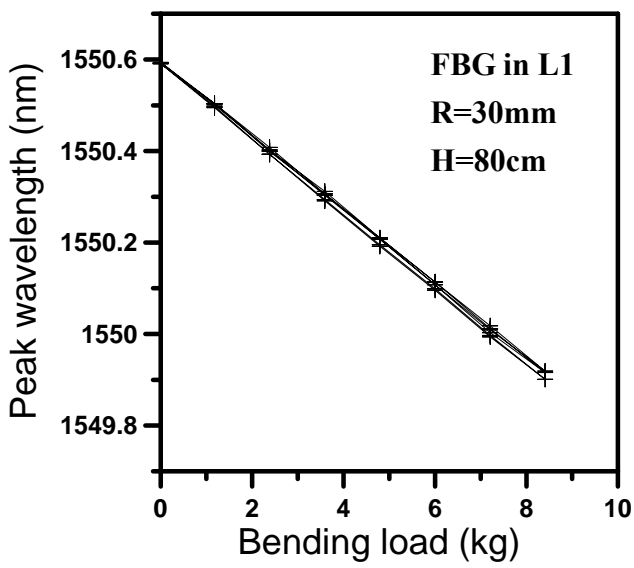
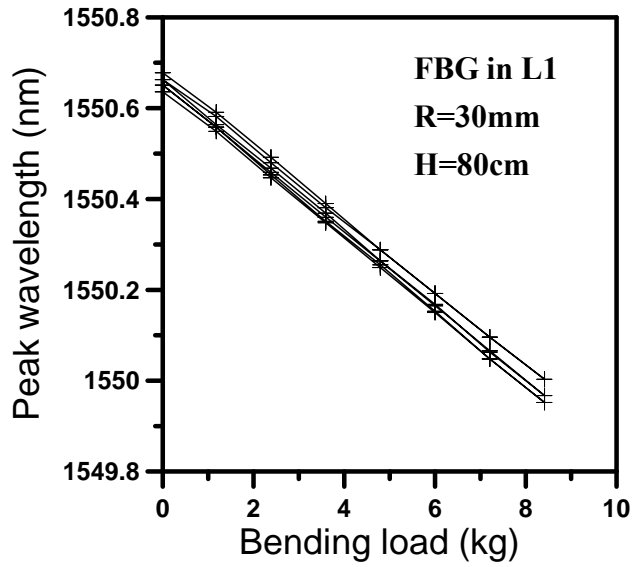
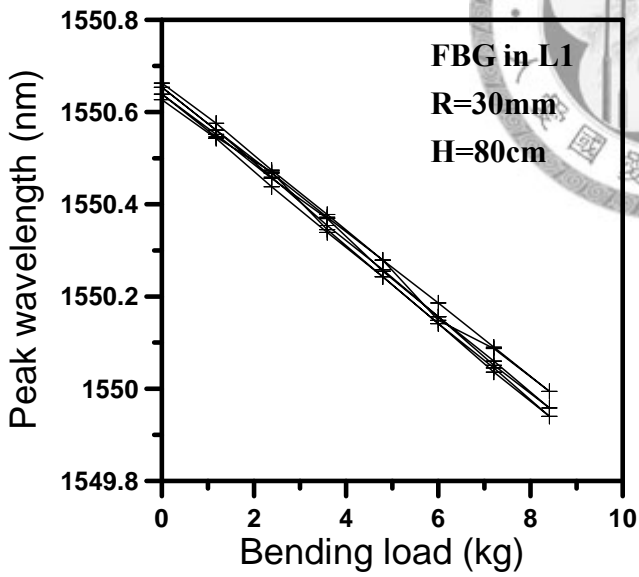
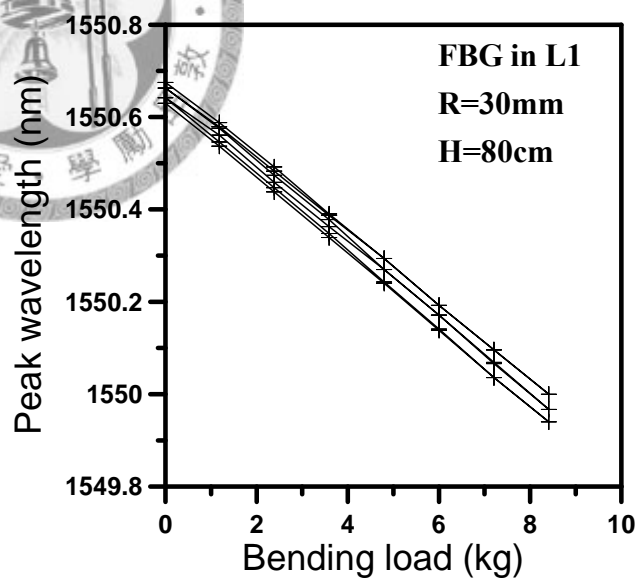
Before impact

After impact at A0

After impact at A0 and A45

After impact at A0, A45, and A90

Fig. 4-11 (a): Comparison of wavelength shifts from embedded FBG sensor in L1 along a bending test before and after impact under an 80cm drop-height and a distance 30mm away from FBG sensors.

After impacting on the CFRP plate specimen, several occasions of damage in the specimens took place. The wavelength shifts along the bending test were influenced by the damage. Fig. 4-11 (a) to (d) show the comparison of wavelength shifts from

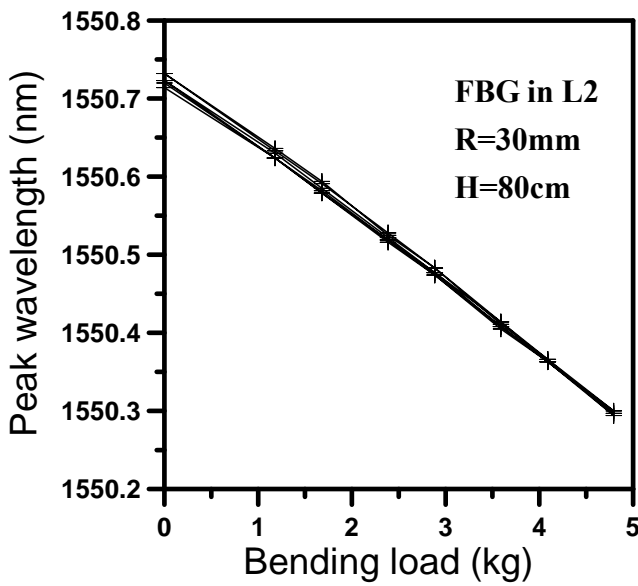
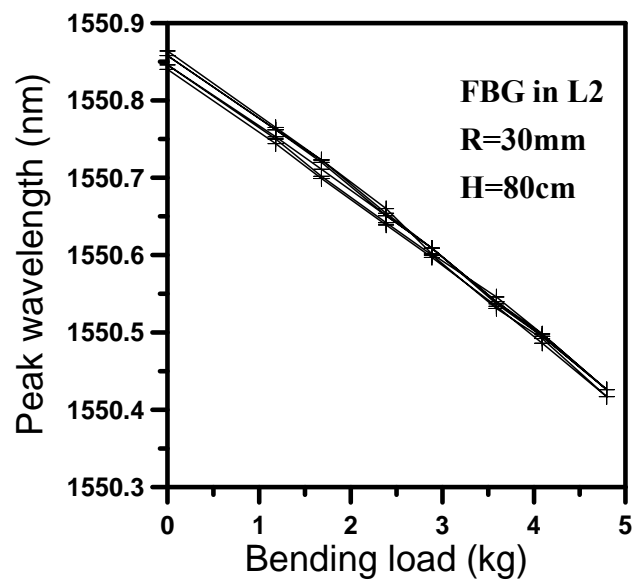
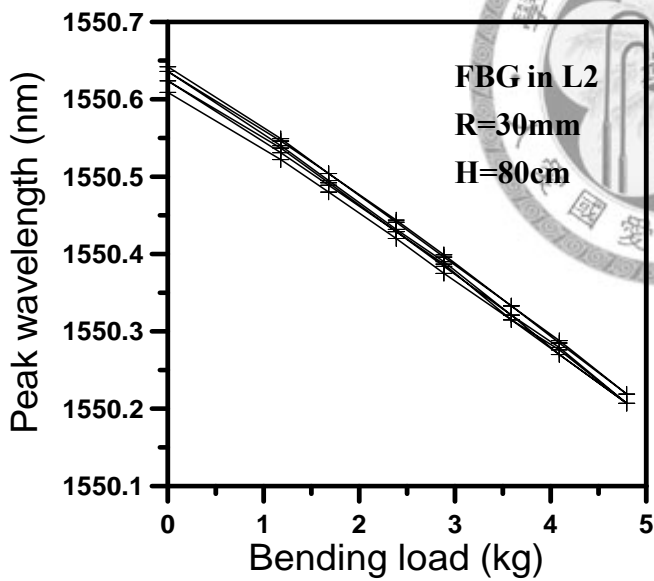
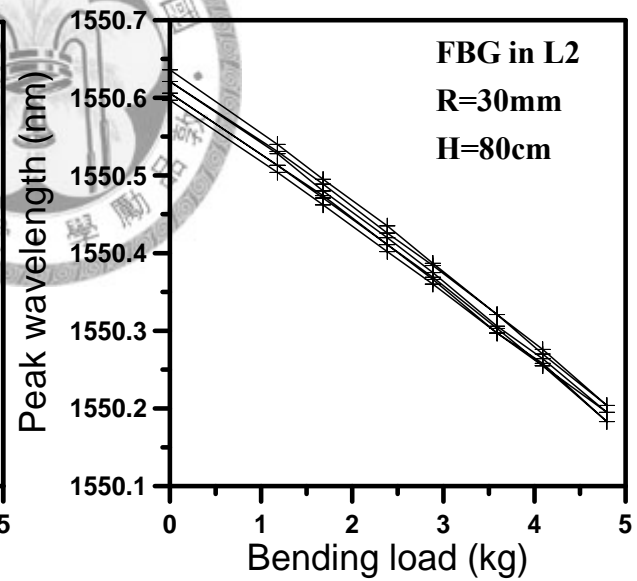
Before impact

After impact at A0

After impact at A0 and A45

After impact at A0, A45, and A90

Fig. 4-11 (b): Comparison of wavelength shifts from embedded FBG sensor in L2 along bending test before and after impact under an 80cm drop height and a distance 30mm away from FBG sensors.

For the FBG in L2 (Table 4.2), the wavelength deviations increased gradually when impacts were applied at A0 (first impact), A45 (second impact), and A90 (third impact), in sequence. It could be observed that there was no decrease in peak wavelength drift after impact at A0, A45, or A90 under the conditions (R=30mm, H80cm) and (R=50mm, H80cm). The drift distance increased gradually as each impact was completed. The similar results were obtained from the FBG in L3 (Table 4.3). After all the impacts were applied, the average drift distances in peak wavelength had significant increase. These results are in line with earlier hypothesis that more impact damages could induced more complex stress under the bending load, causing the larger

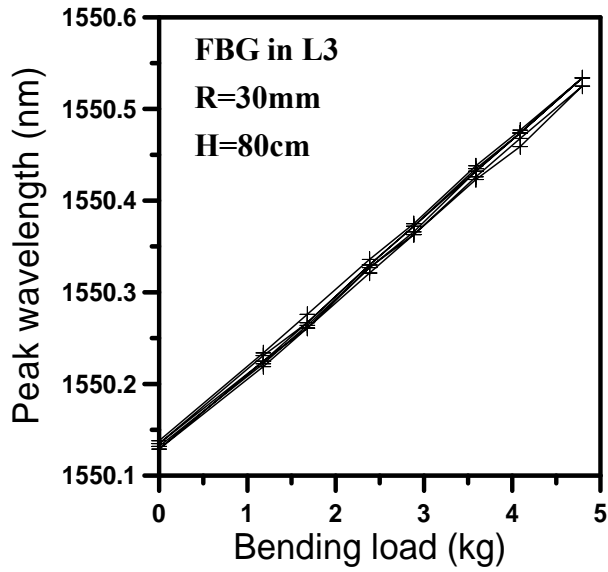
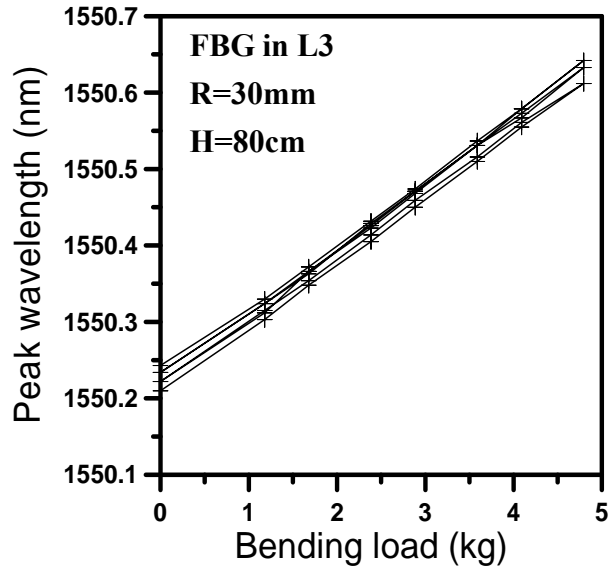
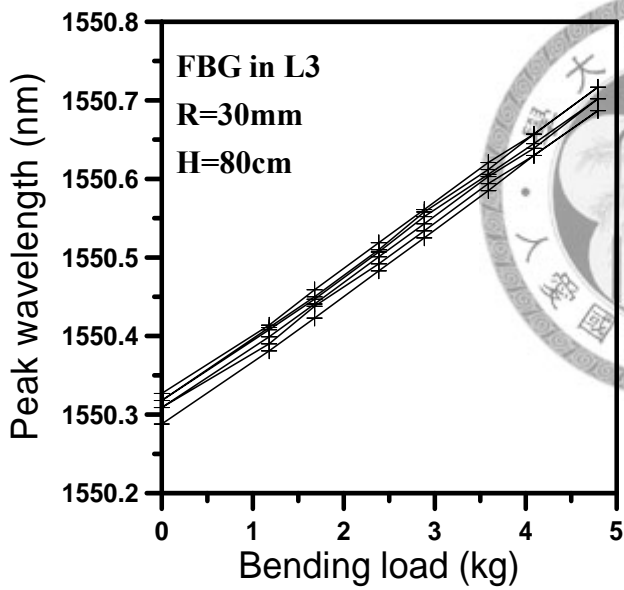
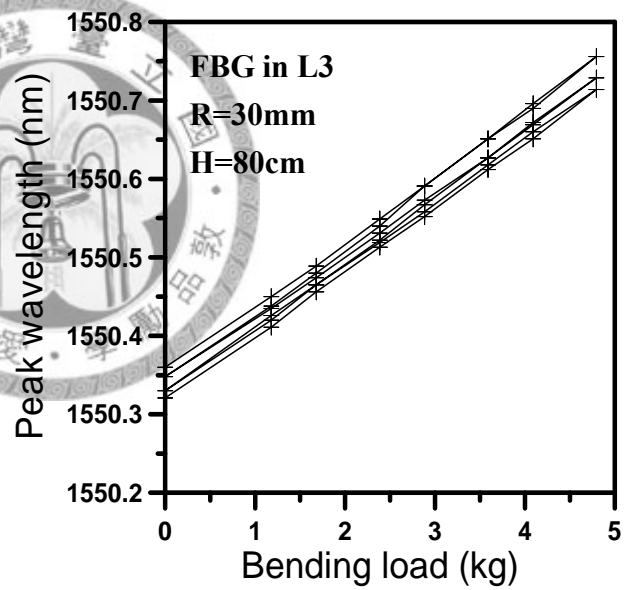
Before impact

After impact at A0

After impact at A0 and A45

**After impact at A0,
A45, and A90**

Fig. 4-11 (c): Comparison of wavelength shifts from embedded FBG sensor in L3 along bending test before and after impact under an 80cm drop height and a distance 30mm away from FBG

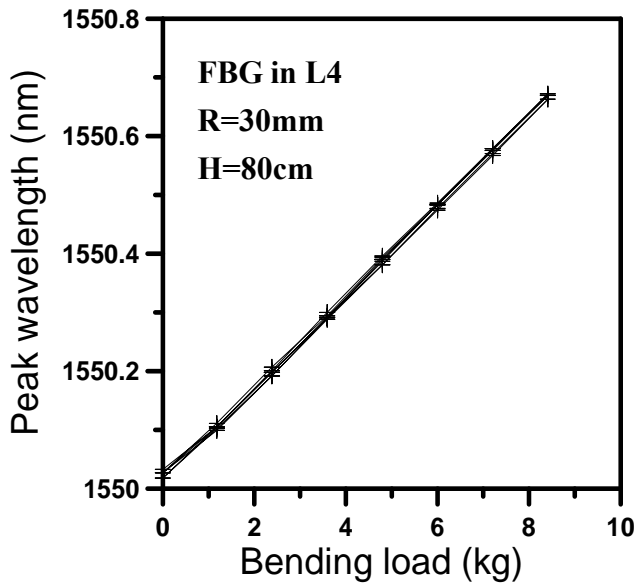
Before impact

Fig. 4-11 (d): Comparison of wavelength shifts from embedded FBG sensor in L4 before and after impact under an 80cm drop height and a distance 30mm away from FBG sensors.

For the FBG in L4 (Table 4.4), the drift distance in peak wavelength gradually increased as each impact was completed under the condition $R=30\text{mm}$, $H=80\text{cm}$. Nevertheless, it was found slight reduction in drift distance between after impact at A0 (first impact) and after impact at A0 and A45 (second impact). It shows the impact induced recovering of drift distance in peak wavelength might occur in L4. After all the impacts were applied, the drift distances increased, which agrees with previous results.

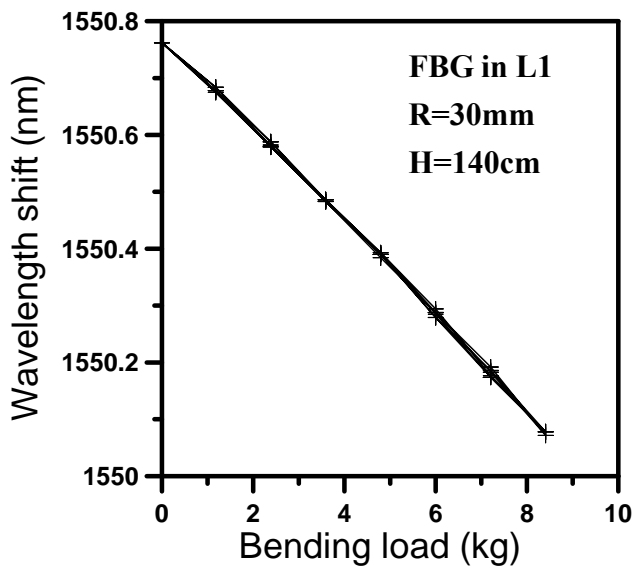
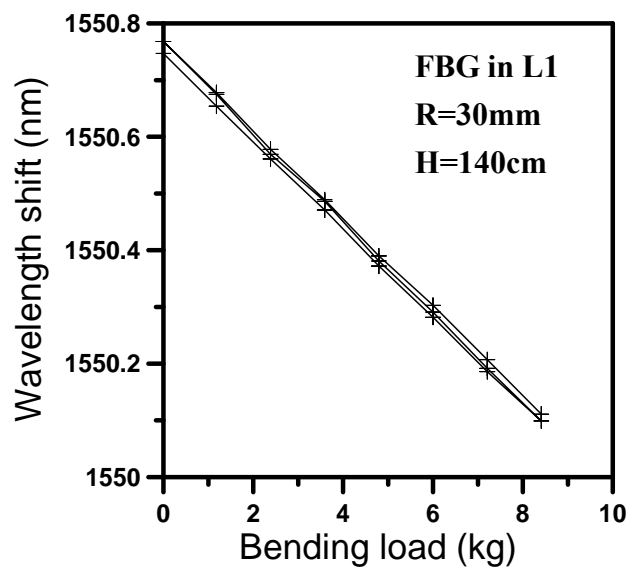
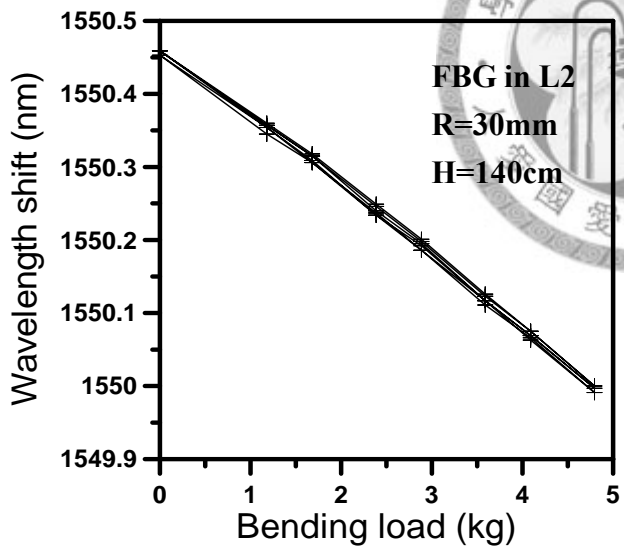
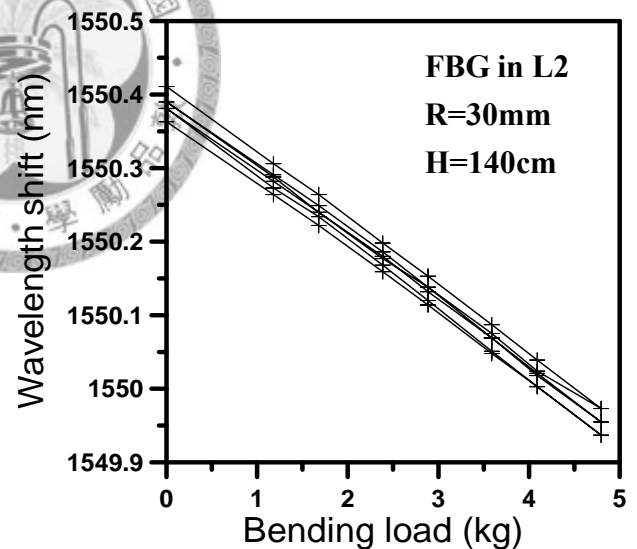
Fig. 4-12 (a): Comparison of wavelength shifts from embedded FBGs in L1 and L2 before and after impact under an 140 cm drop-height and a distance 30mm away from FBG sensors.

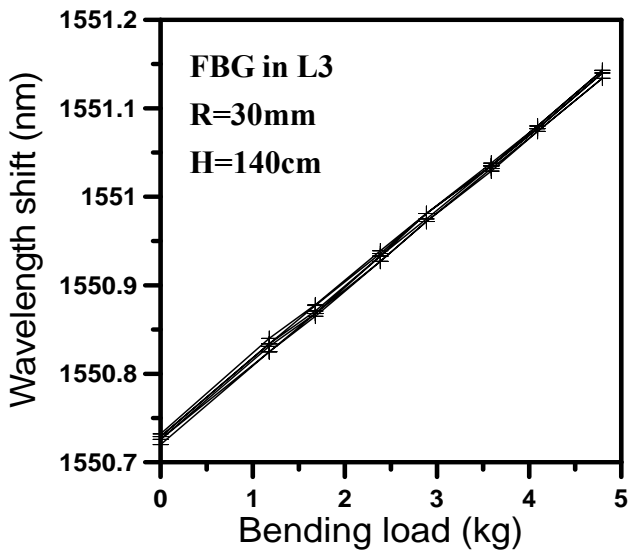
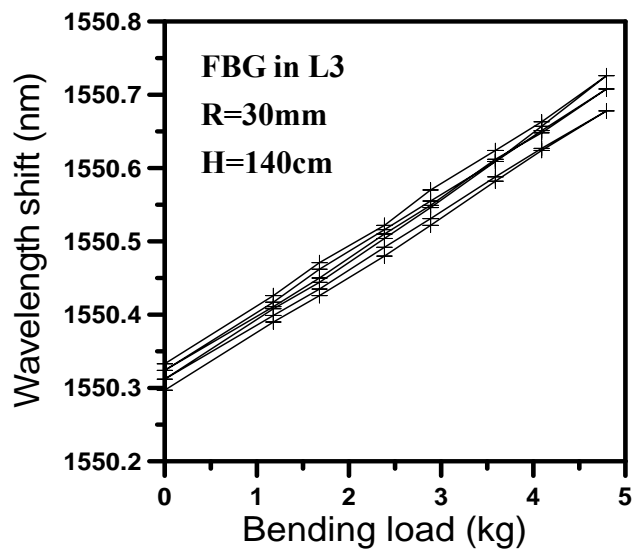
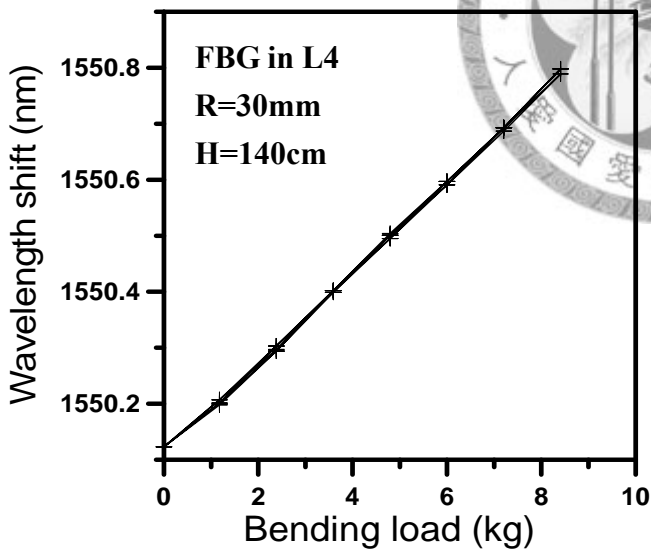
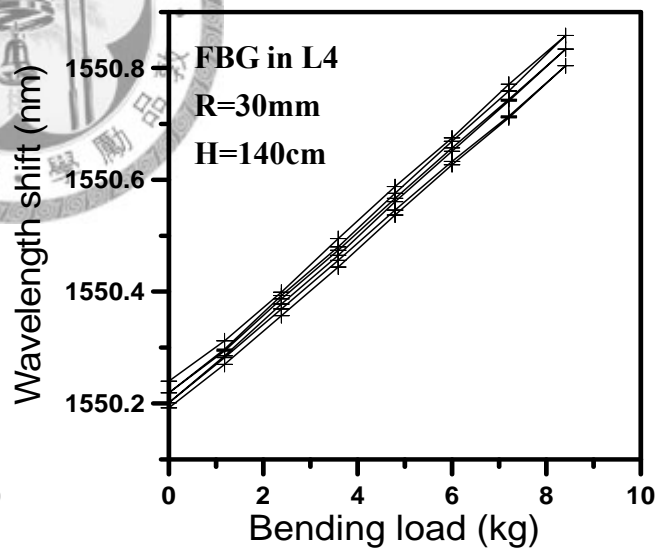
Fig. 4-12 (b): Comparison of wavelength shifts from embedded FBGs in L3 and L4 before and after impact under a 140cm drop-height and a distance 30mm away from FBG sensors.

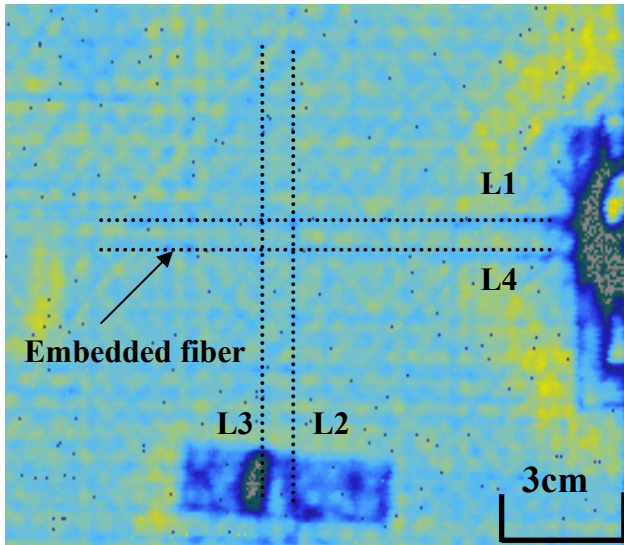
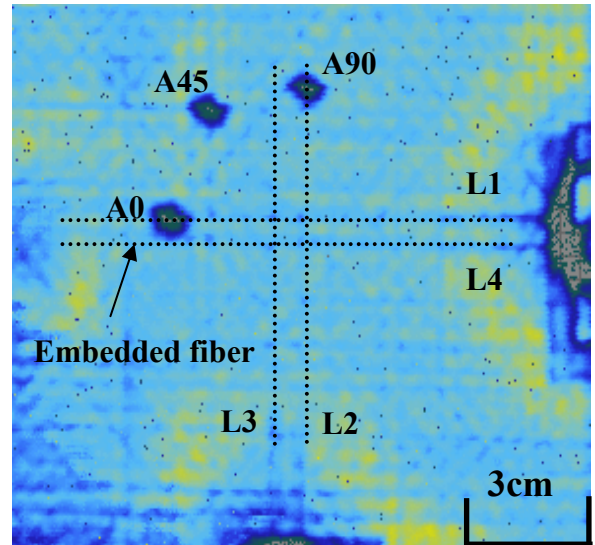
Fig. 4-13: Comparison of Ultrasonic C-scan images between before and after impact under a 80cm drop height and a distance 30mm from the FBG sensors. (a) Before impact (b) After impact at A0, A45, and A90.

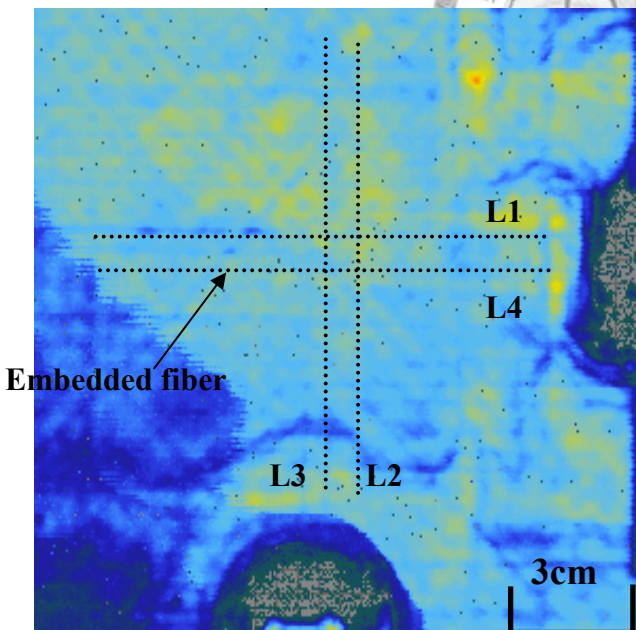
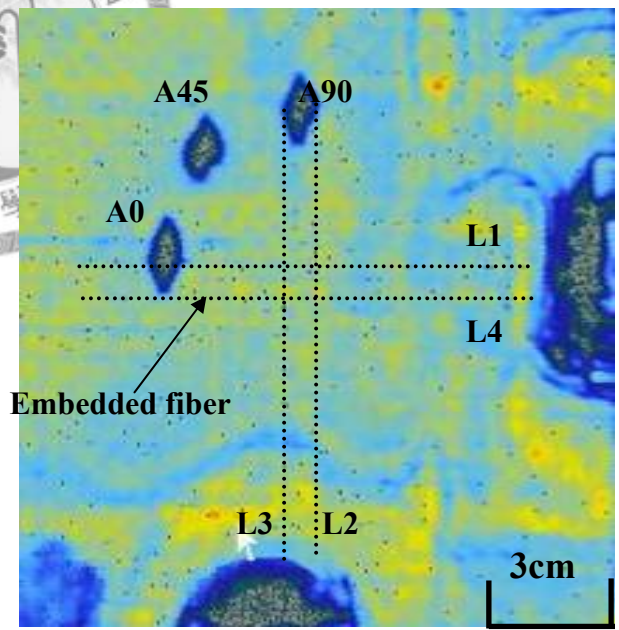
Fig. 4-14: Comparison of Ultrasonic C-scan images between before and after impact under a 140cm drop-height and a distance 30mm from the FBG sensors. (a) Before impact (b) After impact at A0, A45, and A90.

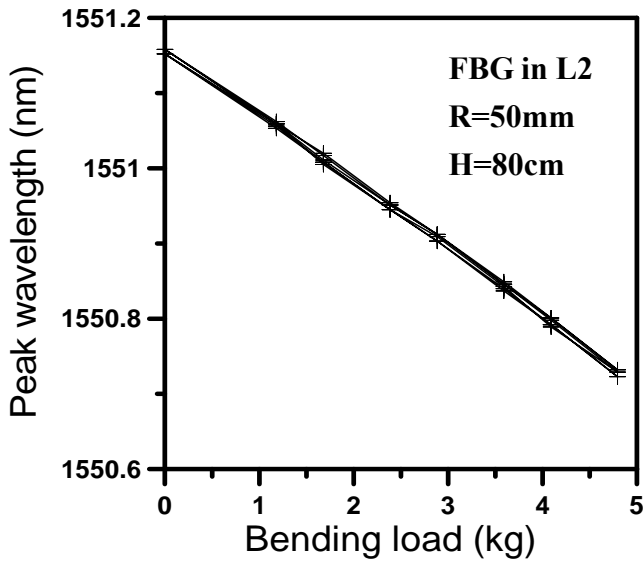
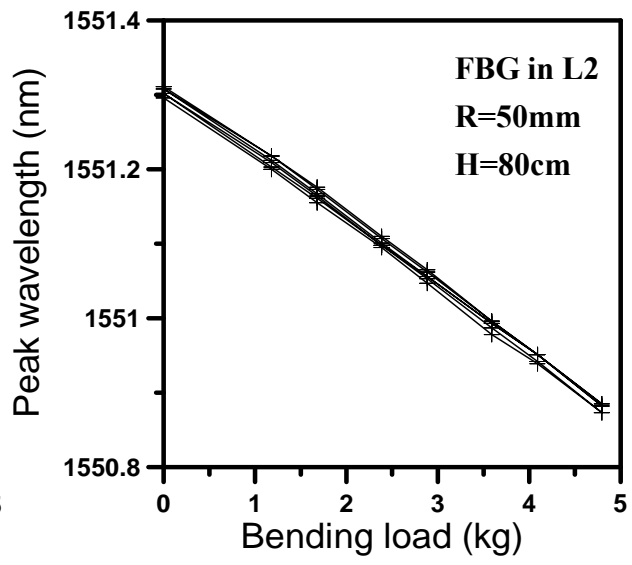
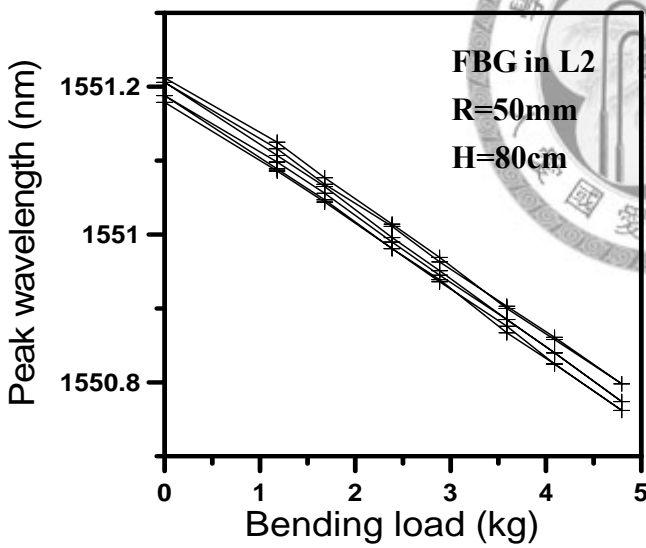
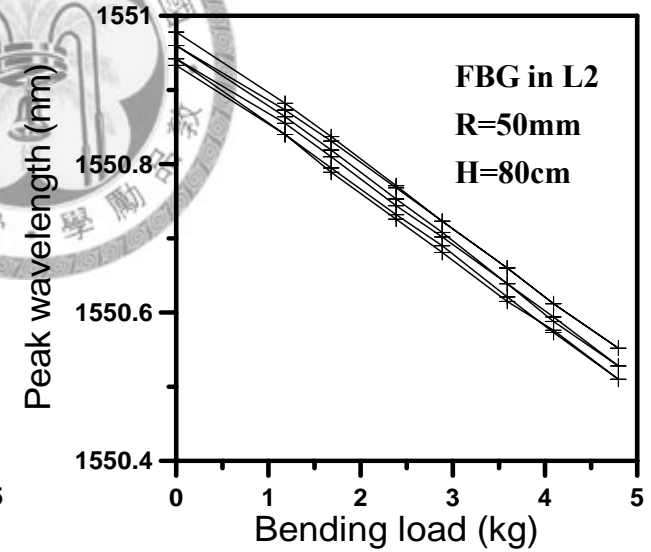
Fig. 4-15 (b): Comparison of wavelength shifts from embedded FBG sensor in L2 along a bending test before and after impact under an 80cm drop height and a distance 50mm away from FBG sensors.

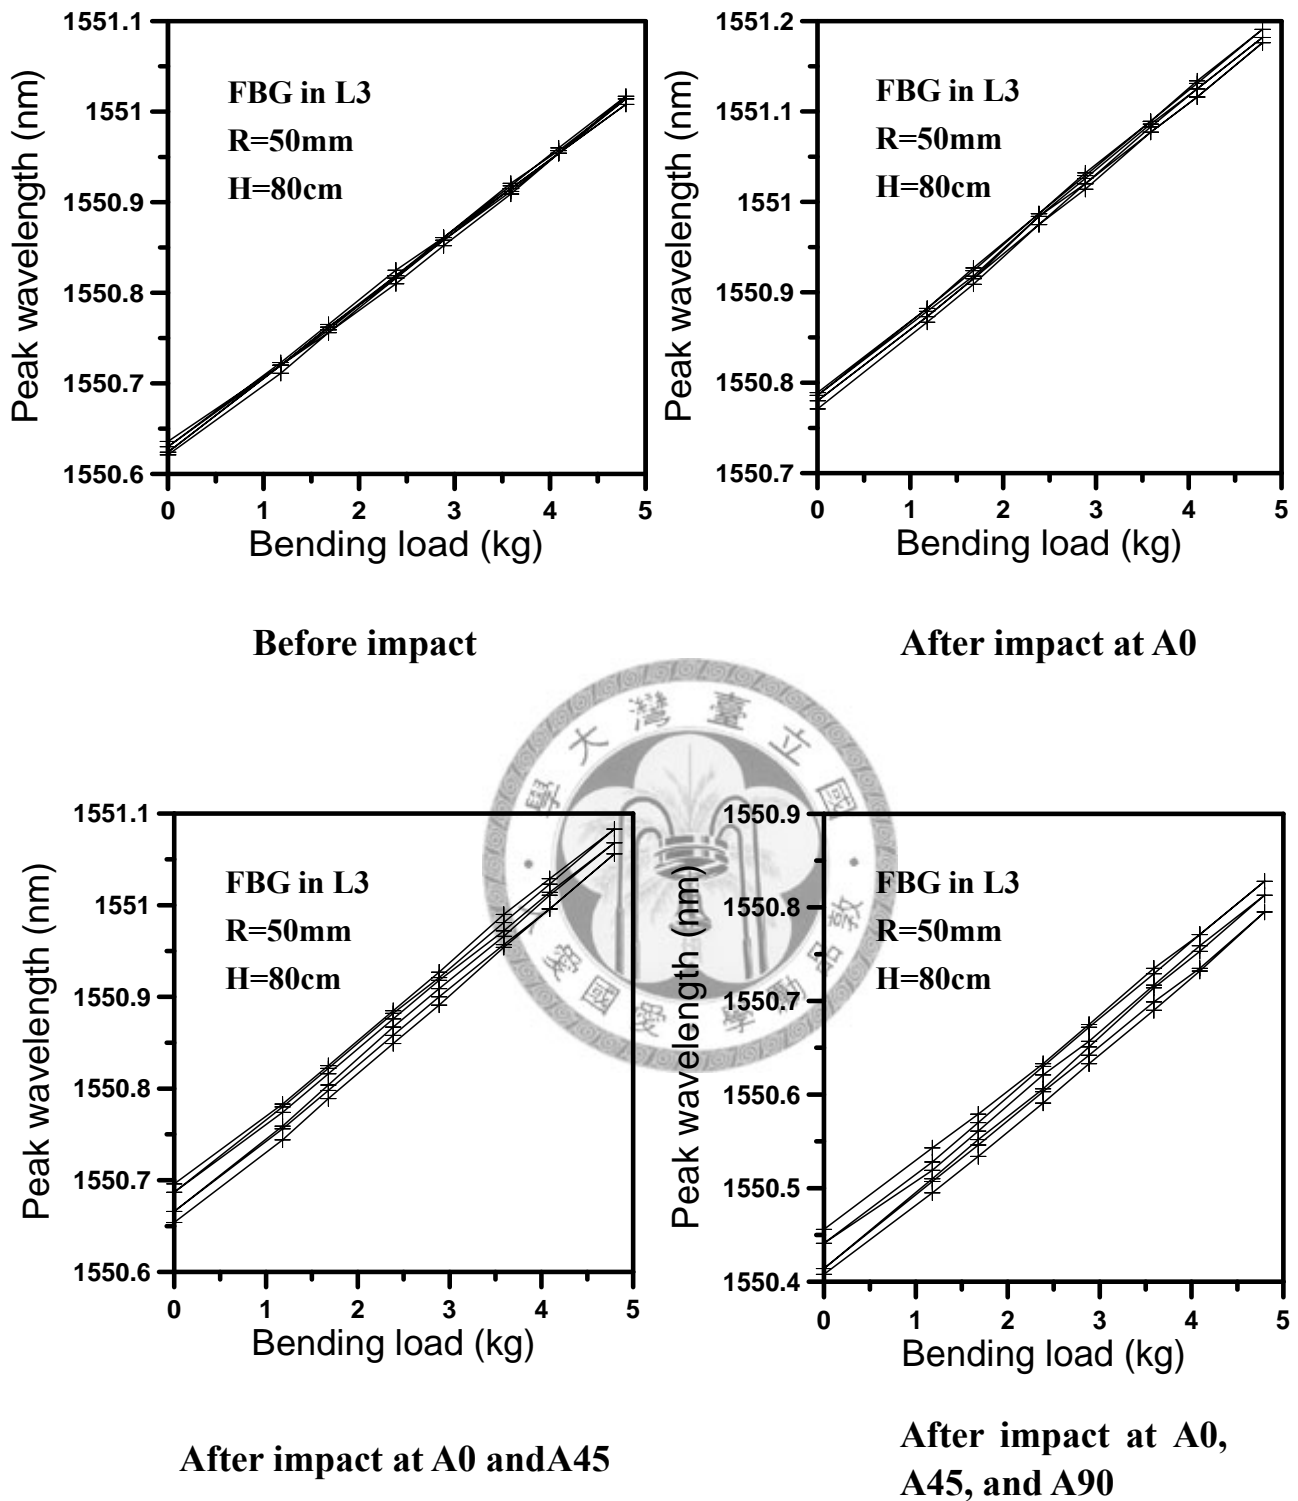
Fig. 4-15 (c): Comparison of wavelength shifts from embedded FBG sensor in L3 along a bending test before and after impact under an 80cm drop height and a distance 50mm away from FBG sensors.

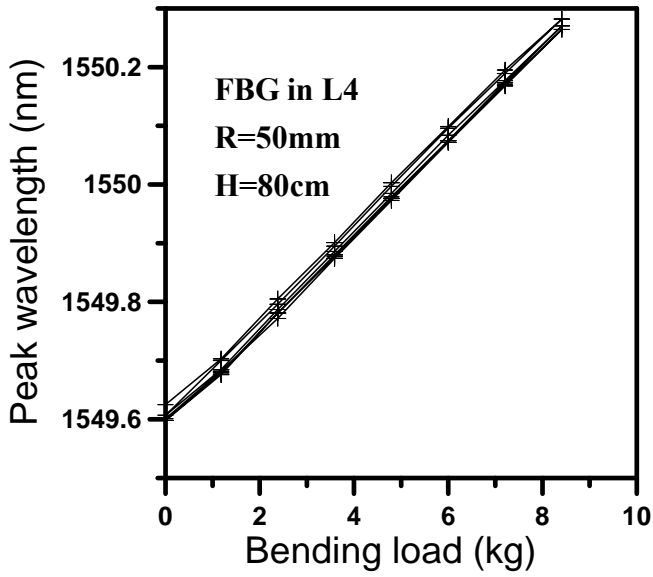
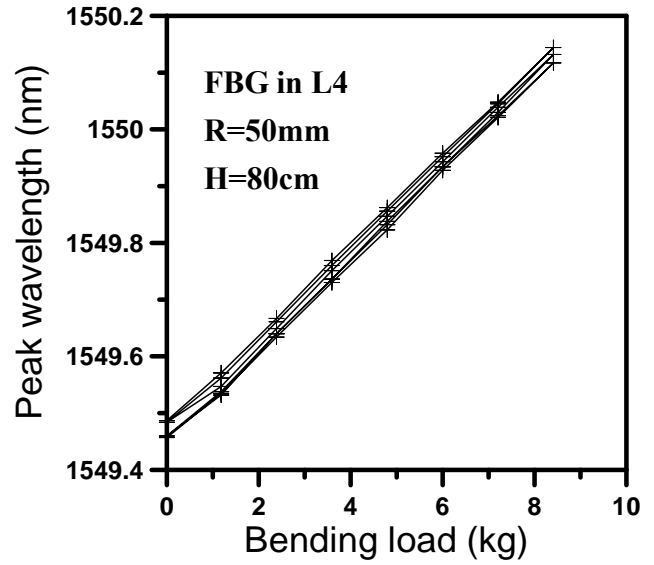
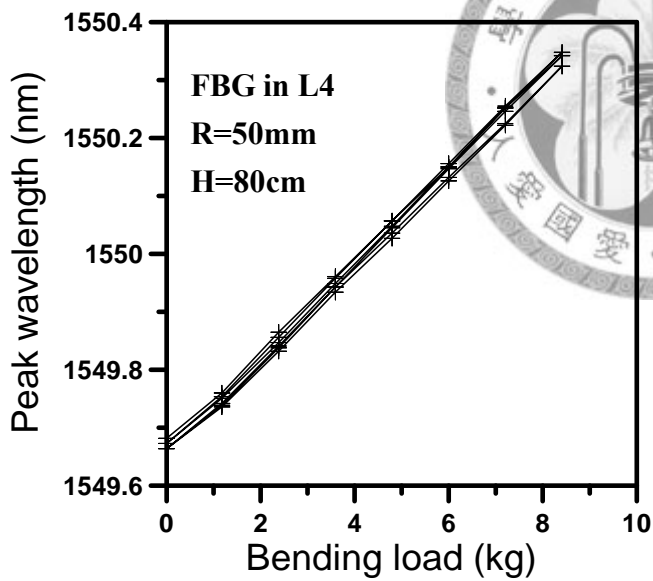
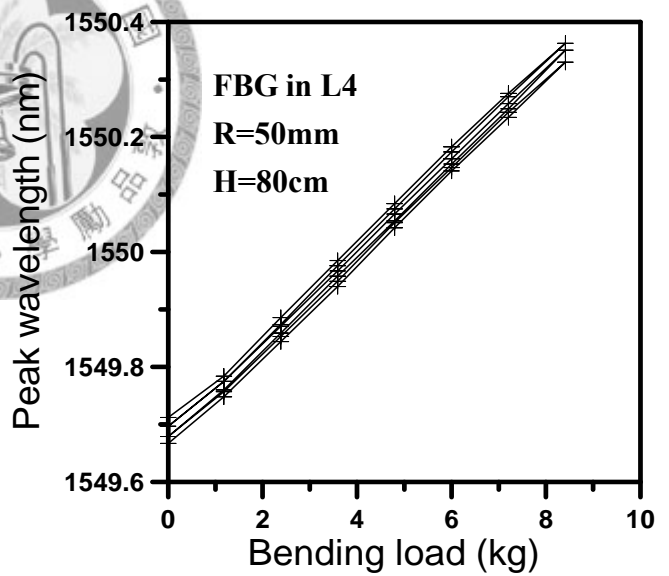
Fig. 4-15 (d): Comparison of wavelength shifts from embedded FBG sensor in L4 along a bending test before and after impact under a 140cm drop height and a distance 50mm away from FBG sensors.

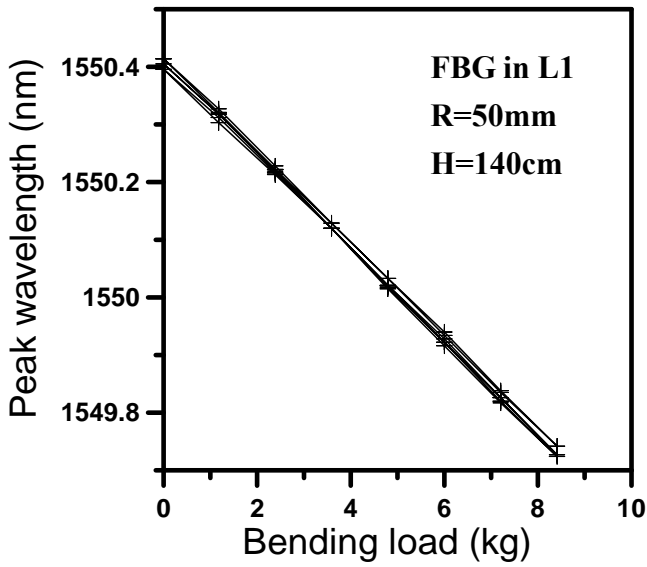
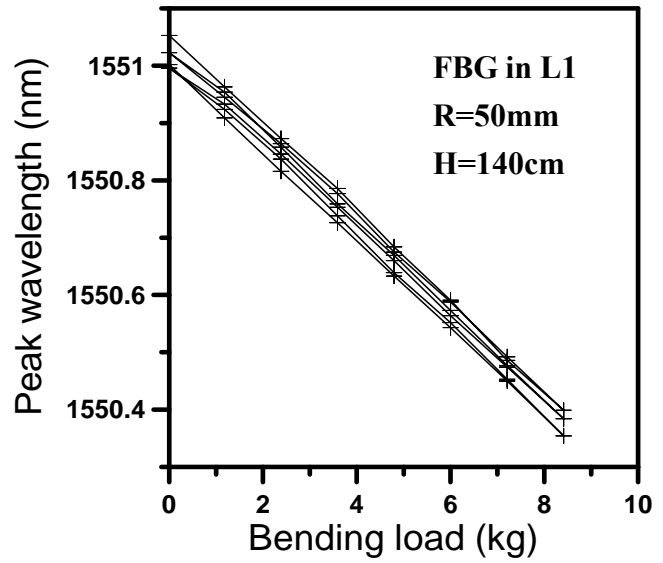
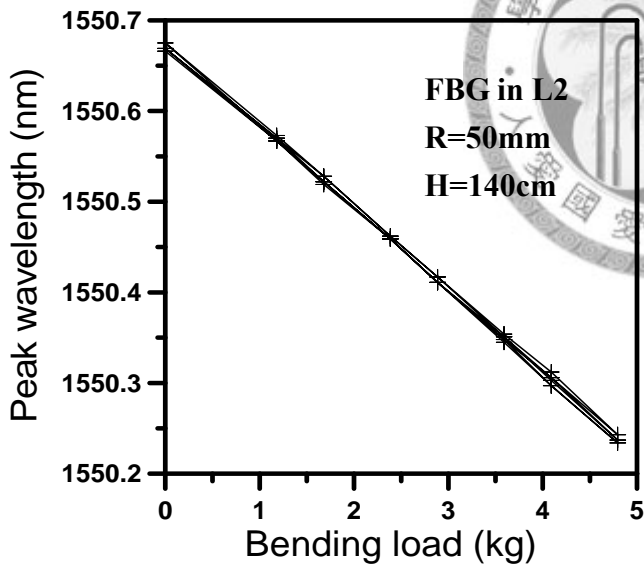
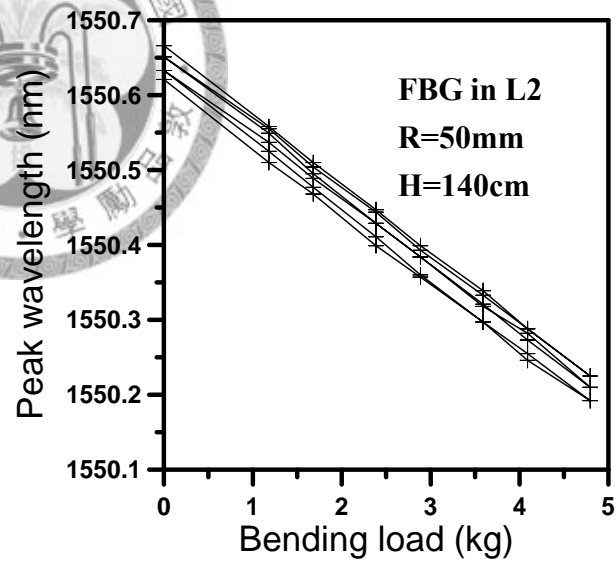
Fig. 4-16 (a): Comparison of wavelength shifts from embedded FBGs in L1 and L2 before and after impact under a 140cm drop height and a distance 50mm away from FBG sensors.
