碩士論文

以內埋式光纖光柵感測器監測碳纖維複合材料衝擊及

Application of Investigating the Impact and Fatigue Damage in

Carbon Fiber Composite by Using Pre-embedded Fiber Bragg

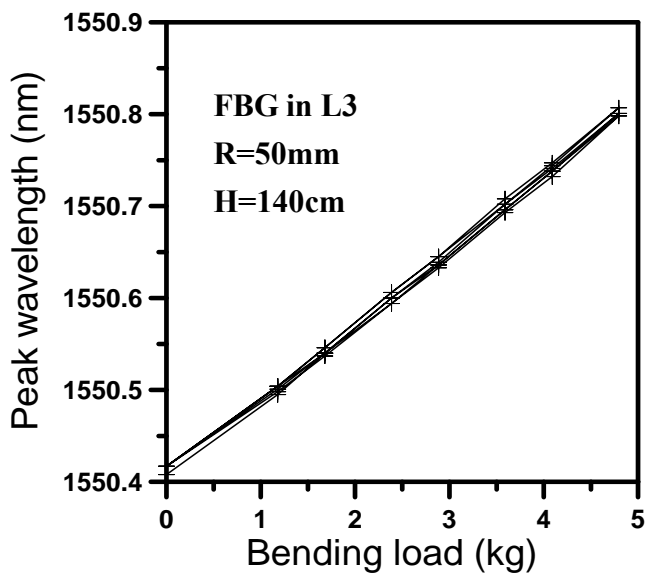
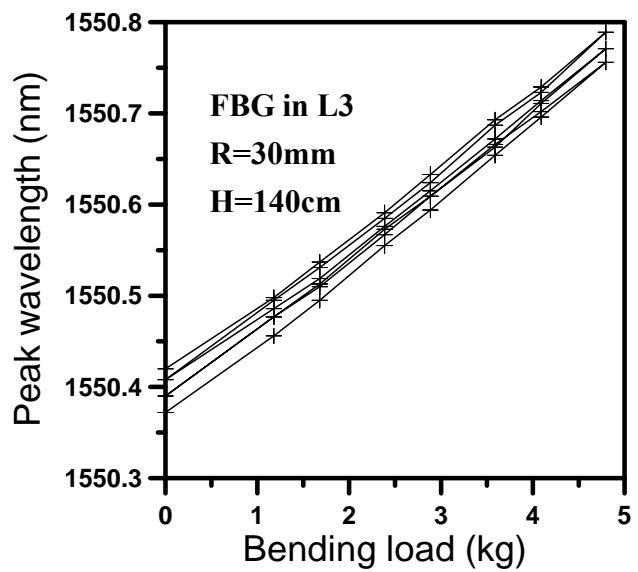
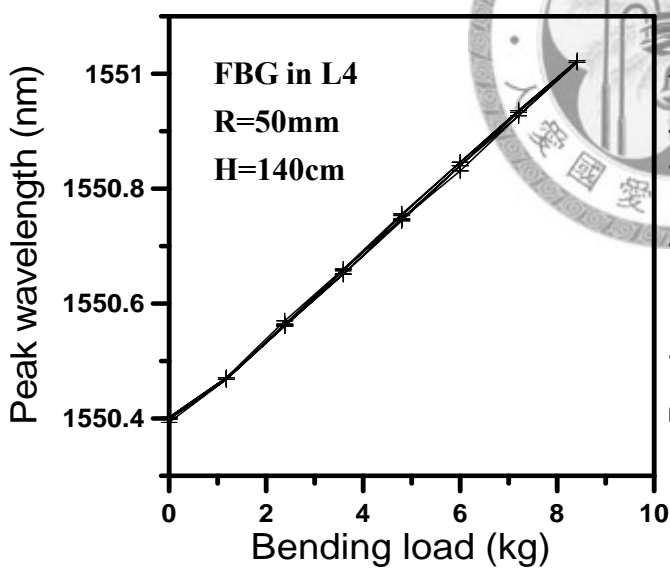
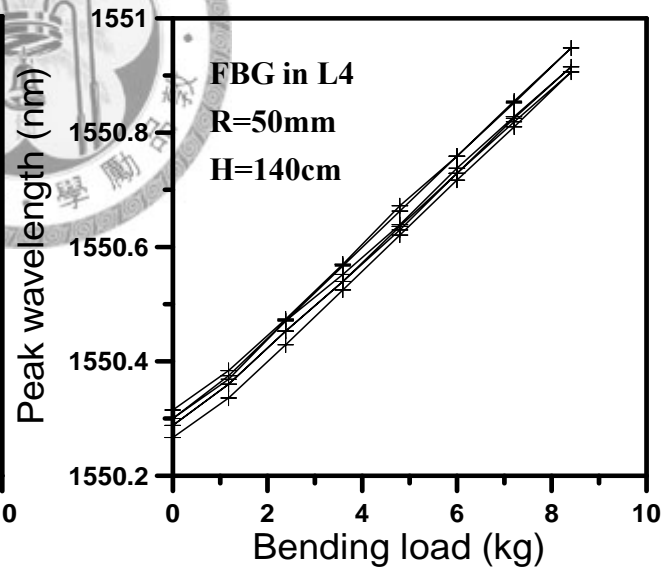
Fig. 4-16 (b): Comparison of wavelength shifts from embedded FBGs in L3 and L4 before and after impact under a 140cm drop height and a distance 50mm away from FBG sensors.

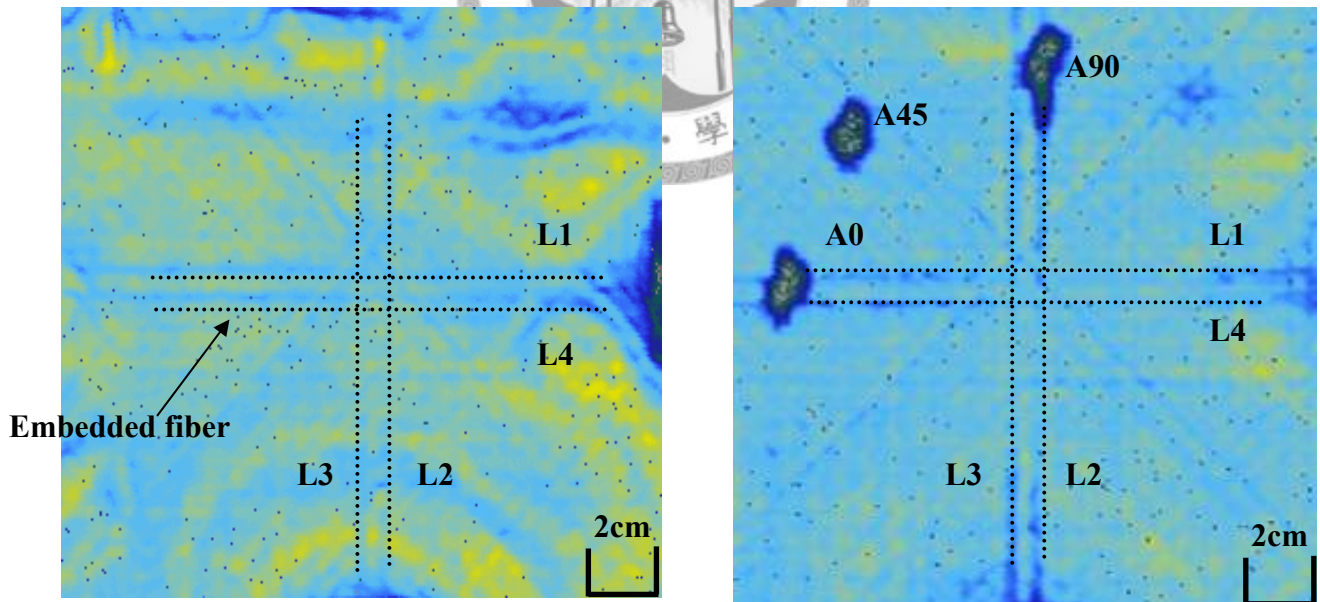
Fig. 4-18: Comparison of Ultrasonic C-scan images between before and after impact under a 140cm drop-height and a distance 50mm from the FBG sensors. (a) Before impact (b) After impact at A0, A45, and A90

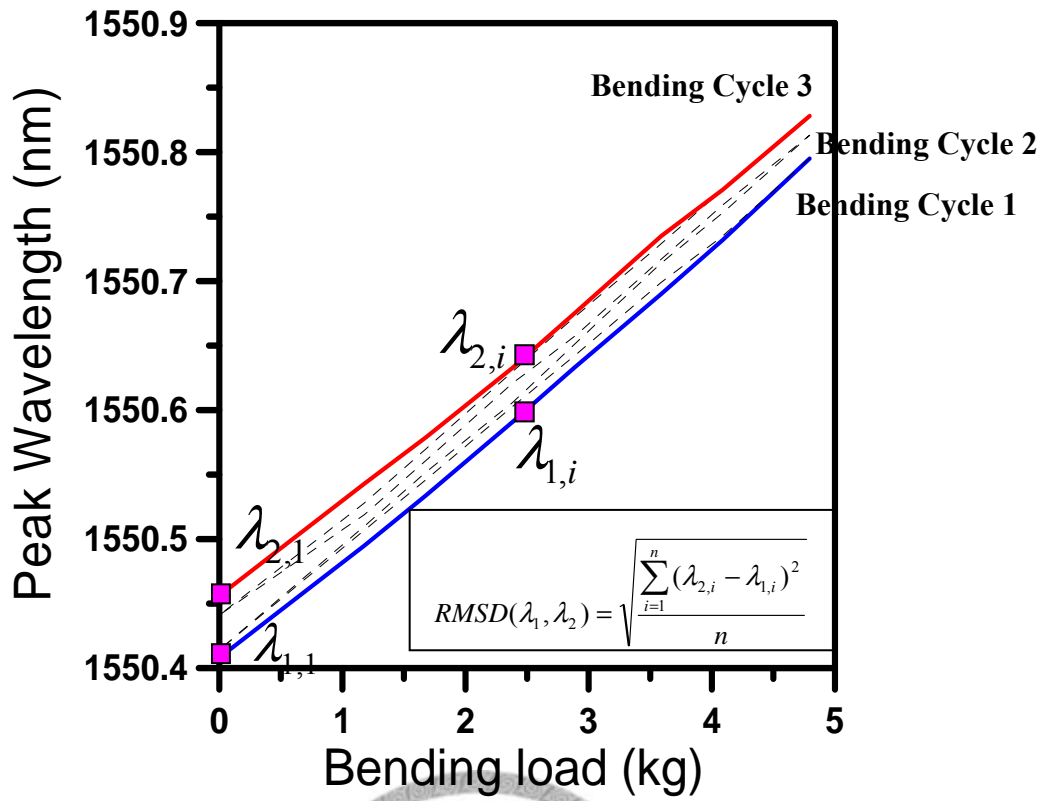
Fig. 4-19: Quantitative evaluation of the average drift distance of peak wavelength lines by RMSD.

So far, we determined the degrees of impact damage by observing the occurrence of hysteresis in the line of peak wavelength shifts. In order to quantify the degrees of hysteresis in wavelength shifts during bending cycles, we utilize the root-mean-square deviation (RMSD) to evaluate the average drift distances before and after impact at A0, A45, and A90. The method was shown in Fig. 4-19. The bottom line is the wavelength shifts of increasing bending load in the first cycle, and the top line is the wavelength

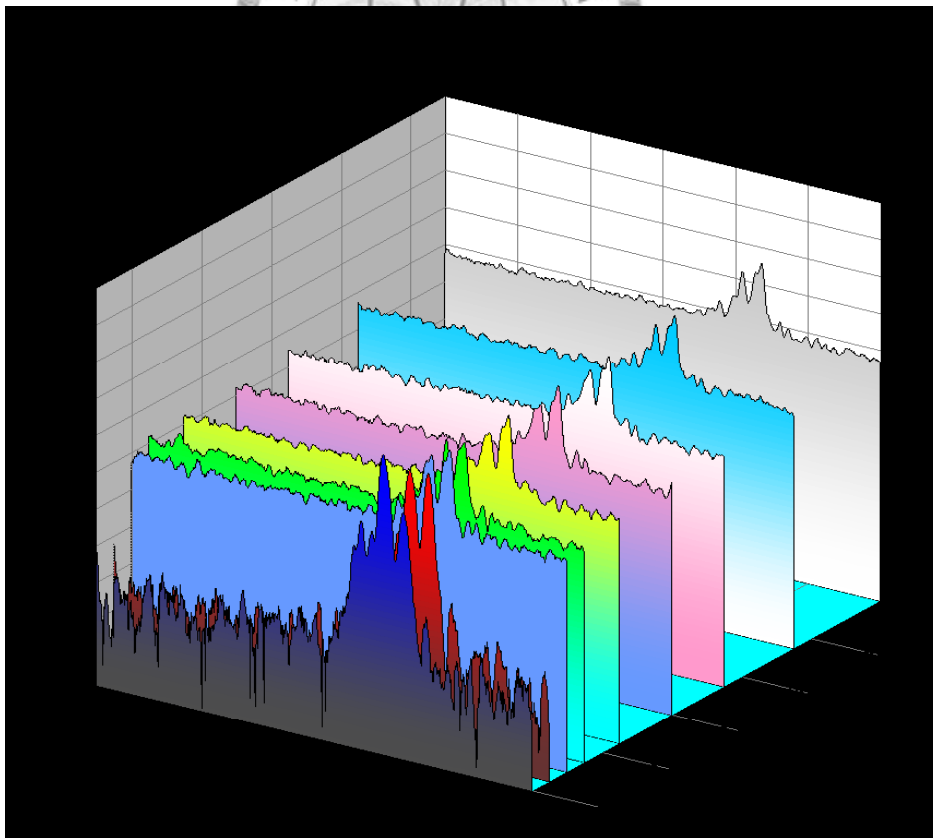
Fig. 4-20: Spectra changes from embedded FBG in L1 with various fatigue cycles under an 80cm drop height and impact at position B

Fig. 4-20 and Fig. 4-21 show the spectra from FBGs embedded in L1 and L4 which were deformed as fatigue cycles increasing after an impact drop from 80cm at the impact position B. After impact, the spectrum was distorted into the irregular forms, which was the same comparing with previous results. As the fatigue cycles increased, the intensity of other wavelengths dramatically increased (at 10000 cycles in L1 and 5000 cycles in L4). As the cycles increased, the characteristic peak of the FBG gradually submerged.

To prove the above more conclusively, attempts were made to out from the CFRP specimen. By submerging the specimen into acetone for about 2~3days, the epoxy could be softened. The fiber can then be carefully drawn out from CFRP specimen. The operation was done under an optical microscope. Fig. 4-33 and Fig 4-34 respectively show the optical micrographs of the FBG sensor embedded in L1 and L4, which spectra before drawing out are shown in Fig 4-20 and Fig. 4-21. The

Further, we conducted a bending test by sticking the fiber which spectra are shown in Fig 4-20 on a spring steel strip to apply a tensile stress on the fiber, as illustrated in Fig 4-36. A strain gage was also adhered in the vicinity of FBG sensor to measure the strain as well. The shifts of waveform along the bending test are shown in Fig 4-37. No significant deformation of spectrum is evident. This shows that the previous impact damage did not induce cracks and damage on the fiber. The founding of the characteristic spectrum in the post-impact fatigue case can only be attributed to non-uniform strain field in the specimen.

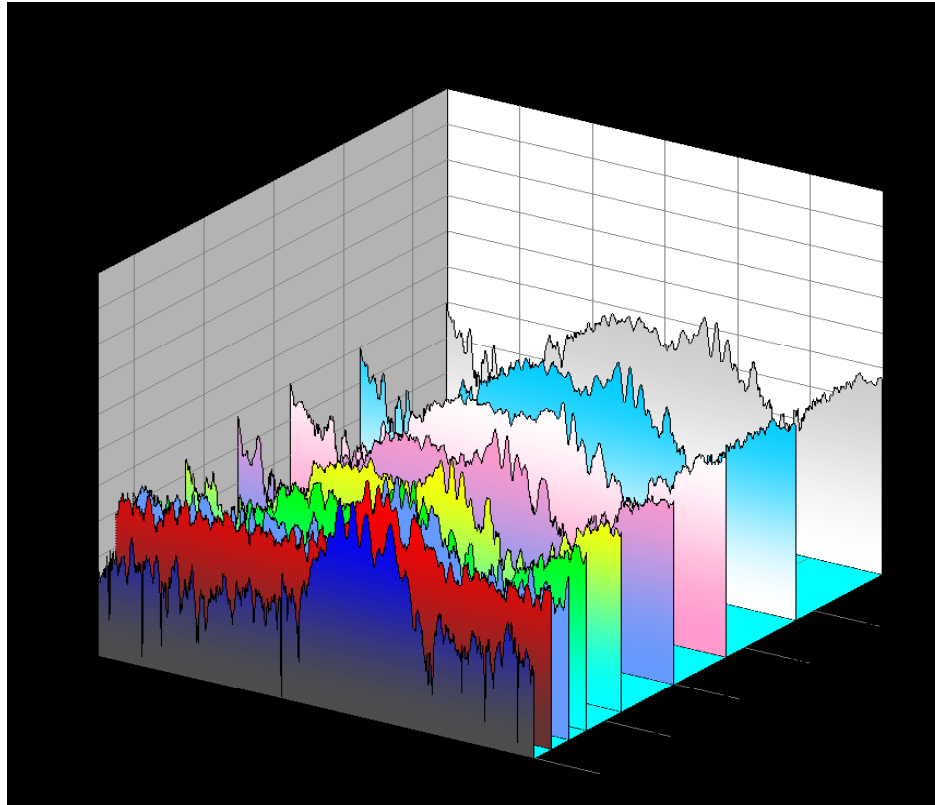
Fig. 4-21: Spectra changes from embedded FBG in L4 with various fatigue cycles under an 80cm drop height and impact at position B

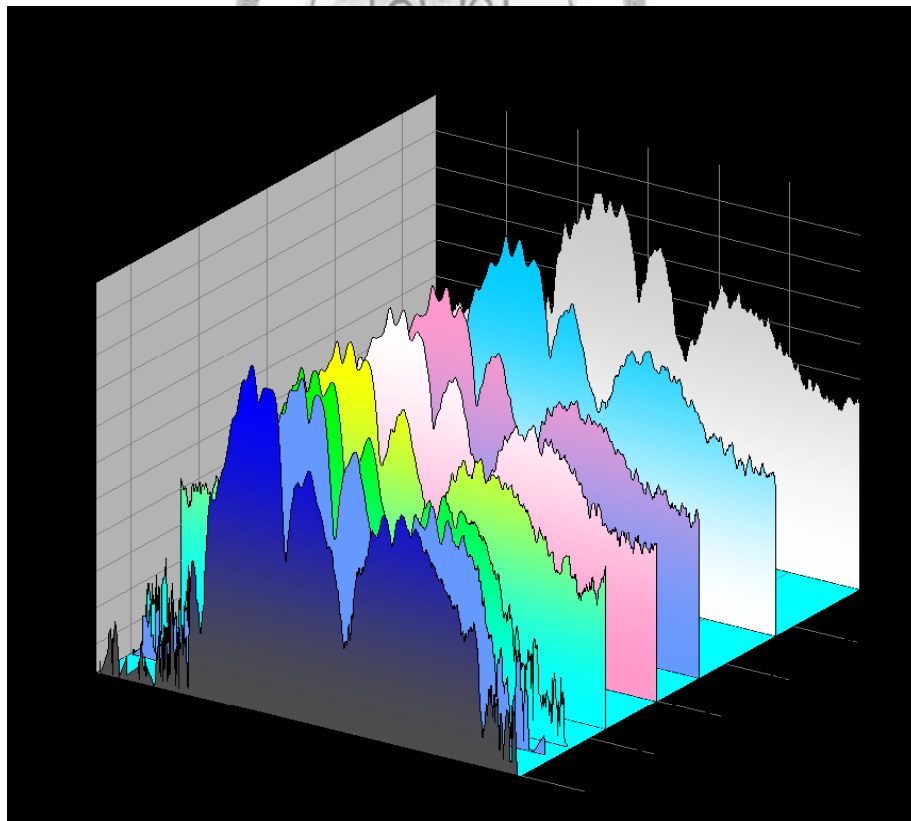
Fig. 4-22: Spectra changes from embedded FBG in L1 with various fatigue cycles under a 140cm drop height and impact at position B

Fig. 4-22 and Fig. 4-23 show the spectra from FBGs embedded in L1 and L4 which were deformed as fatigue cycles increased after an impact drop from 140cm at the impact position B. For the FBG in L1, it was discovered that the intensity of other wavelength notably increased at 10000 cycles, and the waveform slightly changed. As the fatigue cycles increased, the intensity in other wavelength also gradually increased. This result was similar with the previous results which was under drop height 80cm. For the FBG in L4, it also revealed the intensity of other wavelength gradually increased during the fatigue test. At 10000 cycles, we noticed the whole waveform of spectra was significantly altered. The spectra displayed that the waveform became corrugated in other wavelength, and the intensity of wavelength gradually attenuated from 10000 cycles to 200000 cycles. At 200000 cycles, the other wavelength surmounted the reflected wavelength peak, resulting in the wavelength peak of FBG sensor hardly distinguished from the spectrum.

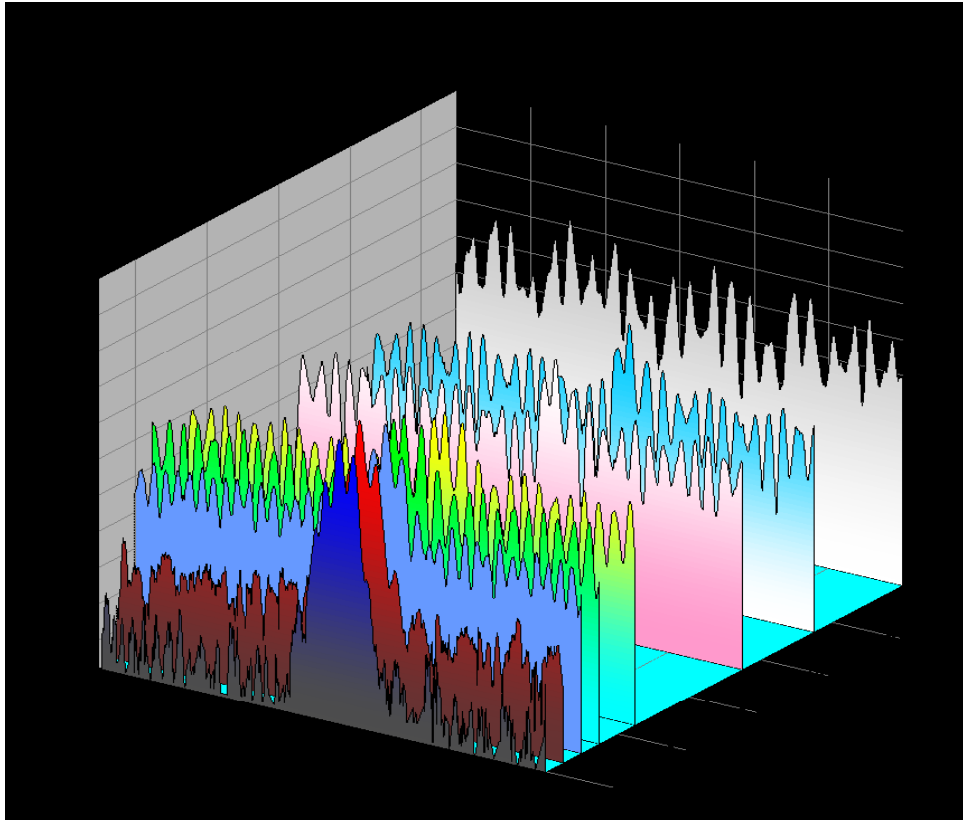
Fig. 4-23: Spectra changes from embedded FBG in L4 with various fatigue cycles under a 140cm drop height and impact at position B

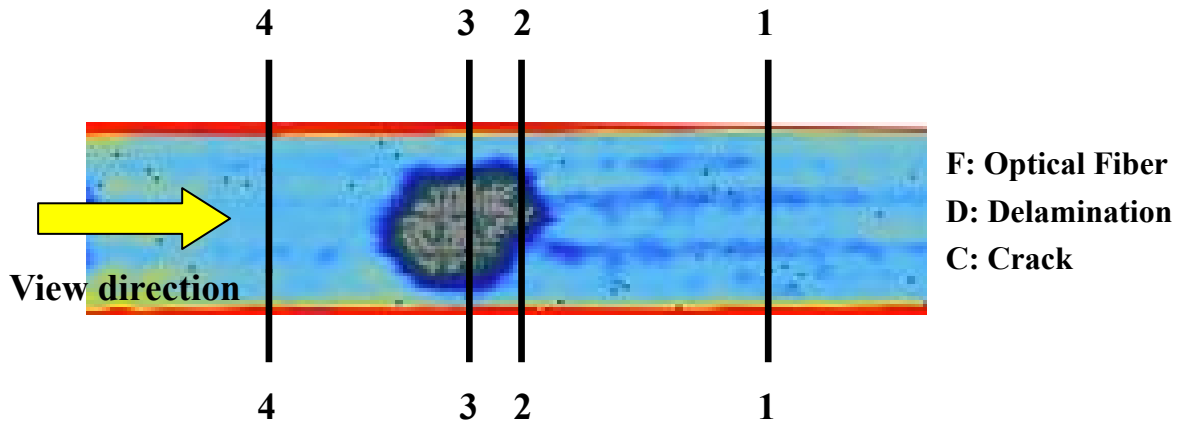
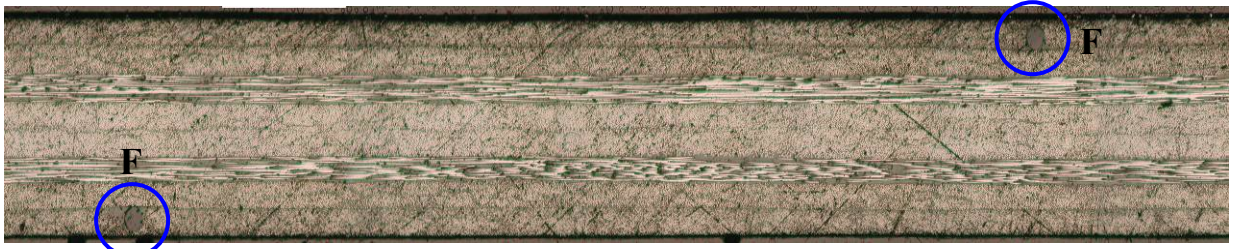
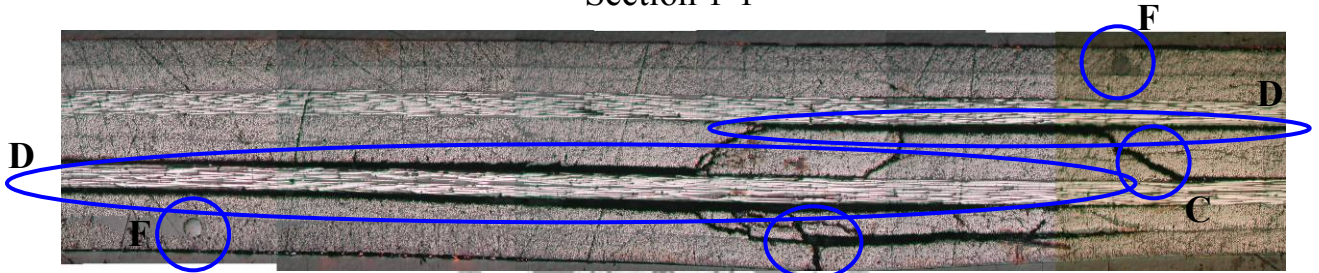
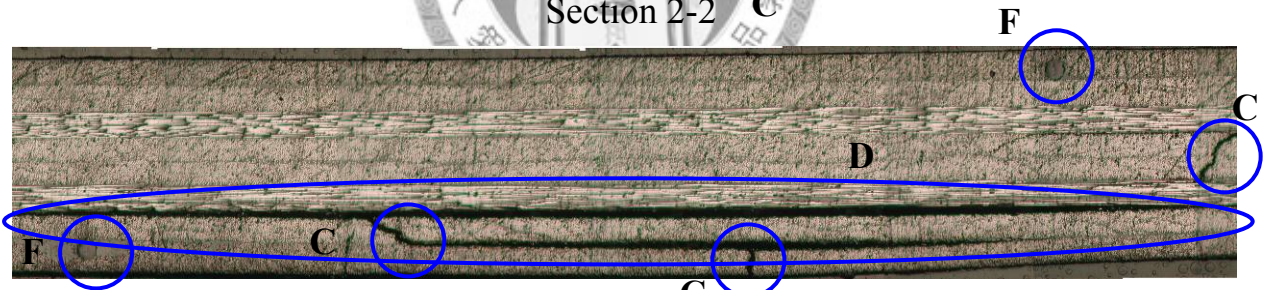
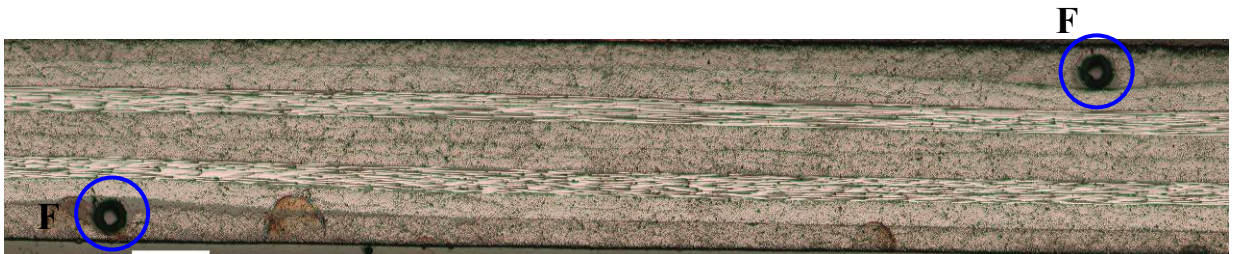
Section 1-1

Section 2-2

Section 3-3

Section 4-4

Fig. 4-25: Optical micrographs on the sectional view of the post-impact fatigued specimen (H=140cm, impact position B, 200000 cycles).

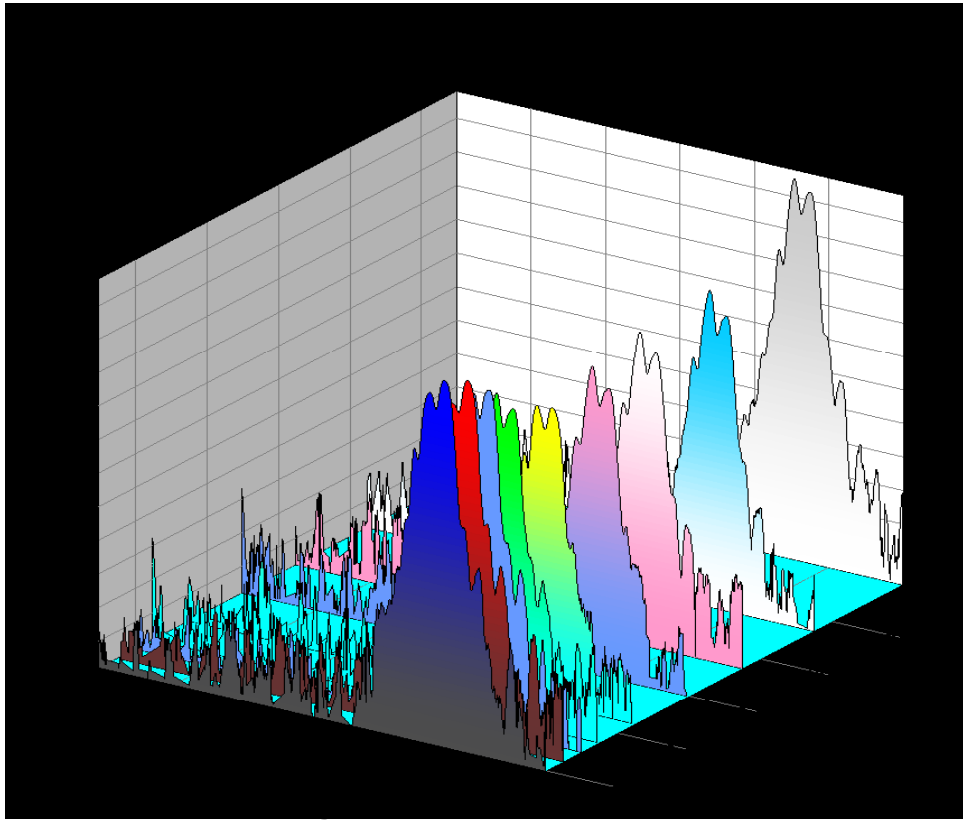
Fig. 4-26: Spectra changes from embedded FBG in L1 with various fatigue cycles under a 140cm drop-height and impact at position A

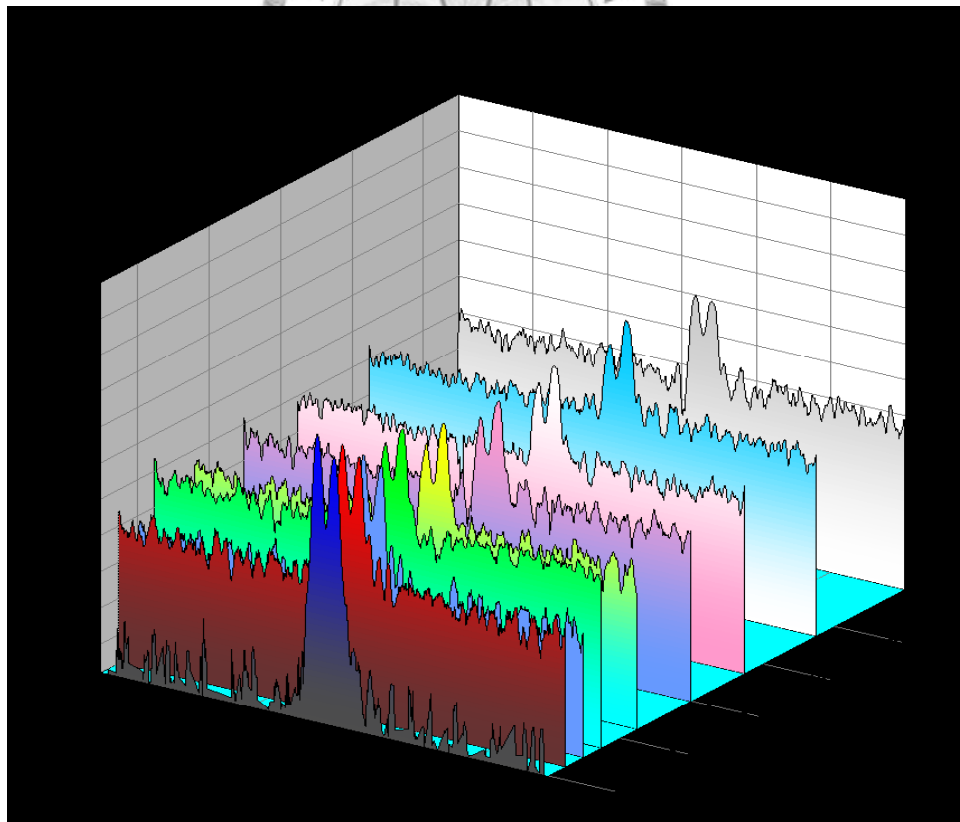
Fig. 4-27: Spectra changes from embedded FBG in L4 with various fatigue cycles under a 140cm drop-height and impact at position A

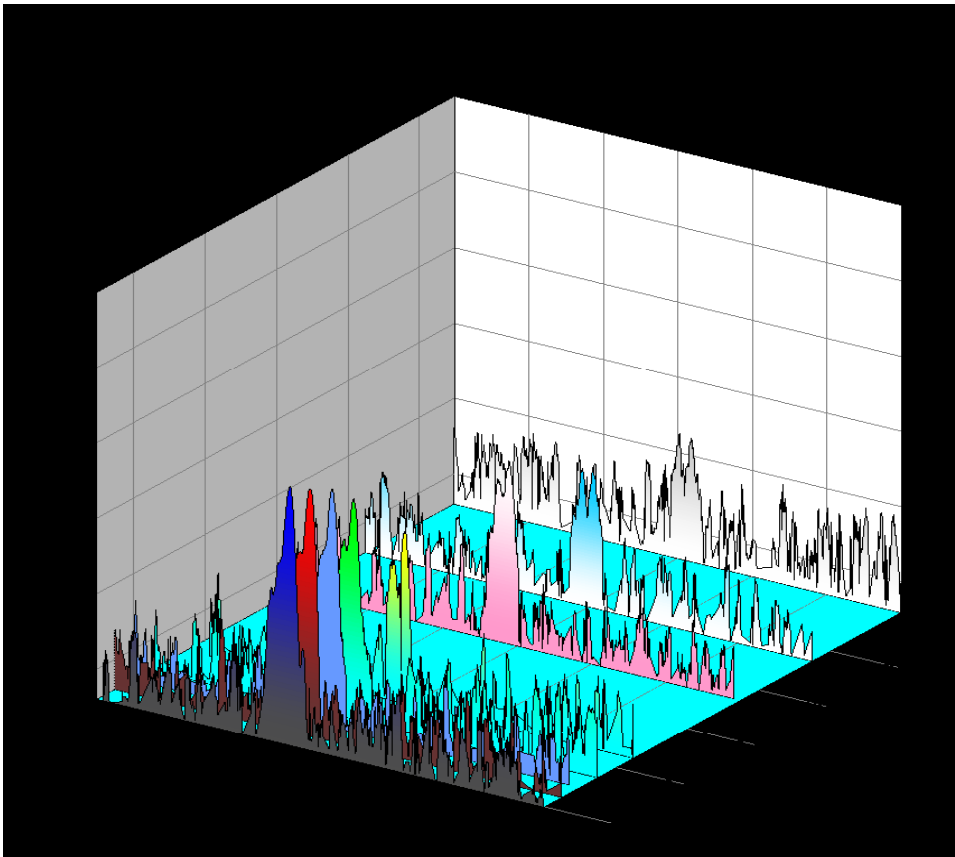
Fig. 4-28: Spectra changes from embedded FBG in L1 with various fatigue cycles under a 140cm drop-height and impact at position C

Fig. 4-28 and Fig. 4-29 show the spectra from FBGs embedded in L1 and L4 with various fatigue cycles under 140cm drop height, and at the impact position C. With respect to the FBG in L1, the intensity of peak wavelength was reduced as the fatigue cycles increased, which indicated that the induced changes of strain fields had affected the reflectivity of FBG sensor. The increasing intensity in other wavelength, however, was not evident. With respect to the FBG in L4, the phenomenon of increasing intensity in other wavelength was not discovered from spectra in the earlier fatigue loading cycles. However, at 200000 cycles, the intensity of other wavelength had increased. The phenomenon only occurred in L4 at 200000 cycles in this test. The Ultrasonic C-scan had also been executed at 0 and 200000 cycles, as shown in Fig. 4-30. From the figure, it can be observed that the impact damage propagation induced was not revealed clearly by C-Scan after fatigue test.

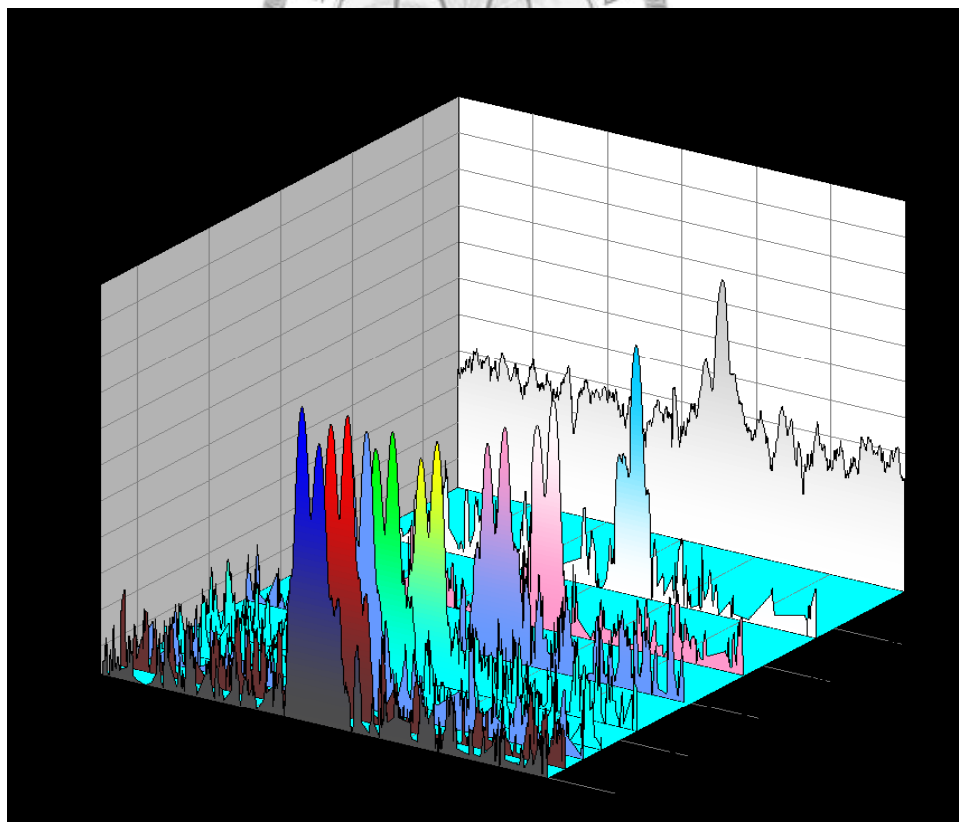
Fig. 4-29: Spectra changes from embedded FBG in L4 with various fatigue cycles under a 140cm drop-height and impact at position C

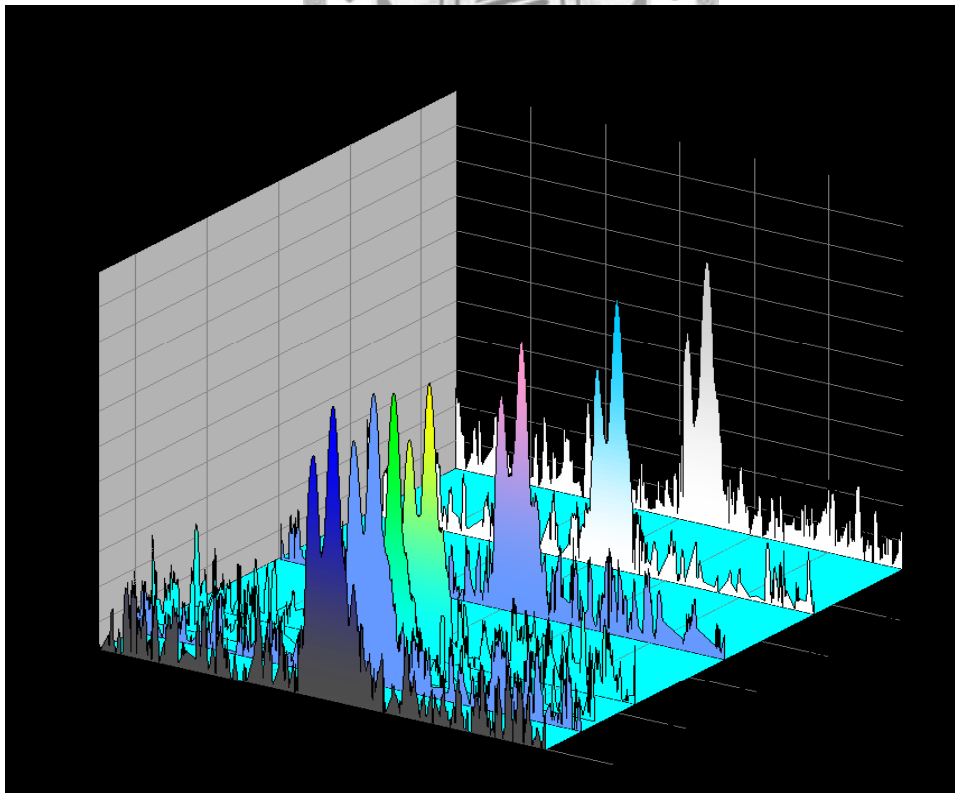
Fig. 4-31: Spectra changes from embedded FBG in L1 with various fatigue cycles without impact.

Since impact damage might be the chief culprit which caused the light in a wide wavelength range to be reflected, we conducted a fatigue test on the specimen without impact. Fig. 4-31 and Fig. 4-32 show the spectra from FBGs embedded in L1 and L4 with various fatigue cycles which had undergone no impact. We observed that the phenomenon of increasing intensity in other wavelength was not found in both figures.

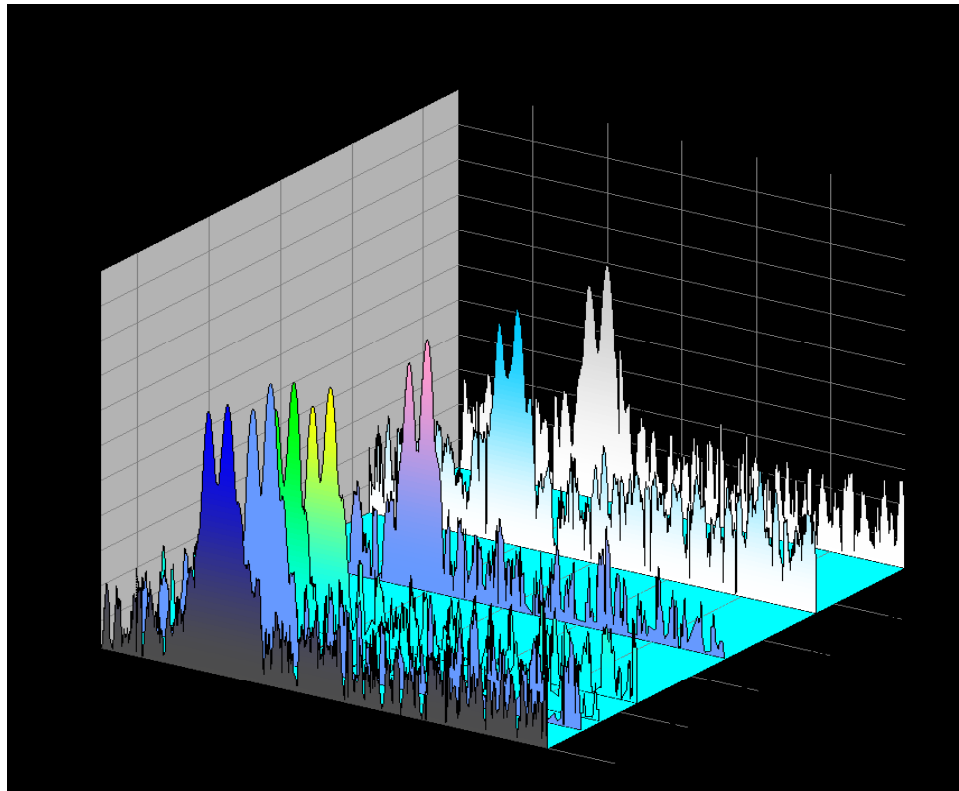
Fig. 4-32: Spectra changes from embedded FBG in L4 with various fatigue cycles without impact.

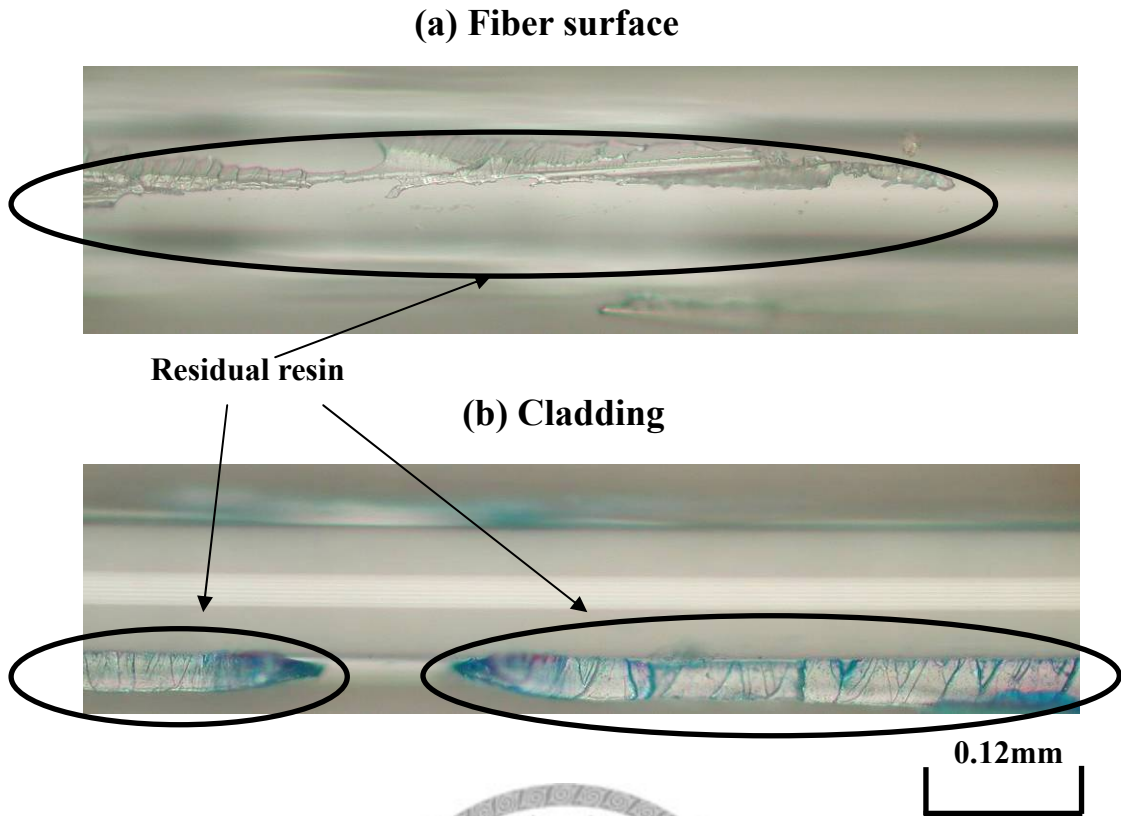
Fig. 4-34: Optical micrographs of the same FBG in L2 as the one whose spectra are shown in Fig 4-21. (a) Focus on fiber surface (b) Focus on cladding

micrographs reveal some residual resins on the fiber surface. No obvious indication of crack was found. We then focused on the cladding of the fiber as shown in Fig 4-33 (b) and Fig 4-34 (b), no evident defect was found. This shows the impact and post-impact fatigue did not induce evident defects the FBG sensor.

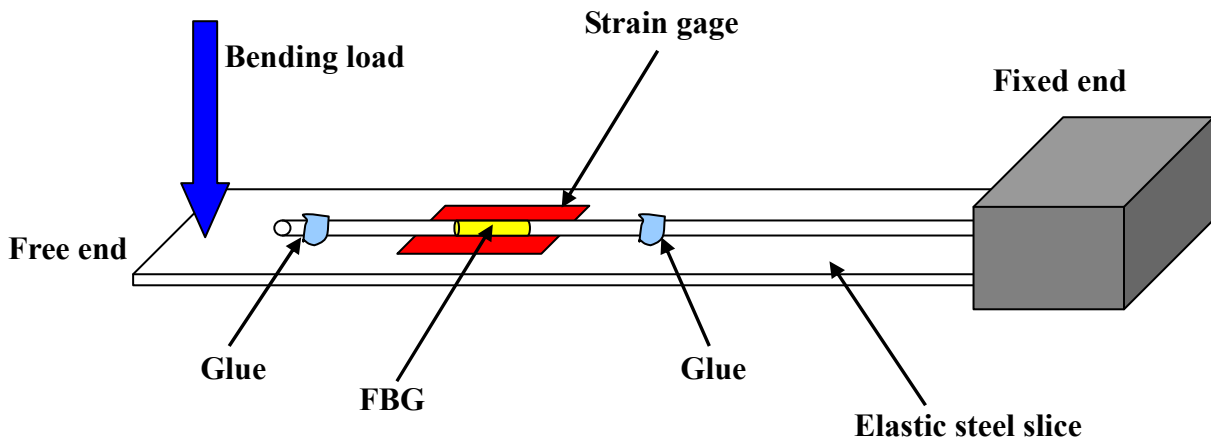
Fig. 4-36: Schematic of experimental set-up in bending test for the FBG drawn out from CFRP specimen.

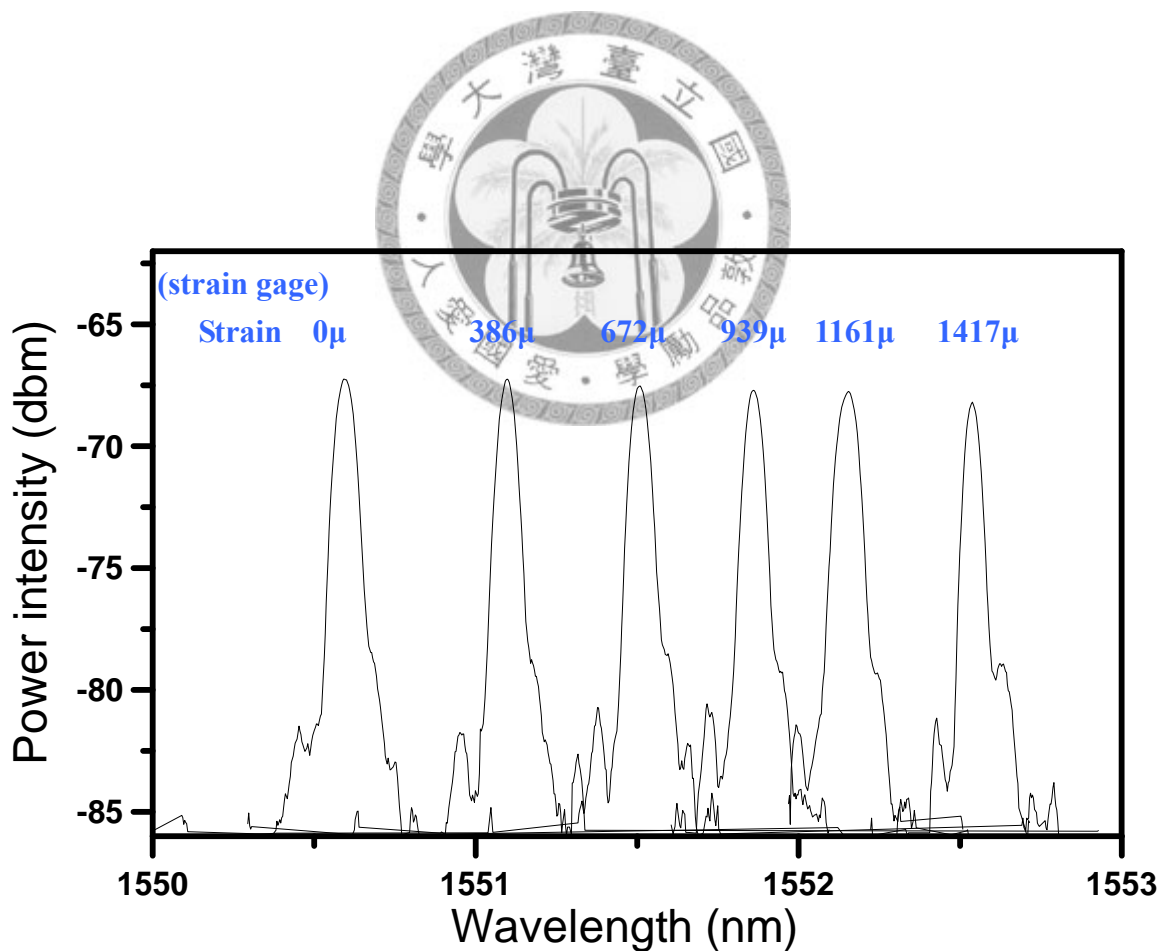
Fig. 4-37: Reflection spectra from the FBG, which is the same as the one whose spectra shown in Fig 4-20, after drawn out from CFRP specimen at various strains

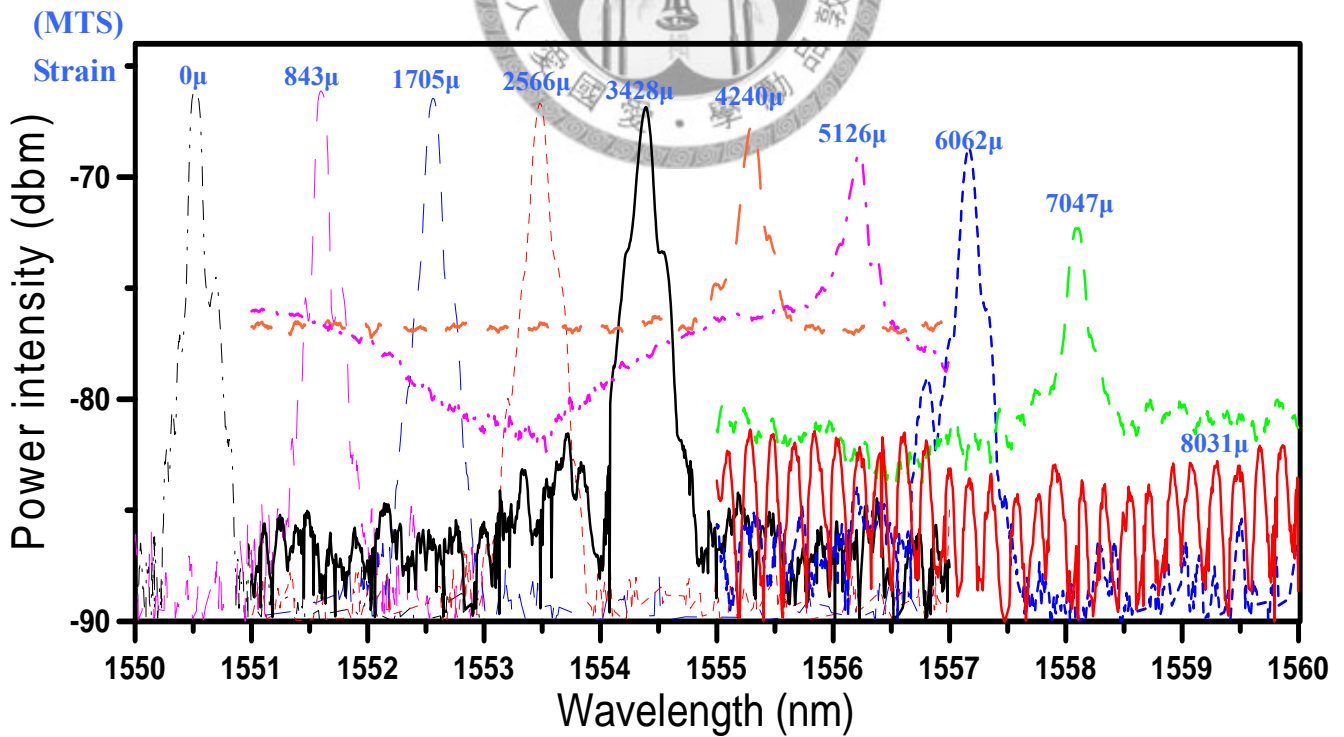
Fig. 4-39: Reflection spectra from the FBG embedded in CFRP specimen along the tensile test at various strains.

This phenomenon of intensity increasing in other wavelengths was also found in tensile test. The specimen without impact was pulled in tension using MTS, and the strains at various tensile loads were measured from Linear Variable Differential Transformer (LVDT) displacement. As shown in Fig. 4-39, the waveform shifted as the tensile load was increased. It could be observed that the waveform just shifted before the strain was about 3428μ . At 4240μ , it was found that the intensity of the other wavelengths was increased, and the wavelength peak was shifted as well. At 5126μ , we could observe that the waveform of other wavelength transformed into corrugated form, Fig. 4-40 shows the spectrum in the wider wavelength span from 1520nm to 1580nm. This waveform of spectrum was also found in Fig.4-21. Additionally, as the strain increased to 6062μ , the intensity of other wavelength reverted to normal state. In the mean time, we could heard that the fracturing sound of

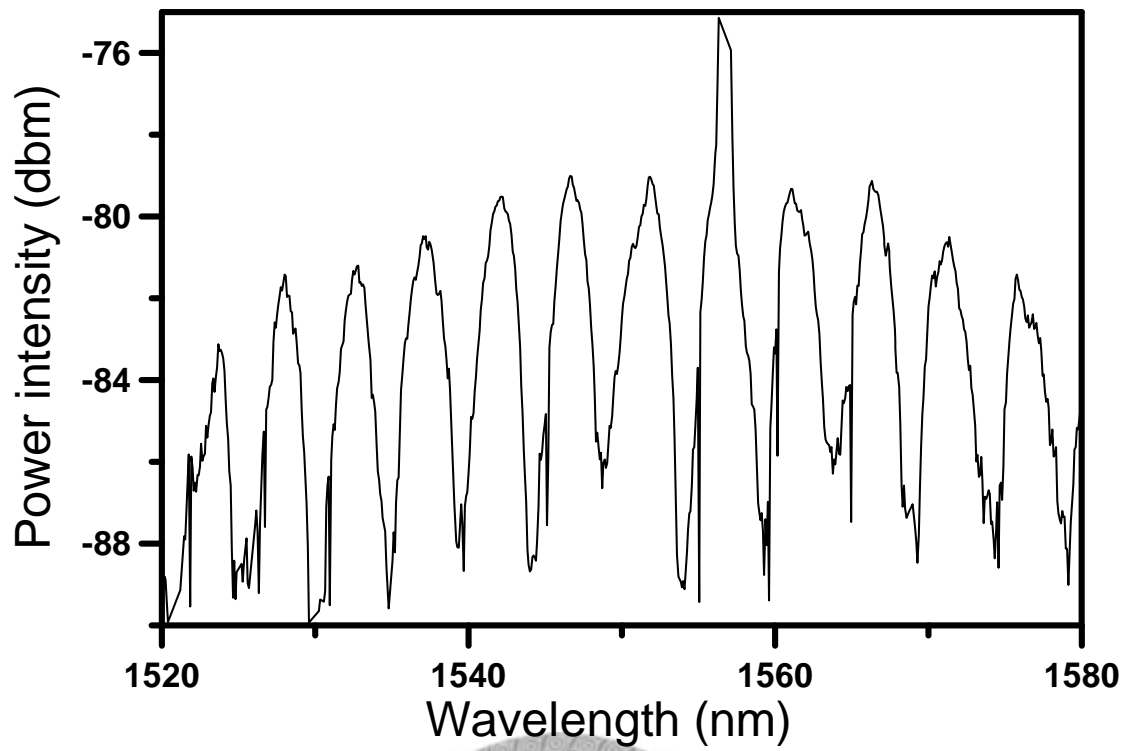
Fig. 4-40: Reflection spectrum at the strain 5126 μ in Fig. 4-38 in the wavelength span from 1520nm to 1580nm

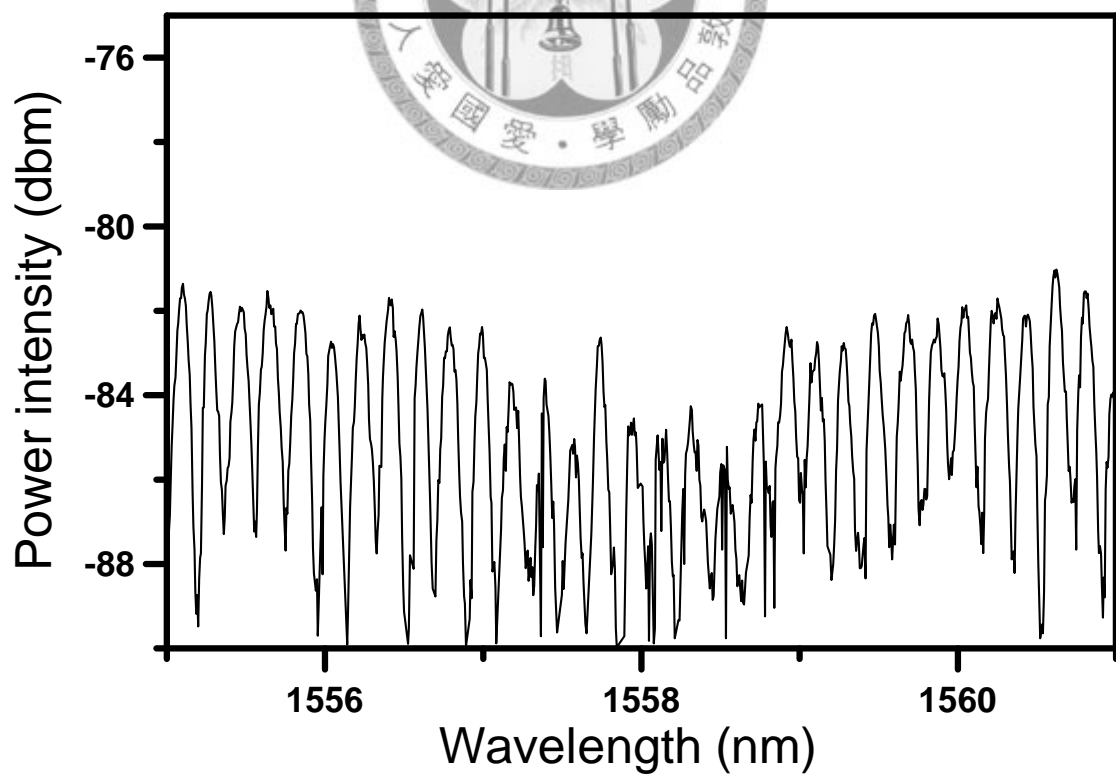
Fig. 4-41: Reflection spectrum at the strain 8031 μ in Fig. 4-38 in the wavelength span from 1555nm to 1561nm

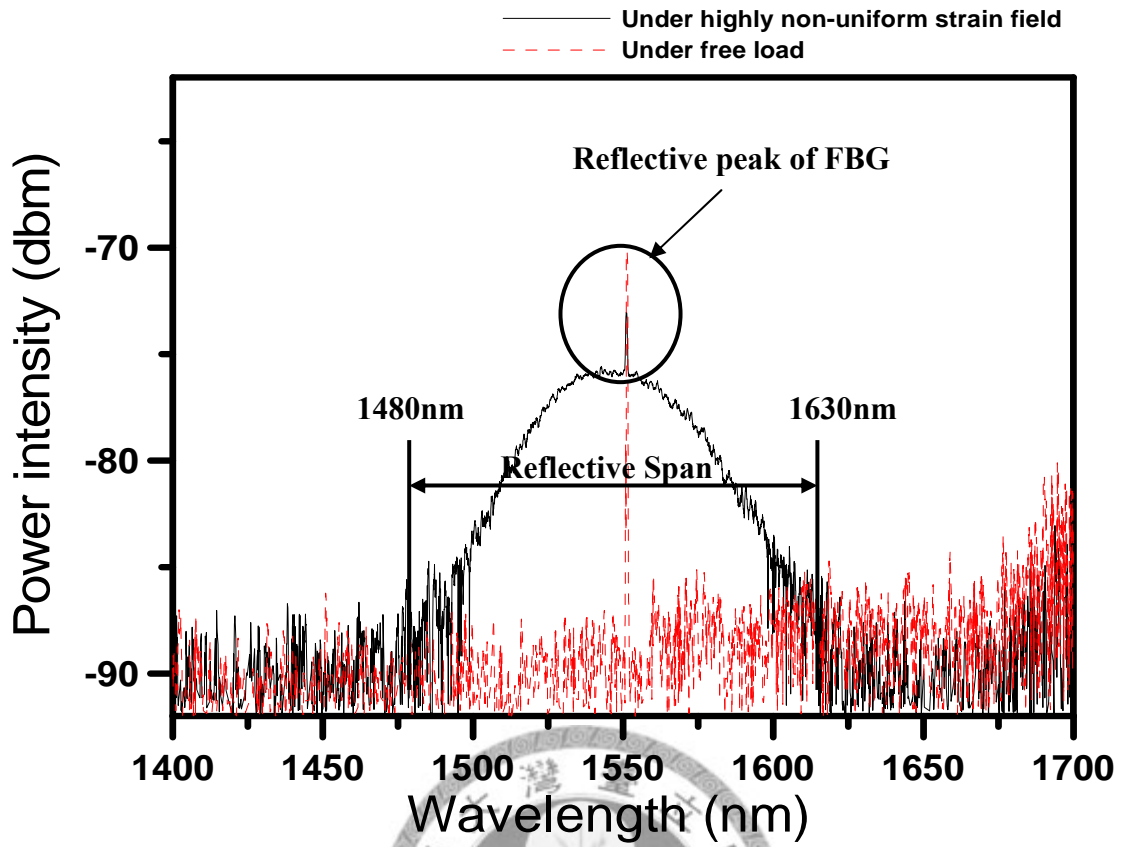
Fig. 4-42: Spectrum of intensity increasing in other wavelength in the span from 1400nm to 1700nm.

tensile test, the impact damage and the further fatigue test can induce complex damage condition that lead to highly non-uniform strain, which cause the FBG sensors to reflect not only the specific wavelength light, but also the light in a wide span from about 1480nm to 1630nm, as shown in Fig. 4-42. Due to this phenomenon, it makes the analysis of monitoring for post-impact fatigue damage progressing was relatively difficult. As a result, for post-impact fatigue damage monitoring applications, it is necessary to improve the fabrication method of this system to avoid the occurrence of the intensity increasing in other wavelength.

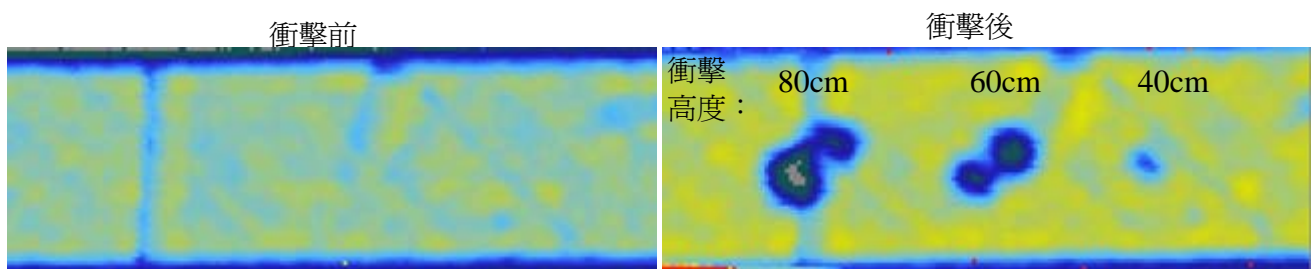
圖 1 衝擊高度為 40~80cm 試片之衝擊前後 C-Scan 掃描檢測結果。

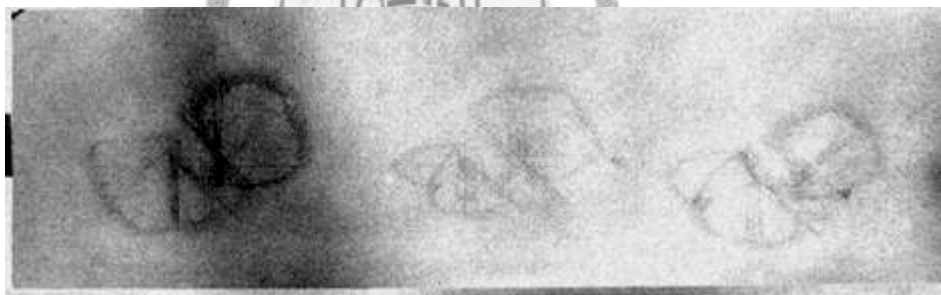
圖 4 衝擊高度為 100~140cm 之試片 X-Ray 照相檢測結果。

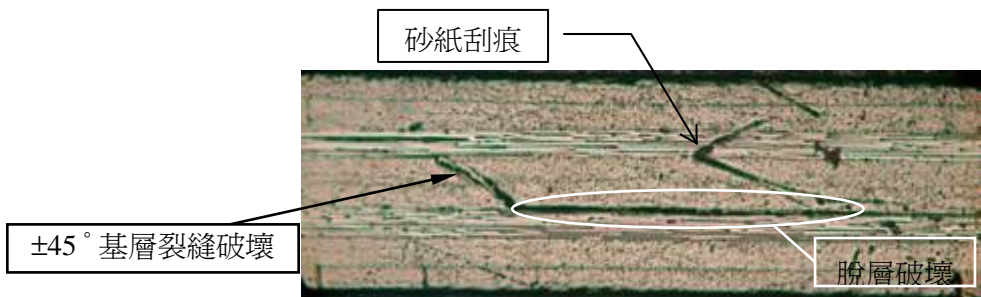
圖 6 衝擊高度 40cm 截面 H-H。 0.6mm

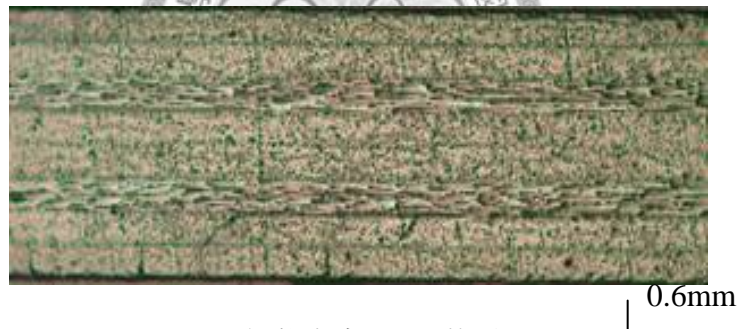
圖 7 衝擊高度 40cm 截面 I-I。
