碩士論文

以內埋式光纖光柵感測器監測碳纖維複合材料衝擊及

Application of Investigating the Impact and Fatigue Damage in

Carbon Fiber Composite by Using Pre-embedded Fiber Bragg

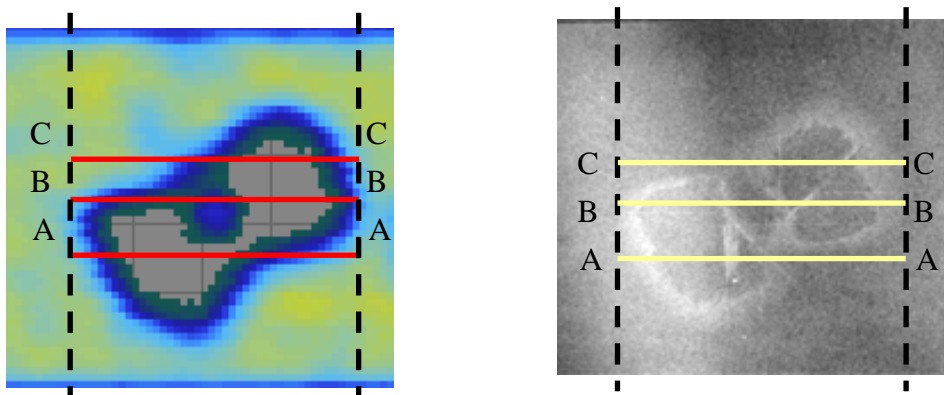
圖 8 衝擊高度 140cm 顯微斷面裁切示意圖。

圖 8 為衝擊高度 140cm 破壞的觀察截面 A-A 至 C-C 與 C-scan 及 X-ray 的破壞顯示區域的位置對應，相較於衝擊較低之衝擊，在脫層破壞中層與層間的距離及脫層破壞規模都嚴重許多，圖 9 中截面 A-A 在串聯不同脫層的基層裂縫破壞之處(圖中圈圈處)，會在 X-ray 的成像中出現較明顯的白色條紋，應為此處的裂縫方向垂直

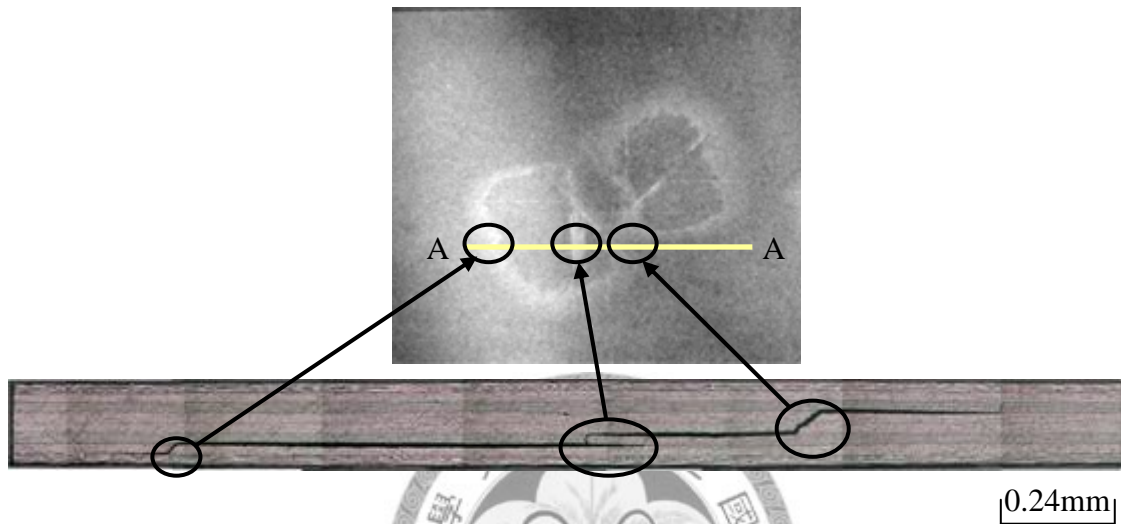
圖 9 衝擊高度 140cm 截面 A-A 破壞機制相對位置圖。

於拍攝的方向之關係，在此顯影劑的含量與厚度也較高，使 X-ray 能量的吸收較明顯所致，此一細節在 C-scan 的檢測是無法辨識的。相同的現象亦出現在圖 10 及 11 兩個截面上。截面 B-B 正好通過衝擊點，圖 11 顯示衝擊點下沒有看到脫層破壞，此與超音波及 X-ray 檢測的顯示吻合。

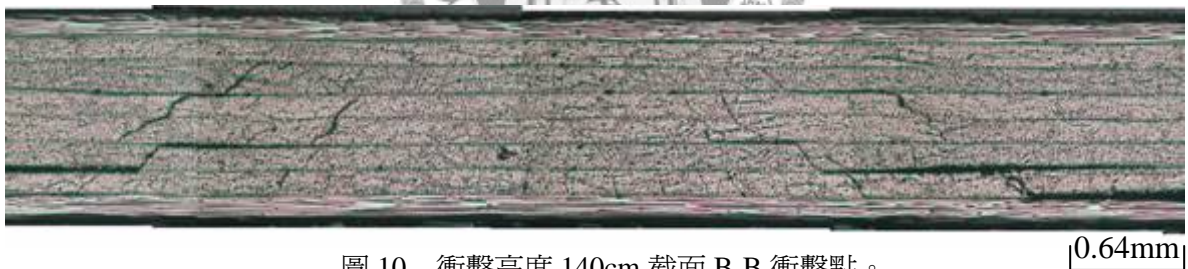
圖 10 衝擊高度 140cm 截面 B-B 衝擊點。

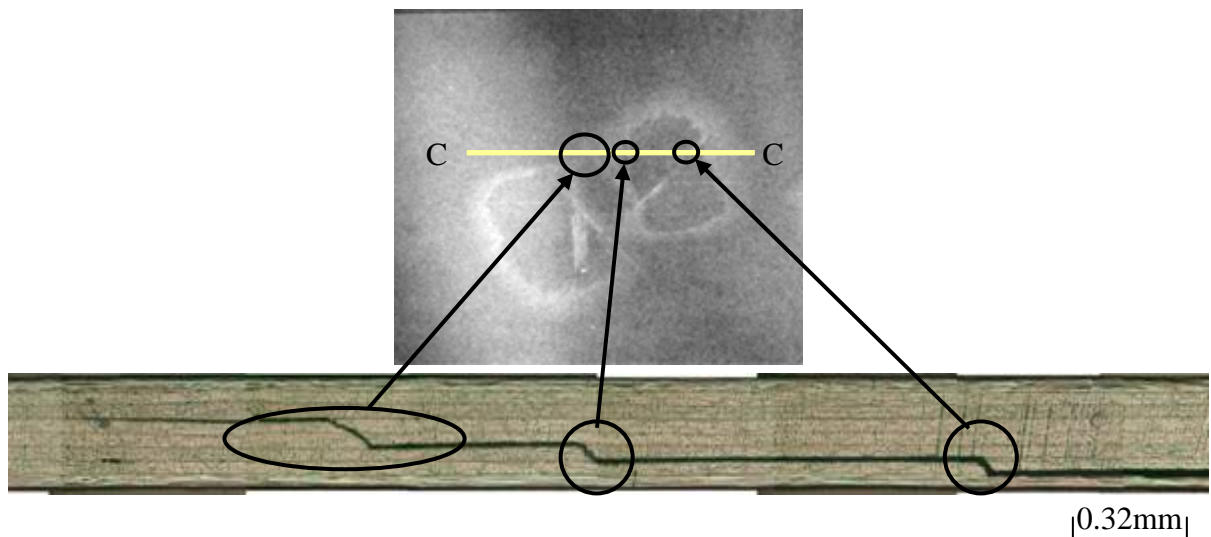
圖 11 衝擊高度 140cm 截面 C-C 破壞機制相對位置圖。

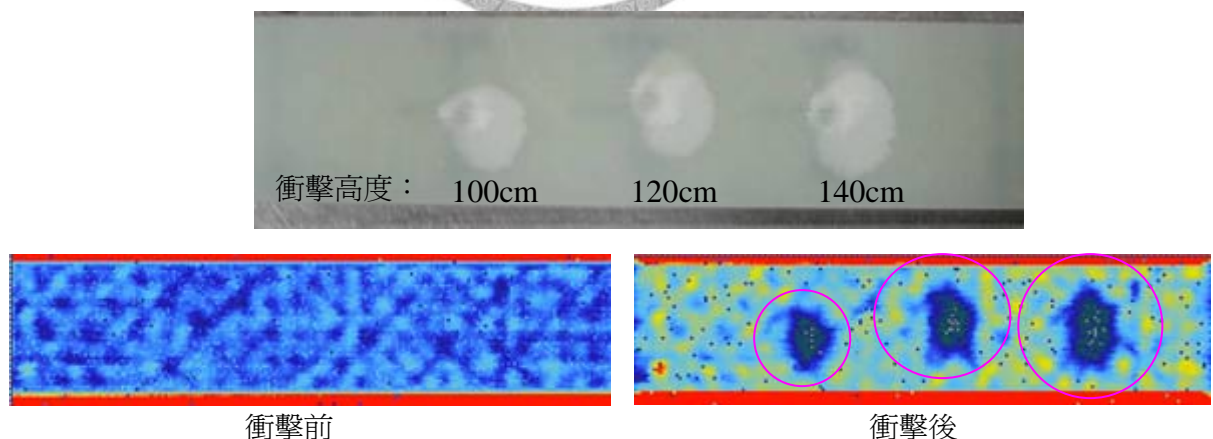
圖 13 衝擊高度為 100~140cm 試片之衝擊前後 C-Scan 掃描檢測結果及衝擊後背面的照片。

的照片以及 C-scan 掃描圖，與上一系列衝擊能量較輕的相比，此系列試片的背面可以更清楚看到破壞的痕跡。由試片衝擊前後的 C-scan 掃描檢測比較結果可知，隨著衝擊高度增加衝擊能量增加，試片受到破壞而使超音波掃描時能量的散失越大，故在掃描圖上呈現出較大的破壞範圍。

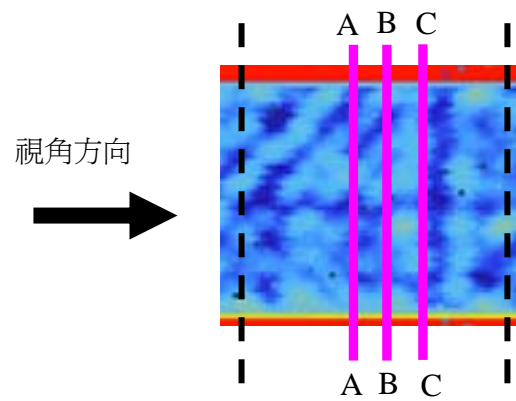
圖 14 衝擊高度 40cm 顯微斷面裁切與超音波檢查結果關係示意圖。

與碳纖維複材一樣，不同衝擊高度所造成的內部破壞除程度上的差異外，破壞機制基本類似，茲以衝擊高度為 40cm 及 120cm 兩個情形來說明玻璃纖維複材衝擊破壞的顯微觀察。圖 14 為衝擊高度 40cm 破壞的觀察截面 A-A 至 C-C 與 C-scan 掃描的位置對應，在此衝擊高度，C-scan 掃描雖未顯示破壞，但顯微觀察則顯示在衝擊範圍內並沒有發現脫層，靠近試片背面處有垂直於試片表面之微小裂縫（見圖 15），微裂縫其數量有限，長度也侷限在最外一層到兩層。這些微裂縫方向，不會導致超音波能量有顯著的散射現象，又與 X-ray 的方向平行，因此，在超音波檢查及 X-ray 照相中，均沒有明確的破壞顯示。

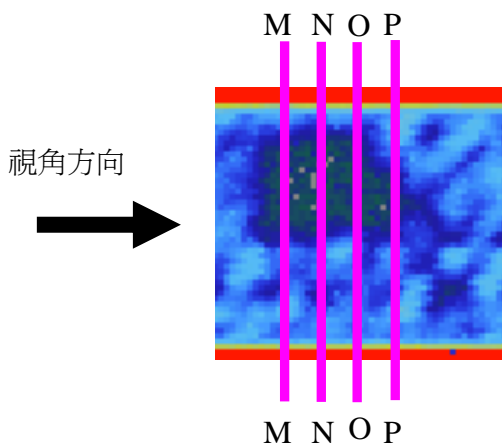
圖 16 衝擊高度 120cm 顯微斷面裁切與超音波檢查結果關係示意圖。

圖 16 為衝擊高度 120cm 破壞的觀察截面 M-M 至 P-P 與 C-scan 掃描的位置對應，圖 17 至 20 為這些截面的顯微觀察。在較高的衝擊能

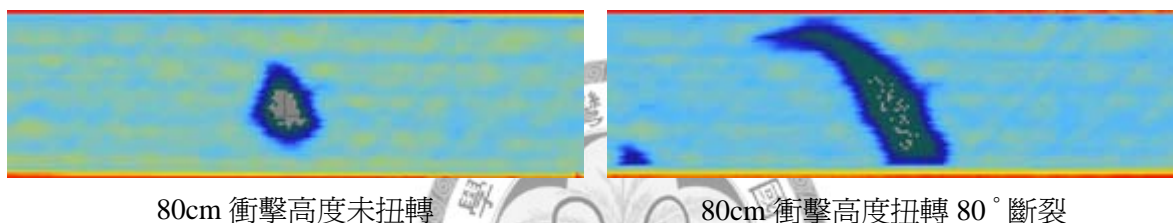
圖 21 炭纖維複材試片經 80cm 高度衝擊之扭轉破壞前後 C-Scan 掃描檢測。

此試驗先以衝擊高度 80cm 打擊試片後，再給予扭轉，圖 21 為先以衝擊高度 80cm 的能量做衝擊再施以扭轉破壞的 C-scan 掃描比較，在扭轉至 60° 時 C-scan 掃描顯示原衝擊點的破壞範圍沒有任何變化，但在扭轉角度增加到 75°~80° 時便瞬間斷裂，圖 22 為斷裂試片的背面觀察。

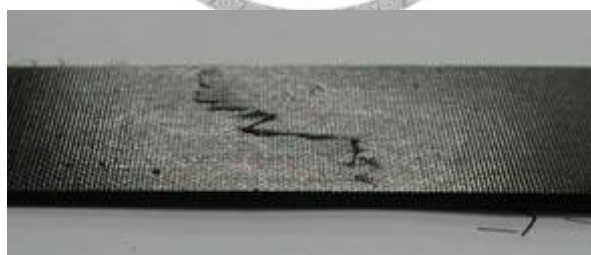
斷裂試片背面扭轉破壞

圖 22 炭纖維複材試片經 80cm 高度衝擊之扭轉破壞後試片表面觀察。

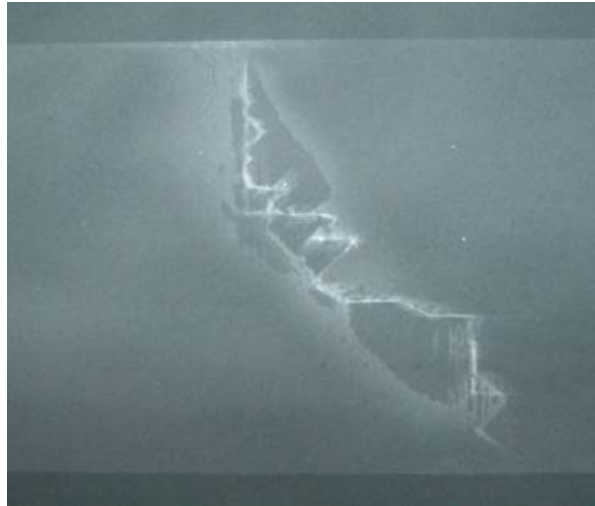
圖 23 炭纖維複材試片經 80cm 高度衝擊之扭轉破壞 X-ray 照相結果。

試片在無顯影劑輔助之情況下，依然無法呈現出破壞的情形，而另一方面有加入顯影劑輔助後則有不錯的顯影效果，破壞顯影區域經放大後（圖 23），其中可以清楚的看見較亮的白色條紋

為主要的裂縫(表面裂縫)，次要的裂縫(基材裂縫)則為較黯淡白色條紋。

X-ray 檢測所顯示的破壞規模與 C-scan 的相差不遠，但 X-ray 於細節的顯示上依然略勝一籌。

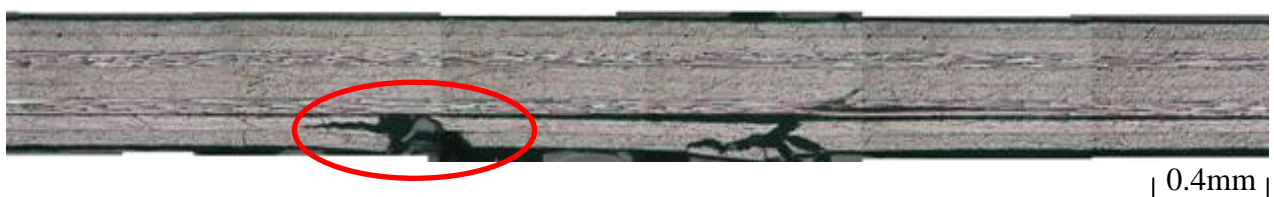
圖 25 炭纖維複材試片經 80cm 高度衝擊之扭轉破壞顯微觀察 A-A 截面。

衝擊高度 80cm 之扭轉破壞所造成的破壞規模較大，因此估計可以觀察到的裂縫發展模式將會較低能量衝擊的試片明顯，圖 24 為裁切之規劃示意圖，由於破壞範圍較大所以欲觀察之截面分為 A-A (圖 25) 與 B-B(圖 26)，A-A 截面由於破壞程度較嚴重以致於裁切試片時便有部分試片剝落，圖 25 的圈圈處顯示出部分試片丟失之

情形。圖 25 與圖 26 中可以發現因扭轉所產生之通往表面裂縫其裂縫面皆相當不平整，除此之外其裂縫之發展方向較不規律，可以推測扭轉角度在達到一定程度時，裂縫將會由原本衝擊破壞處迅速地往最靠近的試片表面做延伸。在試片因扭轉角度過大達到極限而破壞時，除了出現大量的表面裂縫以外，試片內部亦可以觀察到平行於截面之疊層受扭轉產生破壞(圖 27 右上角附近)。

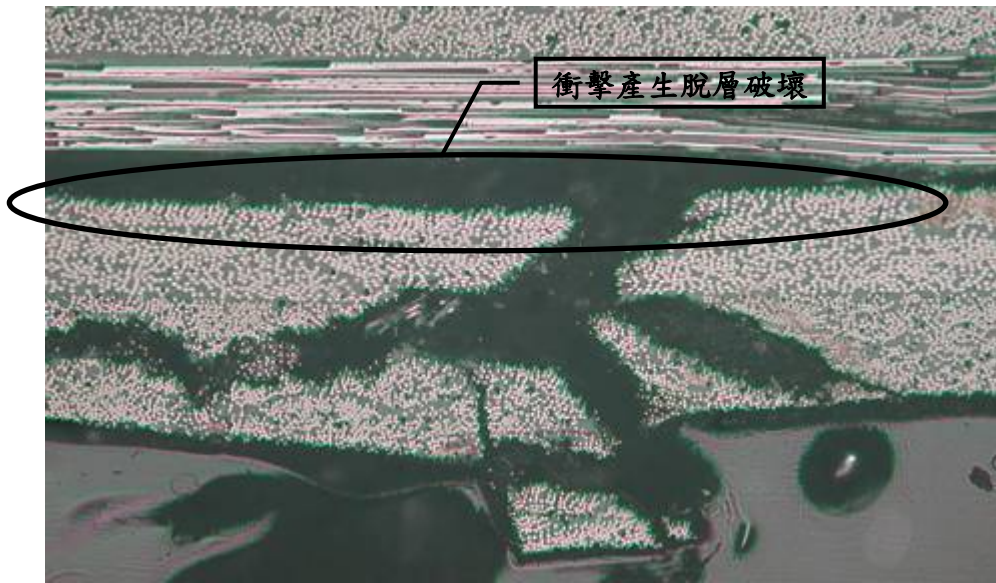
圖 27 炭纖維複材試片經 80cm 高度衝擊之扭轉破壞顯微觀察 A-A 截面右側表面裂縫放大圖。

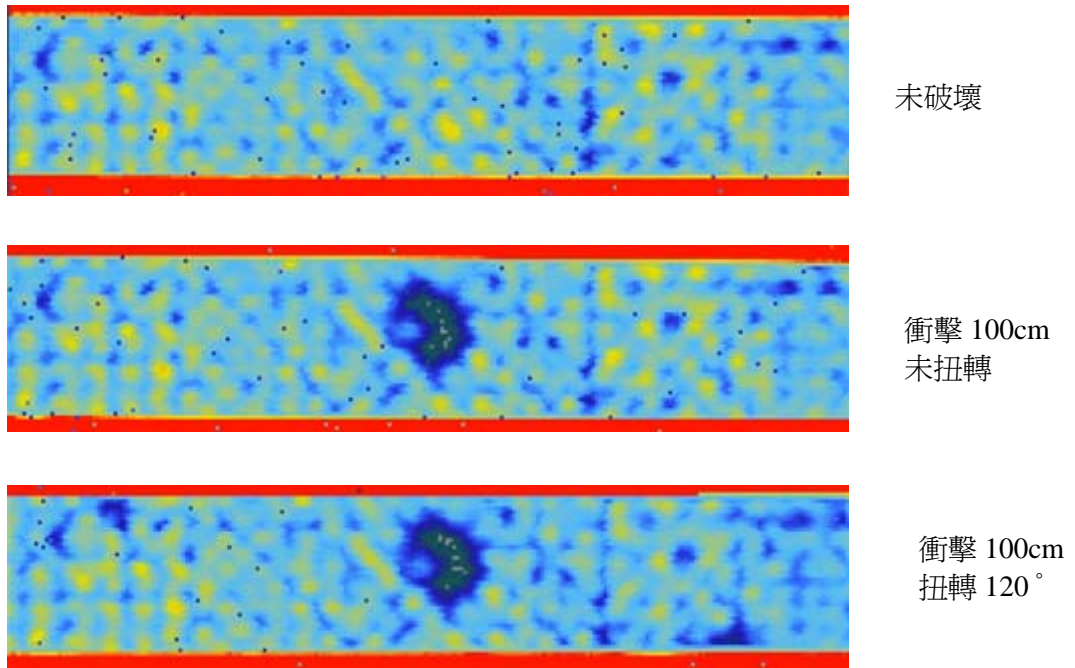
圖 28 玻璃纖維複材試片經 100cm 高度衝擊再扭轉 120° 之超音波 C-scan 掃描圖。

玻璃纖維複材試片先以 110g 鐵製落槌於 100cm 高度衝擊能量打擊試片後，再分別以 100°、110°、120°各種角度進行扭轉，並以超音波掃描 C-scan 進行檢測。圖 28 為衝擊及扭轉前後的 C-scan 掃描圖，不論 100°、110°、120°之扭轉，衝擊點之缺陷皆沒有顯示出擴大之跡象。當扭轉角超過 120°時，試片開始在夾具夾持部位破壞，另一方面，X-ray 照相亦如衝擊破壞的情

形，沒有顯示出破壞的痕跡，推測是衝擊破壞所產生的表面微裂縫在受到扭轉後仍沒有成長至連通到內部破壞，顯影劑無法滲透，故內部缺陷部分仍無法成像。

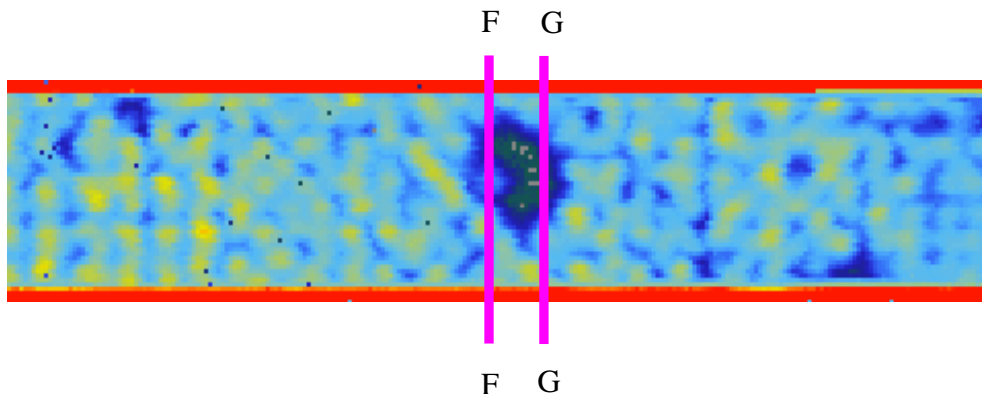
圖 29 玻璃纖維複材試片經 100cm 高度衝擊再扭轉 120° 顯微斷面裁切位置示意圖。

其中 F-F 為落錘衝擊點，G-G 為落槌衝擊點附近所產生之缺陷，圖 30 及圖 31 為此二截面的觀察結果。

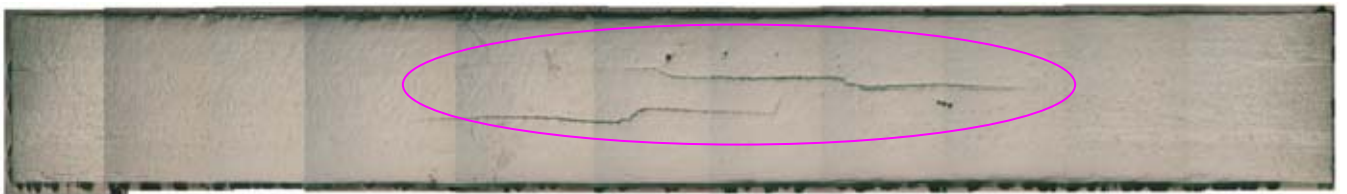
衝擊脫層破壞

圖 31 截面 G-G 顯微觀察圖。

C-scan 檢查顯示在衝擊後，扭轉前或扭轉後的破壞範圍沒有明顯變化的情形，但如觀察本試驗各剖面，則可發現內部脫層裂縫的情形較純粹衝擊之裂縫為嚴重，不過脫層裂縫主要在往上下疊層發展，以致超音波 C-scan 看到的破壞範圍沒有擴大，此一結果，也凸顯出破壞性的顯微觀察較非破壞檢測優越的地方。

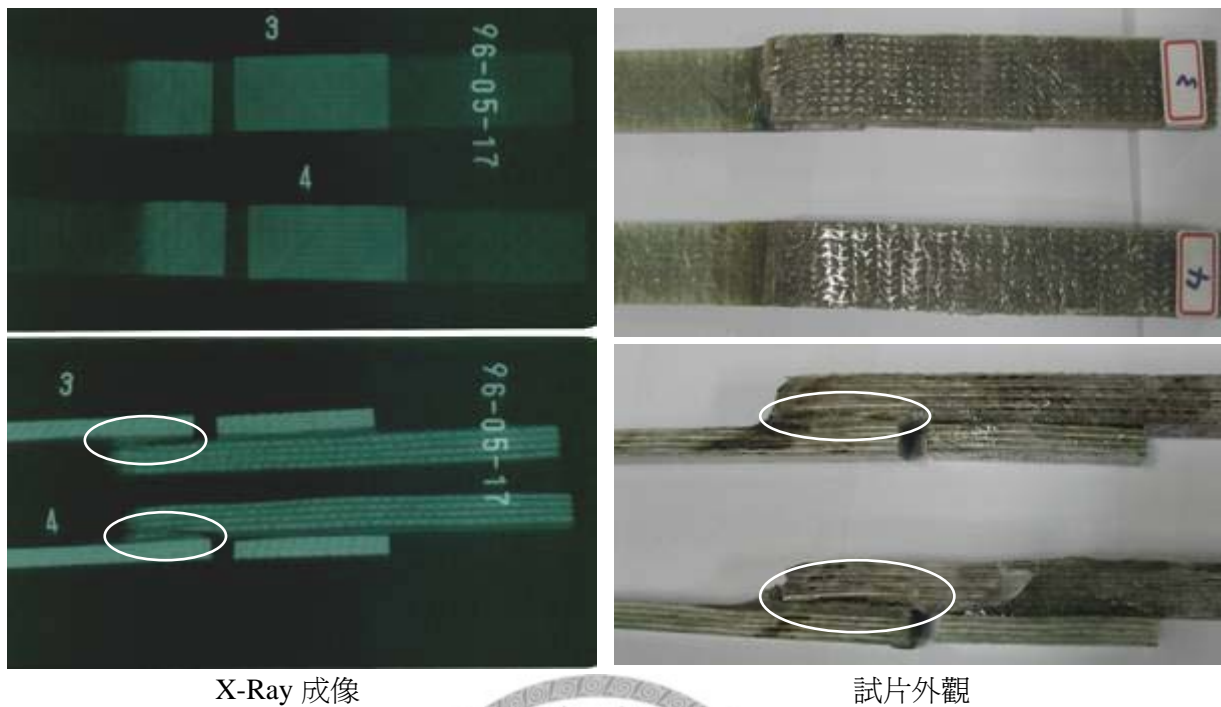
圖 32 膠合破壞試片正面與側面 X-Ray 成像與試片外觀。

圖 32 為脫膠試片正面與側面 X-Ray 成像與試片外觀，此次試驗中皆不加入碘化鋅作為顯影劑，圖右方可以發現，膠合破壞可直接觀察得到，但 X-ray 若由垂直試片表面的方向拍照，卻

無法得到任何與膠合破壞相關之資訊，若由試片側面以 X-ray 照相檢測則會有較佳的效果(圖 32 左下)，因此，在利用 X-ray 照相檢查風機葉片脫膠情形時，建議應採用不同角度拍攝，以利增加其偵測/解讀的可能性。

另考慮到風機葉片結構脫膠可能發生在內部，外面還有複材層板遮蓋，所以此部分檢查，也利用了厚薄不同的遮罩來比較 X-ray 照相檢測的差異，較薄的碳纖維強化複合材料遮罩板，疊層材料為 T300/3501 x 4，疊層方向為 [0/45/90/-45]2S，厚度約為 1mm；另一塊為較厚的玻璃纖維強化複合材料遮罩板，疊層材料為 DBLT1900 x 6，厚度約為 10mm 遮罩距離也有較遠的 300mm 與較短的 10mm 兩種參數，結果各種遮罩的情形，均不影響試片側面 X-ray 照相明確顯示脫膠破壞。
